Subject Marine Incident GSG42827

Marine & Pollution Incident Investigation Report

Collision between vessels, Water Park Creek Corio Bay.

Incident date: 21/12/2017

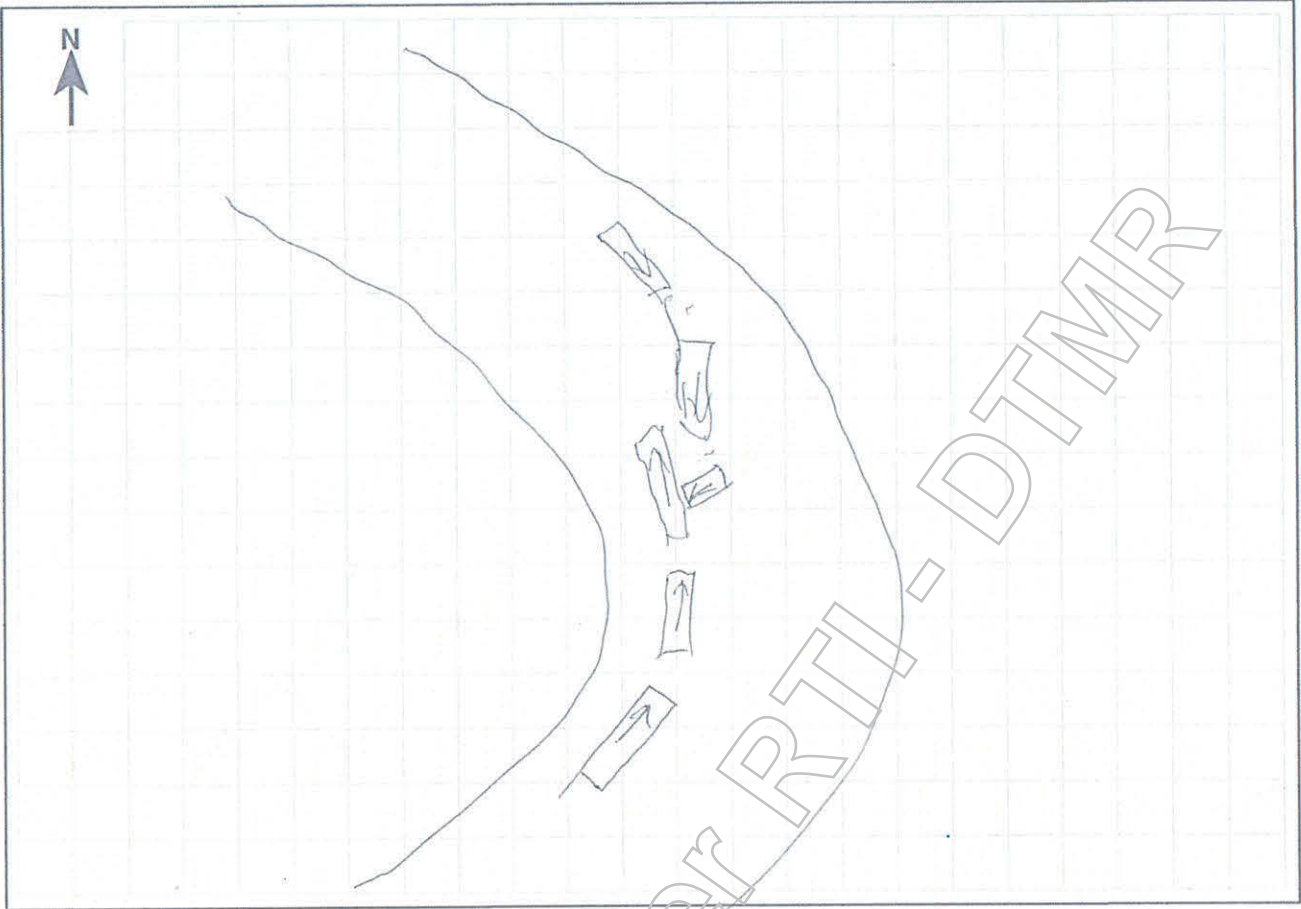
During A LEFT HAND TURN the other vessel
en deavour to pass over the by doing a
sharp RIGHT TURN which resulted in
impact on the front RIGHT OF my
collision was at SPEED DAMAGED to BOTH Vessels
Vessel. NO INJURY Reported. Although
1 on board.
