# Moreton Bay Rail Project

## Independent Hydraulic Review

Prepared for: Department of Transport and Main  
Roads  
Date: 7 August, 2015

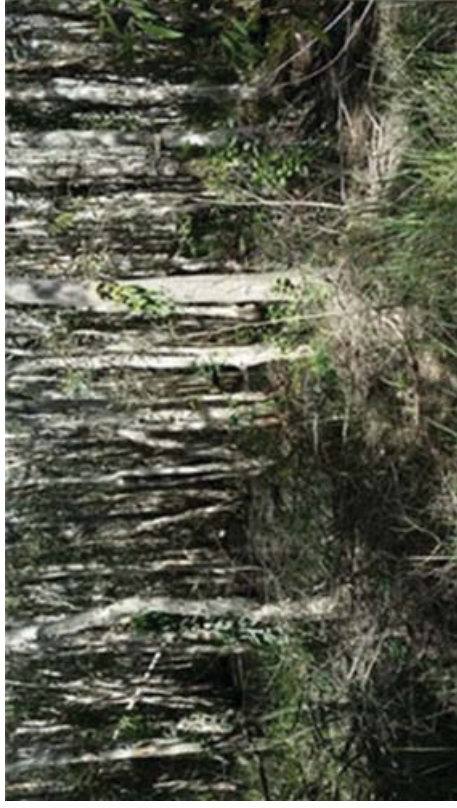
Fences near McGahey Street, Rothwell (16/07/2015)

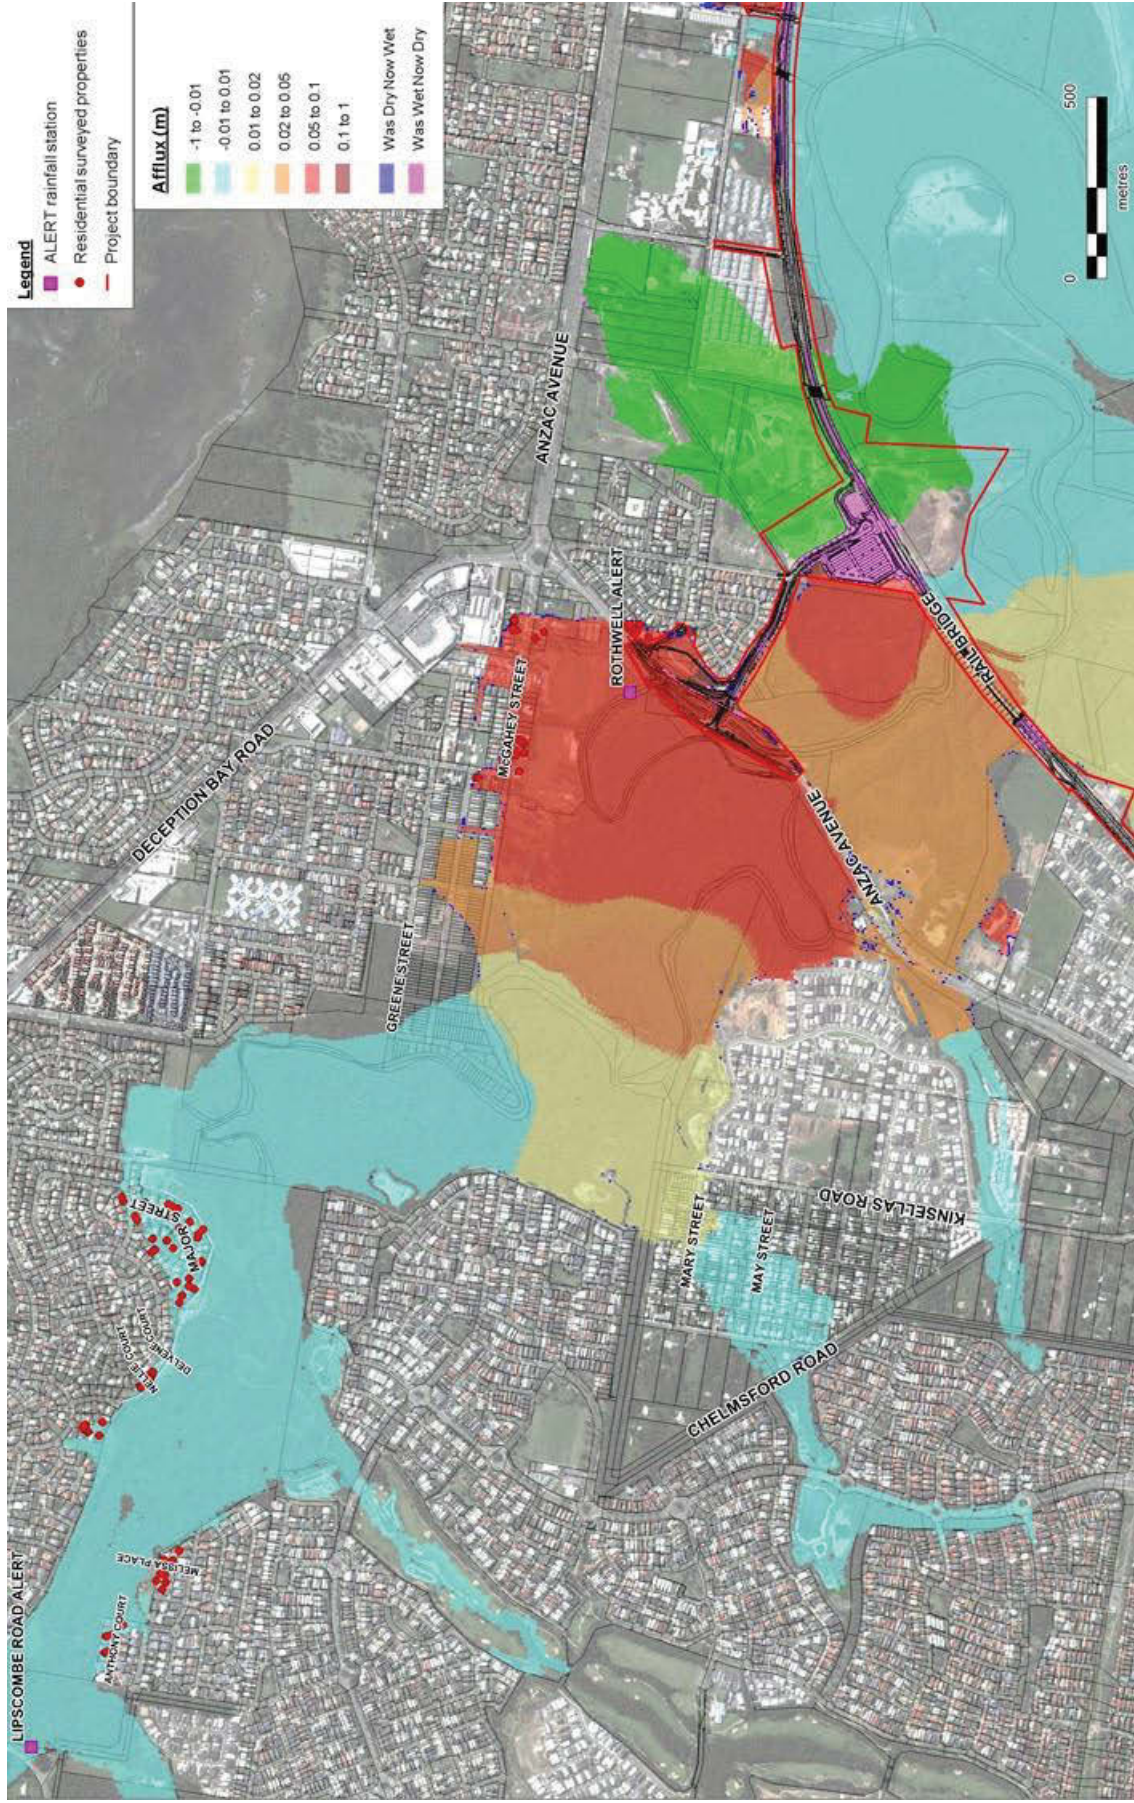
Figure 32 – Afflux, 1% AEP event, Developed vs Existing Base condition

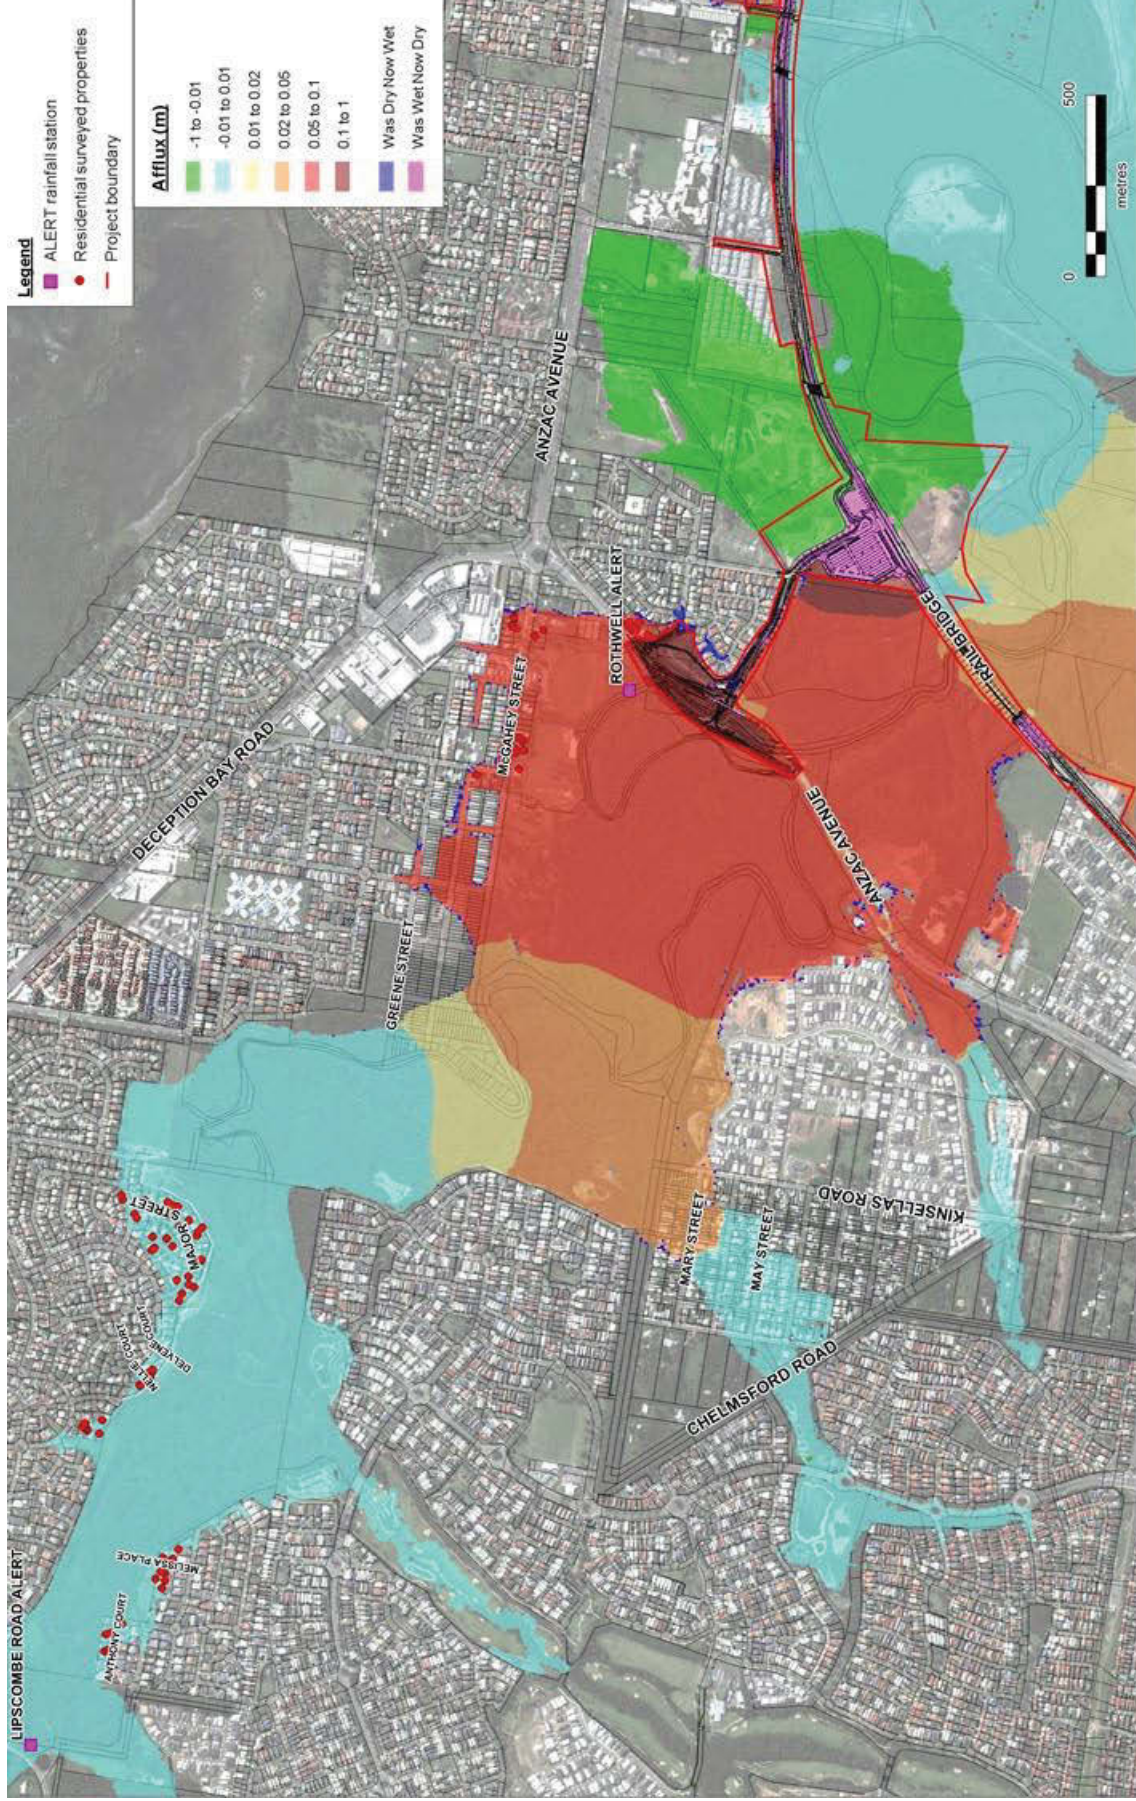
Afflux calculated by comparing resulting water levels from the existing base and developed conditions indicate the MBR project works increased the flood levels upstream of project works within the Saltwater Creek catchment during the 1<sup>st</sup> May 2015 event. The magnitude of the increase varies depending on the location within the catchment and are summarised below:

- There was no increase in flood levels upstream of Greene Street, Rothwell including Major Street and properties further upstream;
- There was an afflux affecting properties at and near Mary Street, Mango Hill. The water level observed was approximately 4.2 mAHD and of this 35 mm can be attributed to the MBR Project;
- There was an afflux affecting properties in McGahey Street, Rothwell. The water level observed was approximately 3.92 mAHD and of this 90-100 mm can be attributed to the MBR Project;
- There was an afflux affecting properties at Anzac Avenue, Rothwell. The water level observed was approximately 3.91 mAHD and of this 90-105 mm can be attributed to the MBR Project; and
- Higher localised affluxes not affecting properties occurred within the downstream section of the floodplain.

Figure 33 – Afflux, 1<sup>st</sup> May 2015 event, Developed condition vs. Existing Base condition

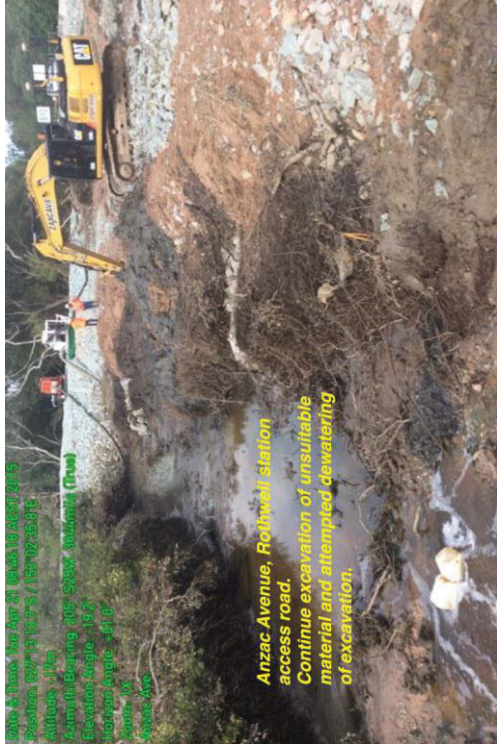
Temporary Works at Anzac Avenue (21/04/2015)
