**Ipswich Connected Vehicle Pilot**

# **Lessons Learned Report**

**March 2022**

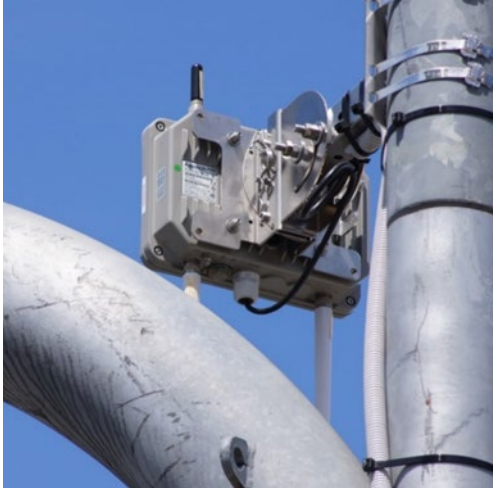
#### Example 1: obstructions from existing road infrastructure

Antenna range should equal to or exceed the approach length defined in MAPEM. Range can be impacted by obstructions such as roadside infrastructure and trees, which can impact the timeliness of the use-case warnings.

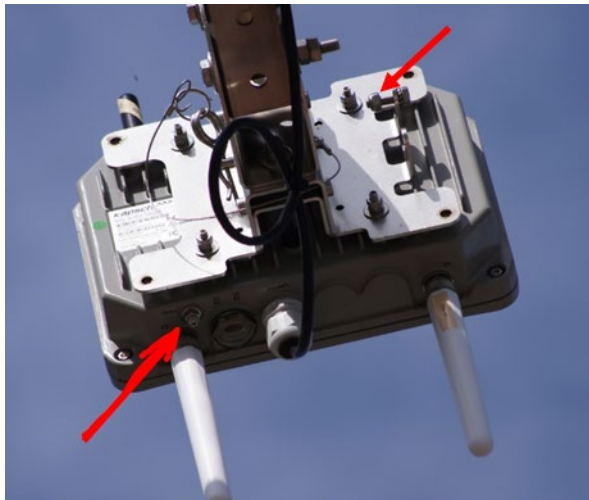
**Situation: Grounding points were not utilised**

During commissioning the grounding ports on the devices were not connected per the vendor's specifications.

Use installation checklists.

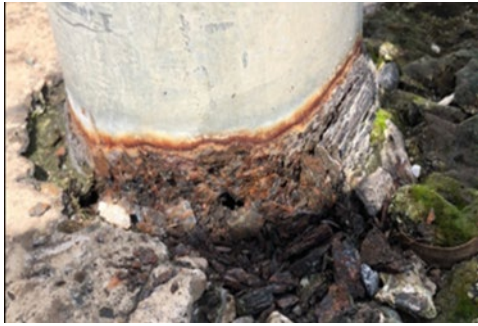
**Situation: Poor traffic pole condition**

Engineering and Technology Structures did not support mounting of any weight of device on traffic poles without structural analysis. On an existing pole, the analysis must consider the integrity of the pole such as the degree of internal corrosion.

Upon visual assessment the traffic poles were found to be in fair to good condition. Assuming a degree of pole degradation/aging (a design reduction factor of 0.95), the preliminary structural analysis for several standard pole types indicate that increases in the load are within the design capacity and risk of structural failure due to the installation of the device is low (see attached report). The additional loading imposed by the installation of the device has been estimated at 2% for Types A to C poles, and 25% for Type D poles (see CAVI typical designs). Type D (pedestrian poles) show the largest increase due to the installation of the extension pole to mount the device at the recommended height.

- That the regions use the result of the analysis for mounting of low weight ITS devices (< 10 kg) – noting the standard pole types and mounting arrangements captured in the analysis.
- That RoadTek replace corroded poles and / or missing grout pads when installing the ITS device.
