2023 Annual Compliance Report EPBC 2020/8692

Yorkeys Knob Boating Facility

2 February 2023 to 1 February 2024

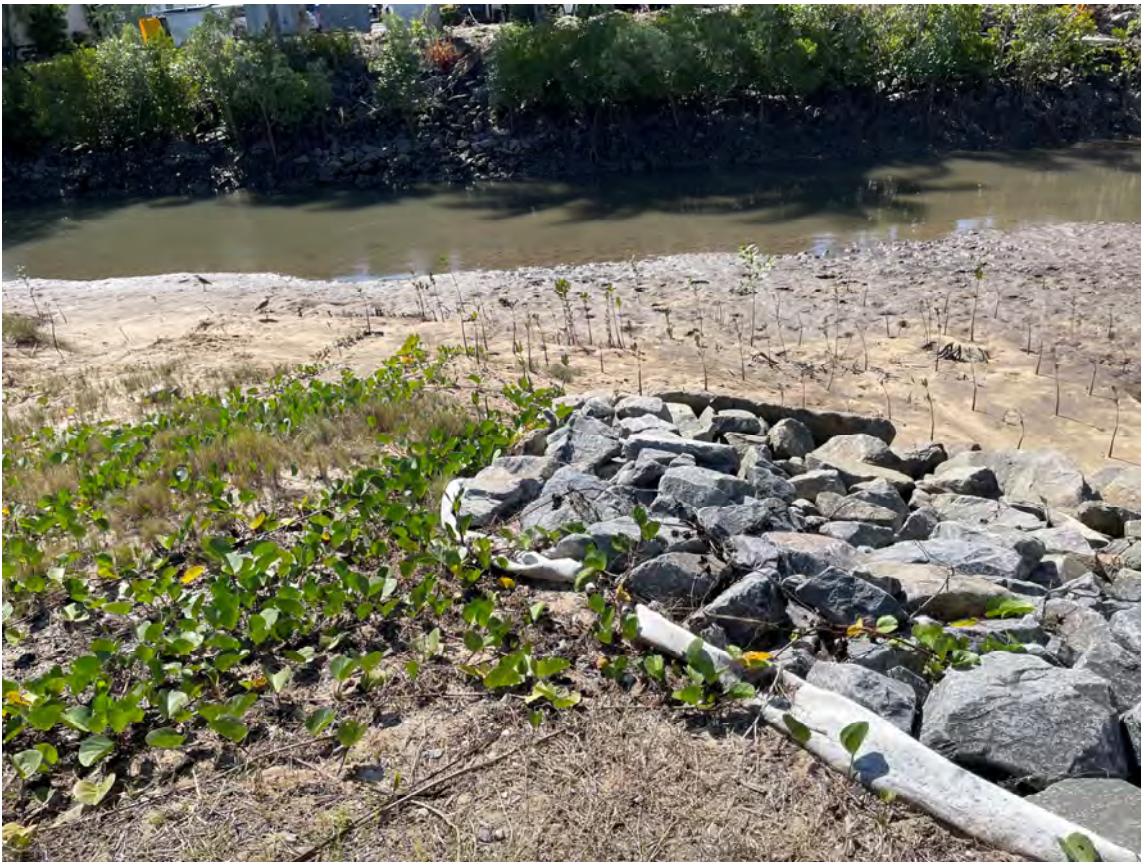
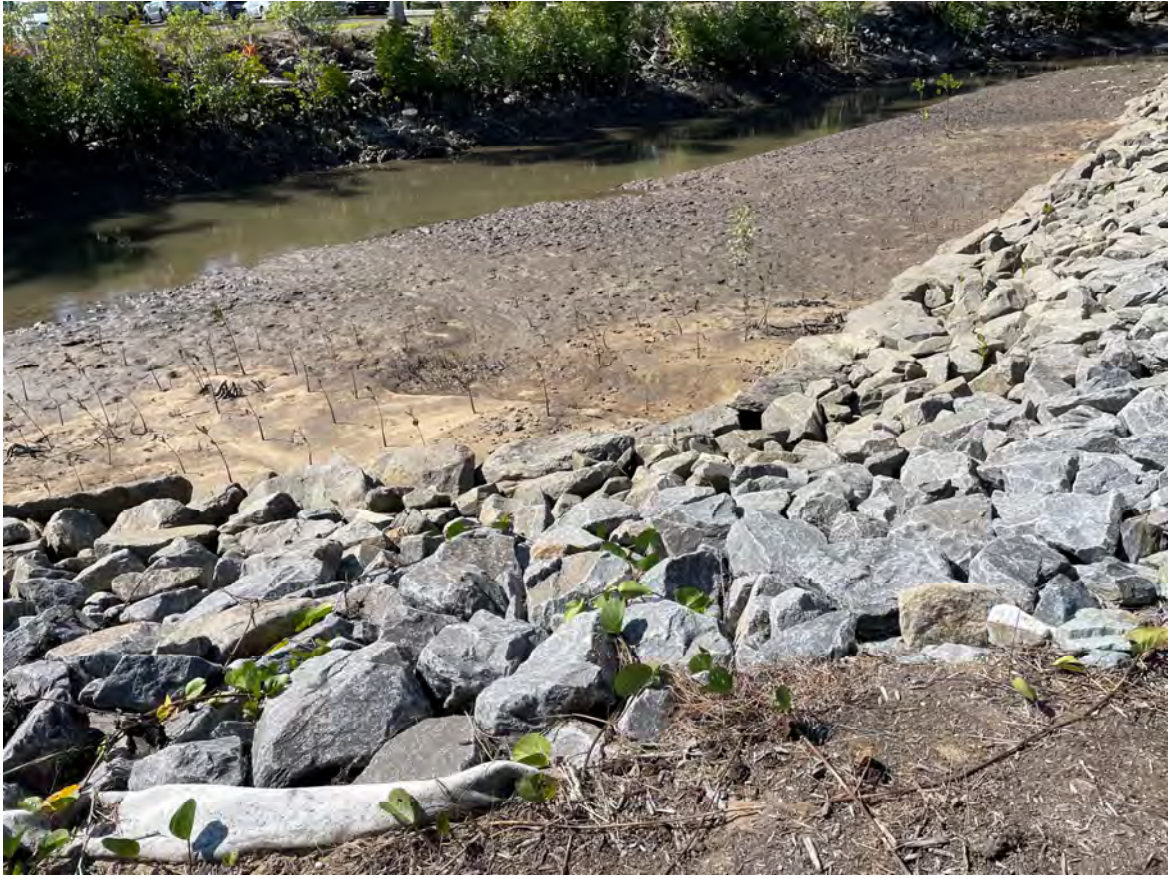
Implementation of this plan commenced with planting completed on 23 February 2024 aligned with the Cairns Regional Council's (CRC) (TMR's partner in this project) approved mangrove harvesting permit window resulting in the planting of minimum of 190 Mangrove hypocotyls in the rehabilitation area and 45 littoral/strand seedings. CRC's specialist contractor who undertook the planting have subsequently completed the monitoring work to date. Two photos from 17 July 2024 below indicate positive rehabilitation results to date with monitoring works continuing.

A post works drone capture and assessment of mangrove recovery in the incident area occurred as detailed in **Appendix 7** which in summary showed that TMR and its contractor were successful in achieving no net additional marine plant impact resulting from the incident (IE the originally approved marine plant impact area for the project was less than the actual marine plant impact area, including the incident area.) However, the post works survey showed that only 0.005 ha of natural recovery had occurred in the incident area which included an incident impact area of 0.031ha. Based on the above outcome in accordance with the non-compliance and rehab strategy **Appendix 4** TMR commissioned a rehabilitation plan for rehabilitation of 0.031ha of mangroves, which can be found in **Appendix 5**. This rehabilitation plan was subsequently provided to DCCEE and DAF on 31 January 2024 (**Appendix 6**)

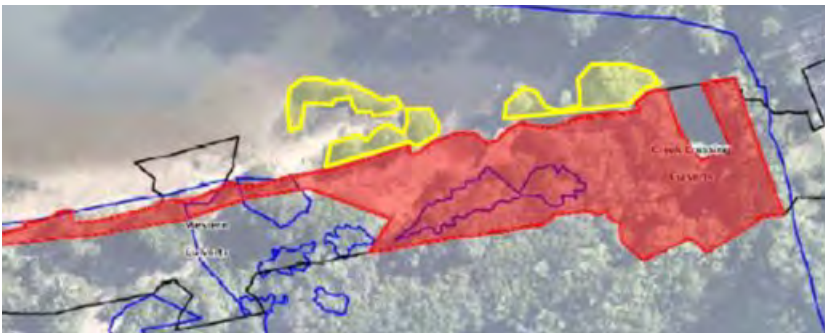
I regret to inform you that our contractor has in error undertaken works including the removal of a small number of shoreline mangrove trees that are outside of the specified impact footprint. See indicative image below with vegetation in question marked in yellow.

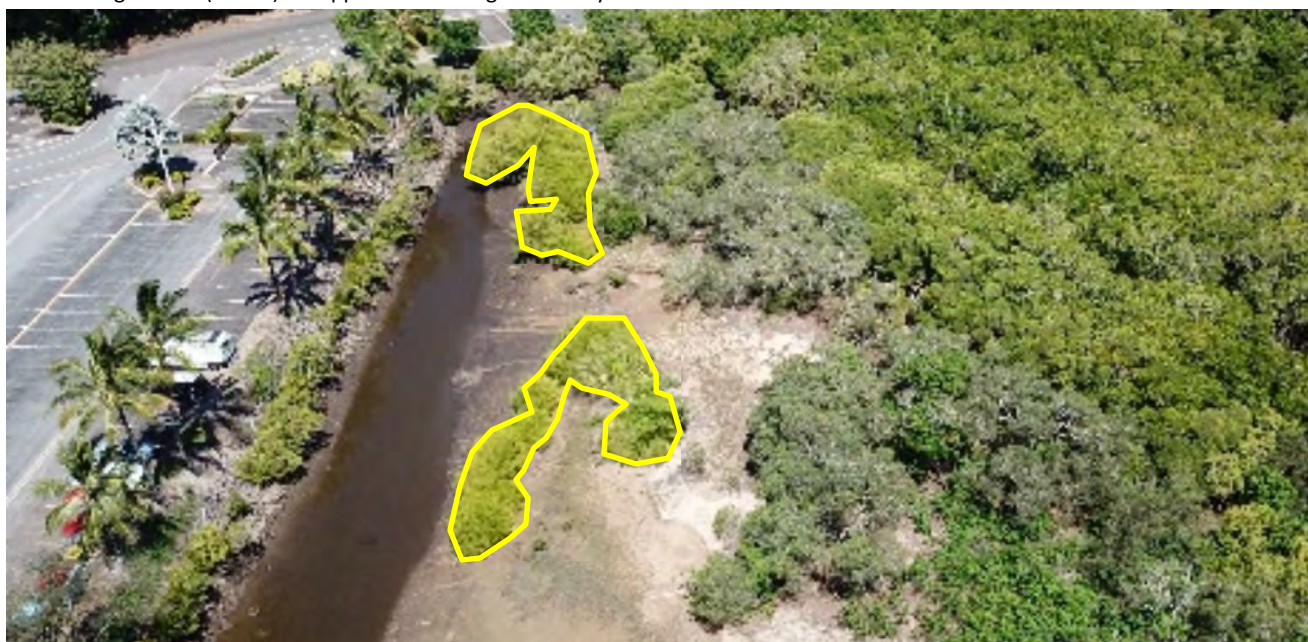
Pre-Clearing Picture (below). Unapproved Clearing shown in yellow at near low tide.

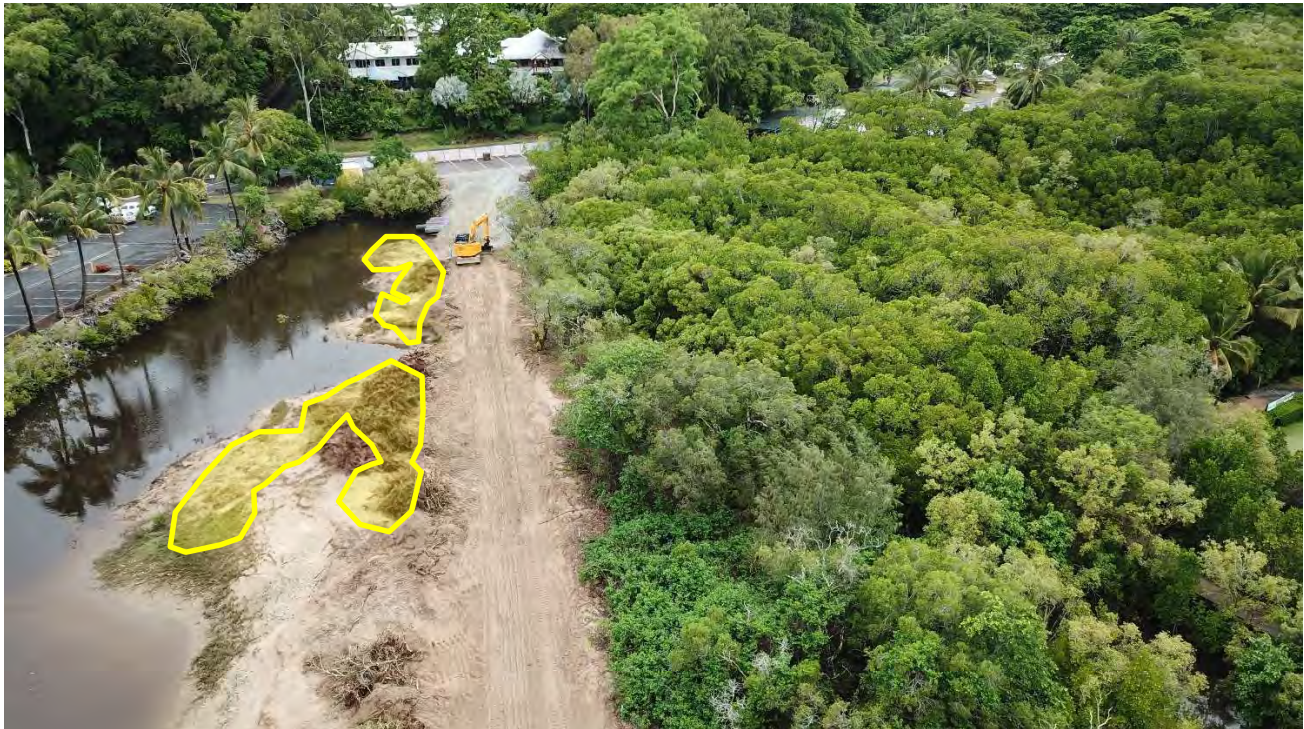
Post-Clearing Picture (below). Unapproved Clearing shown in yellow at near low tide.

1. The non-conformance causes an approval condition breach as clearing took place outside the approved clearing limits/project area.
2. The environmental impacts seem minor to moderate for the following reasons:

21. The projects overall offset area calculation should remain unchanged due to reduced actual clearing area across the site. The figure below indicates the area **not cleared in green**. The **yellow** area indicates the **additional clearing** which amounts to approximately 0.0244ha (244m²). We propose to provide a comparison image/drawing upon completion of the works to verify the actual offset.

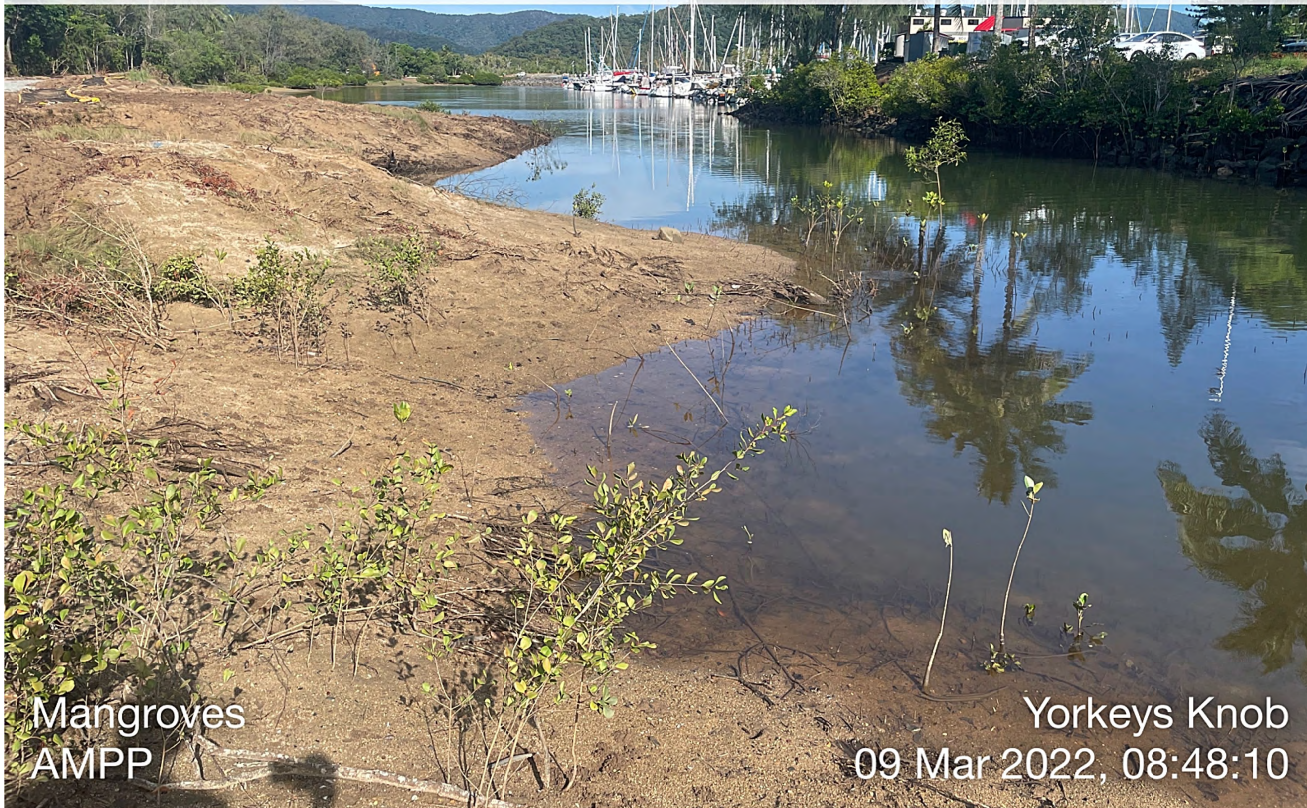
Yorkeys Knob
09 Mar 2022, 08:48:10

After completion of the clearing works, it was noted that the extent of clearing conducted on the northern side of the Access Rd in between CH60 and CH110, exceeded the extent of the approved Marine Plant Impact Area as shown on the below figure with red shading.

Mangroves
AMPP

Measures to prevent reoccurrence:		
<p>26. Hall shall review its Environmental Management Plan and all Project Approval Documents as a Project Team Exercise to ensure no misunderstanding of the plan's environmental requirements and associated approval conditions.</p> <p>27. The action shall be documented via a Minutes of Meeting and a revised Plan if changes are being made.</p>		
Report prepared by: [REDACTED]	Date: 03-Mar-2022	Signature: [REDACTED]
Client Response:		
Corrective Action Accepted:	<input type="checkbox"/>	Initial
Corrective Action Rejected:	<input type="checkbox"/>	Initial
Conditions / Comments:		
NCR CLOSE OUT	Supplementary information attached? <input type="checkbox"/>	
Approved Corrective Action Completed:		/ /
	Contractors Representative Sign:	Date:
		/ /
	Client's Representative Sign:	Date:
Comments:

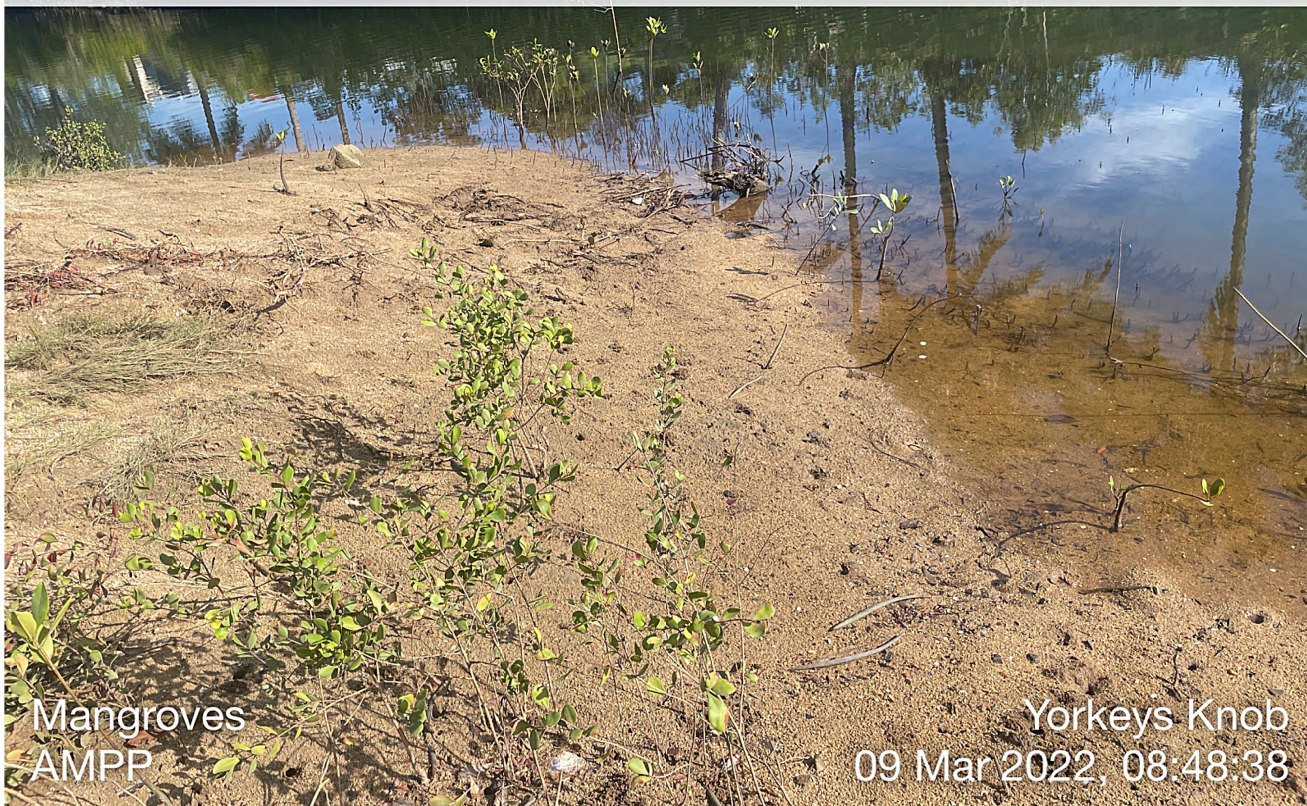
Yorkeys Knob
09 Mar 2022, 08:48:38

Mangroves
AMPP

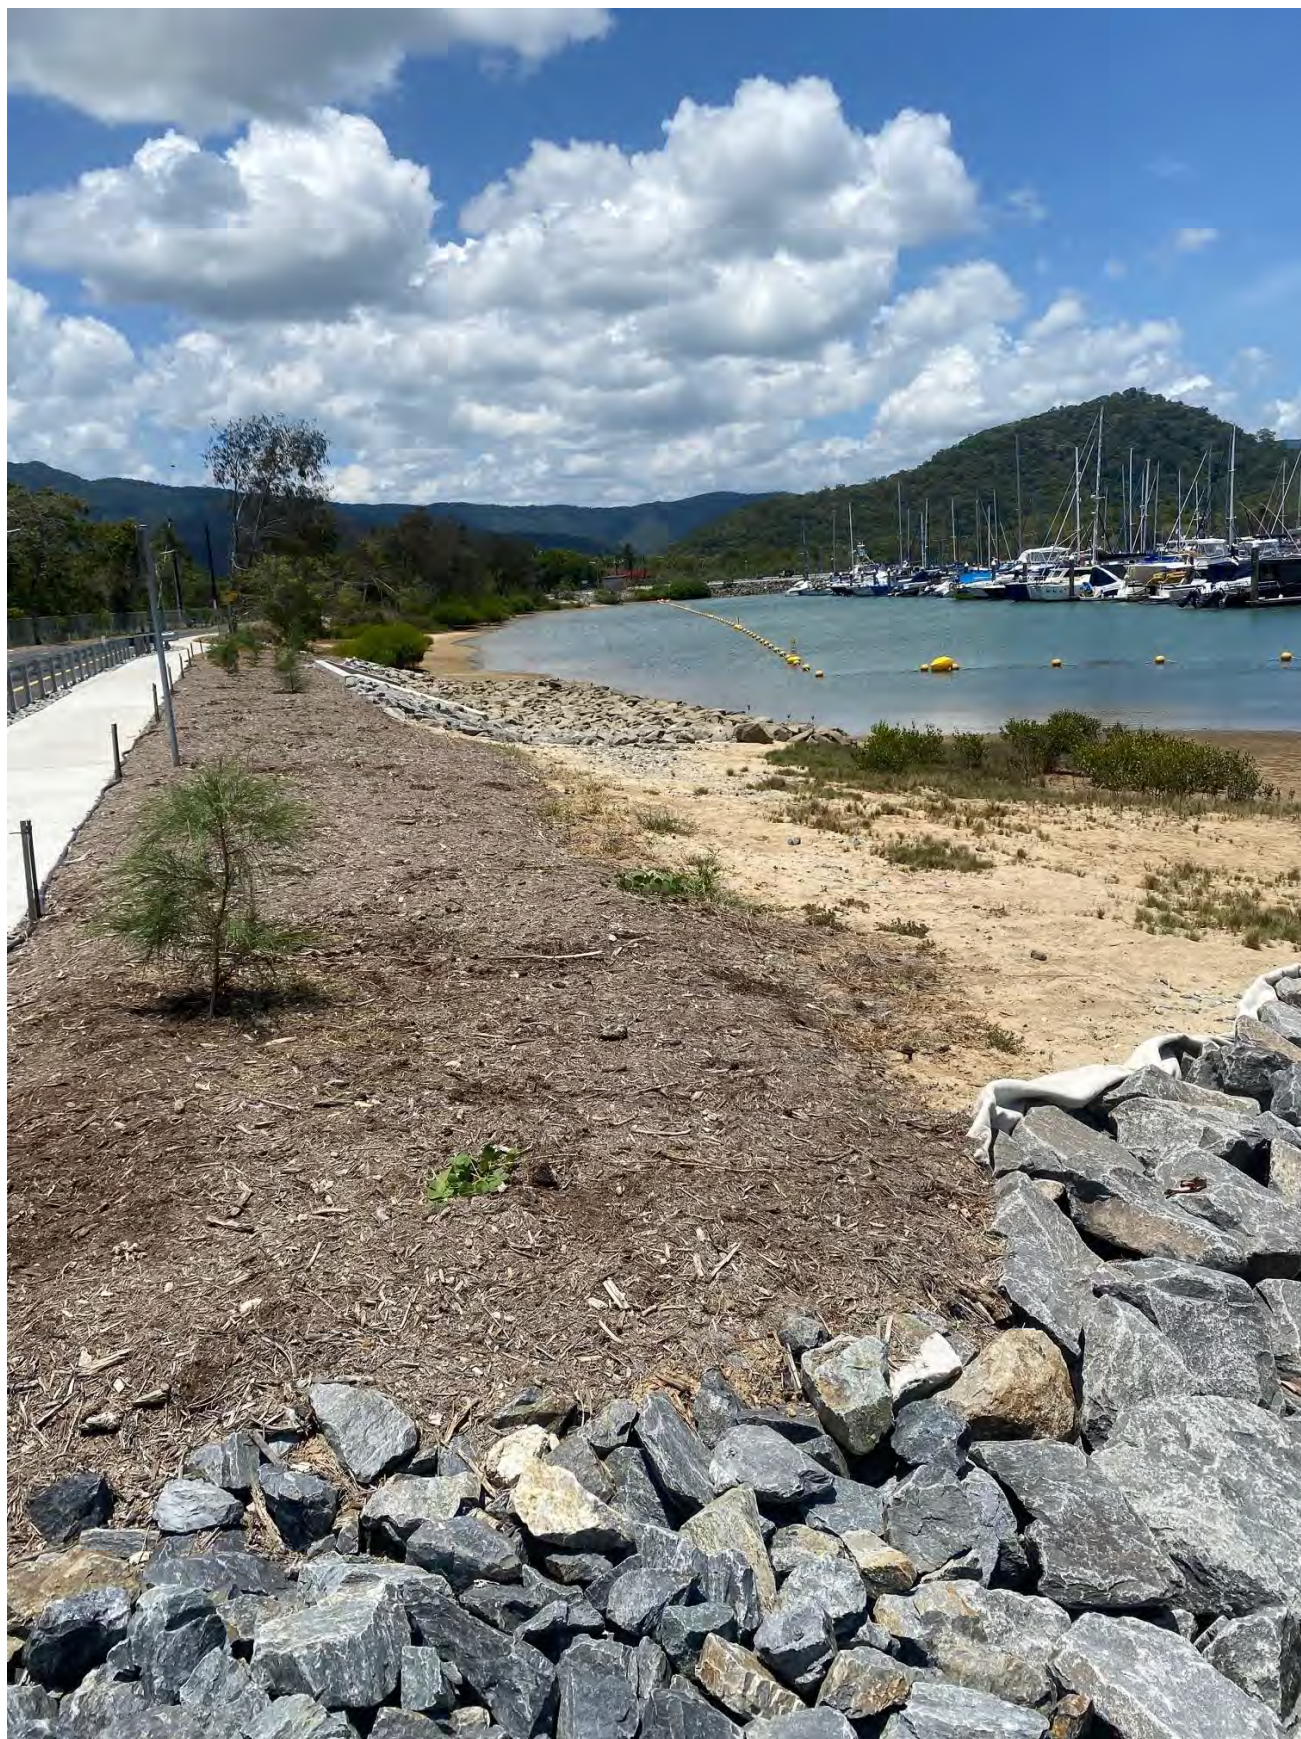
As noted, there are two discrete areas (A and B) requiring treatment (see Table 1. Plate 1). Area A encompasses two vegetation communities. Littoral vegetation would naturally occur on the upper portions of Area A, including the mulched and upper bare areas shown in Plate 1. This image shows mature beach she-oak (*Casuarina equisetifolia*) in the background and the same species planted in the foreground. As noted, pre-clearance vegetation is unknown, however littoral vegetation, of which beach she-oak is typical, would likely have extended to the area where tidal influence is minimal (as evidenced by the appearance of beach she-oak above tidal influence on Plate 1). Stands of black mangrove occur directly below the mature beach she-oak at the high tide mark, clearly indicating the influence of tidal inundation and the two ecological niches present. Accordingly, all the area above the stand of black mangrove in Area A will require replanting with littoral/strand species.

Plate 1: Littoral/strand zone vegetation in Area A.

Around 160m² of this community will require active restoration and plantings should commence adjacent to the existing mulched margin (see Plate 1). Planting of ca.45 trees and shrubs at random 1.5m x 1.5m spacings will be done during suitable weather conditions. For each planted stem, a slow-release fertiliser tablet (e.g., Agriform) will be provided at planting, along with the recommended quantity of water crystals to preserve soil moisture. All stems should be provided with 10l of water at planting, with follow-up watering during any extended dry period.

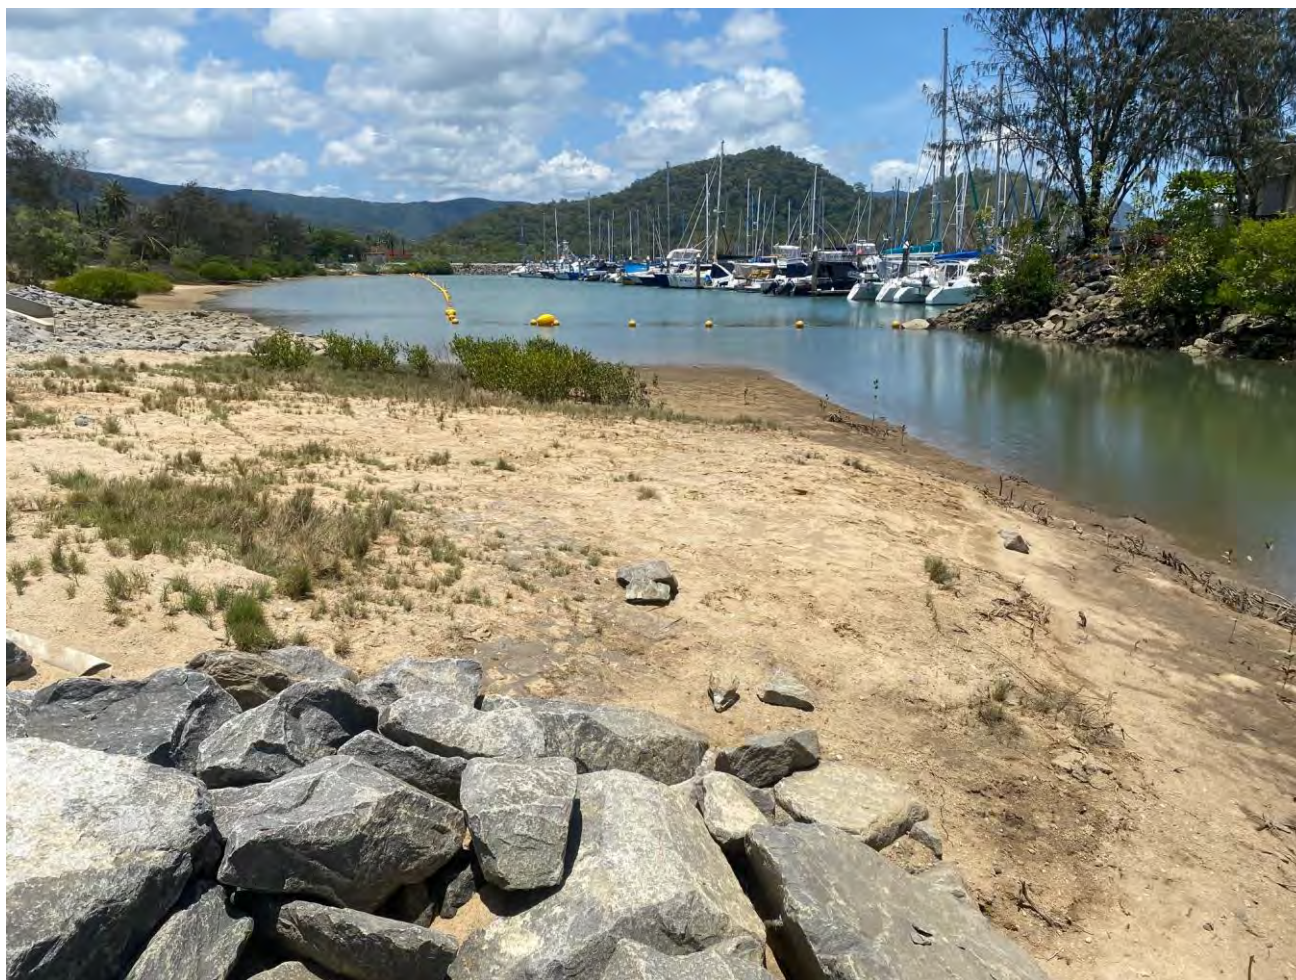
Plate 2 shows Area A in greater detail. Marine couch is more common in the tidally influenced area, becoming sparser as this influence diminishes. Black mangrove lines the high tide mark; regenerating stilt-root mangrove follows the low tide line, emphasising its tolerance of increased inundation. It is likely that stilt-root mangrove formerly extended from the low to high-water mark. Accordingly, stilt-root mangrove will require re-establishment across all the area between the low and high-water mark of Area A.

Plate 2: Area A, showing gradation of tidal inundation and vegetation responses.

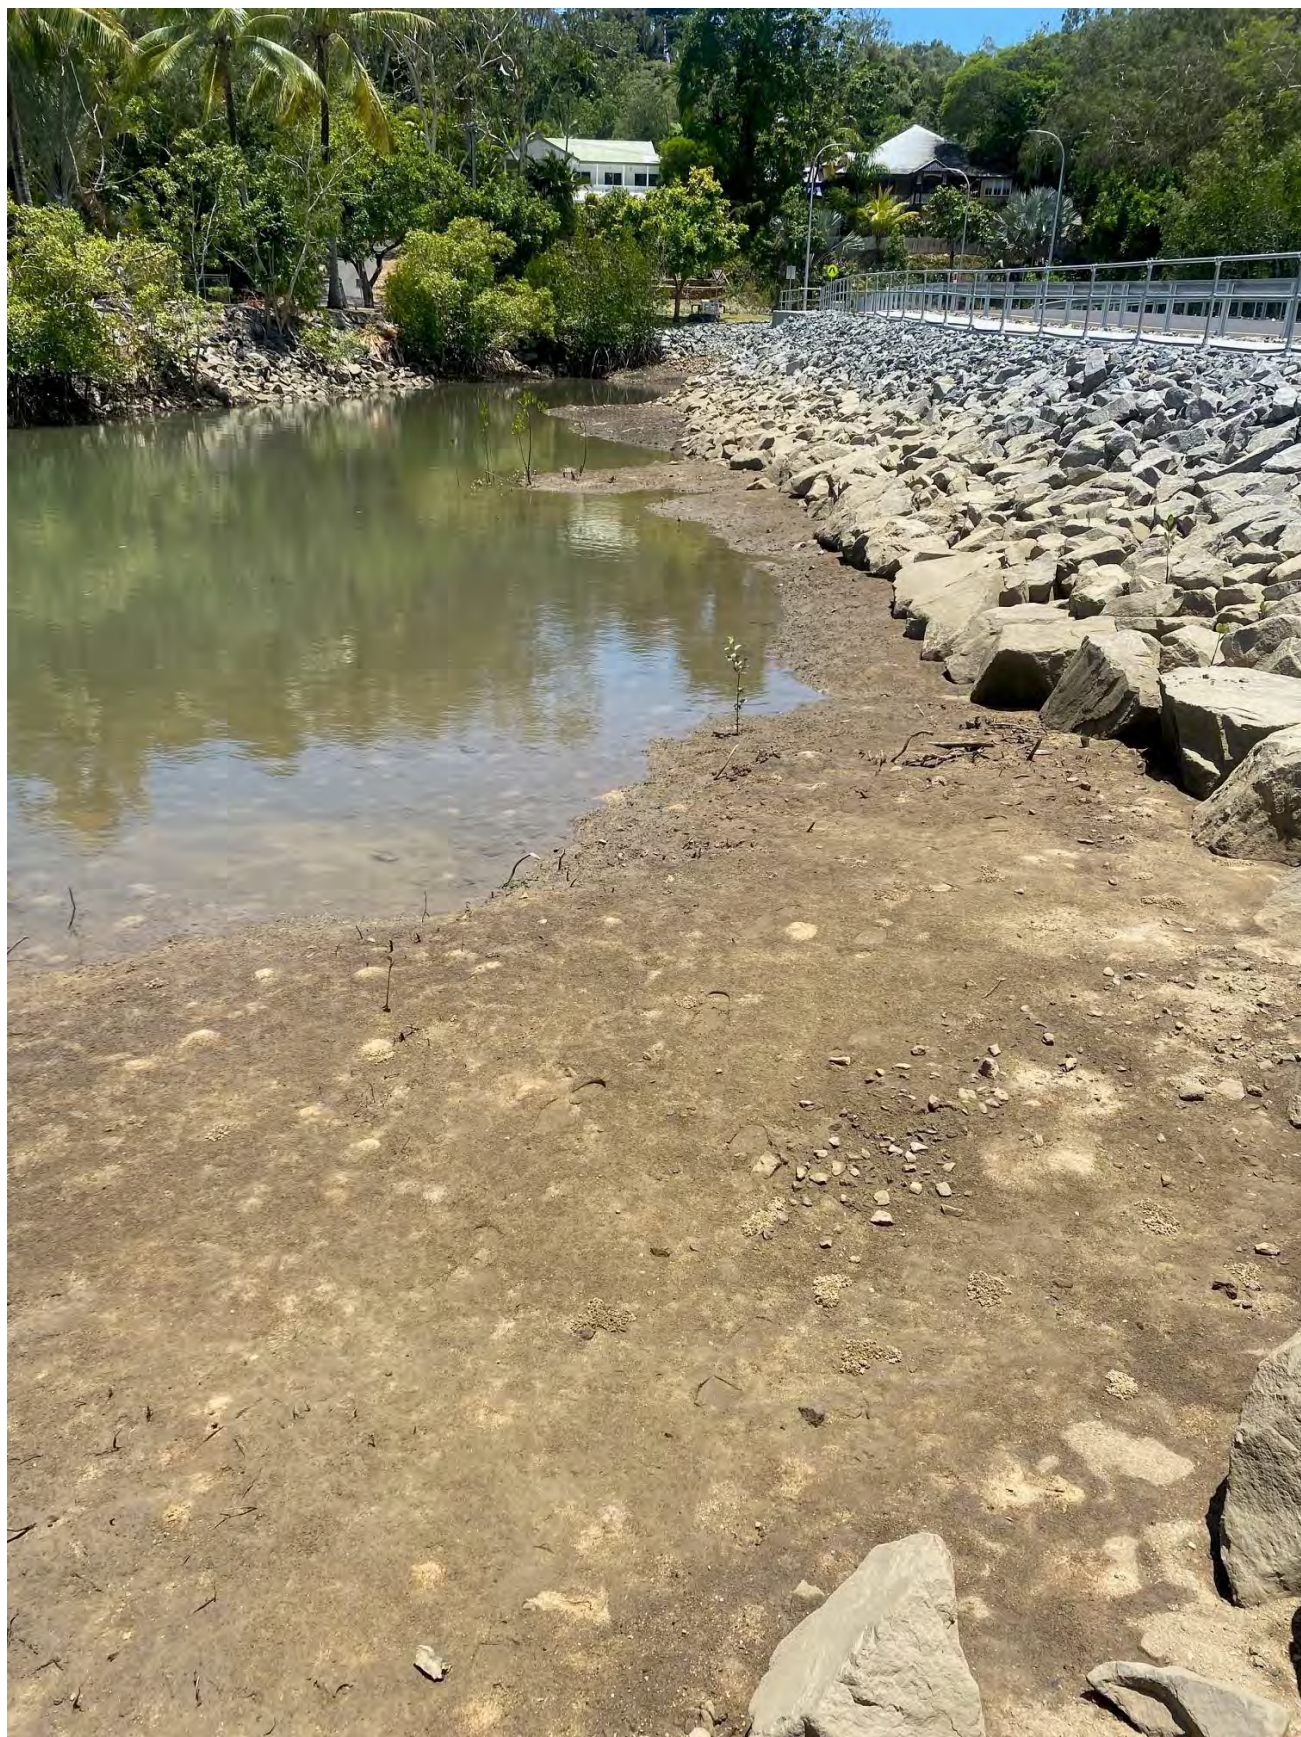
Area B contains the remainder of the site and consists of a narrow band of mud soil flanked by rip-rap (see Plate 3). Mud soils and tidal inundation indicate that mangroves only would have been present in this area. Occasional individuals of stilt-root mangrove only are regenerating, confirming the area will support mangroves and stilt-root mangroves are ecologically adapted to the tidal variation visible in Plate 2.

Plate 3: Area B showing mud soil with some regeneration of stilt-root mangrove.

As noted, natural regeneration will be relied upon to recover the mangrove-dominated Area B and will be accelerated by planting stilt-root mangrove hypocotyls during a low-tide. Mangrove hypocotyls will be established on 1m x 1m spacings. A fertiliser tablet should be provided to each stem at planting. An area of ca.90m² will require rehabilitation, so a minimum of 90 hypocotyls will be required. This is a one-off planting that is intended to provide a framework around which natural regeneration can be hastened. No supplementary planting would be required.

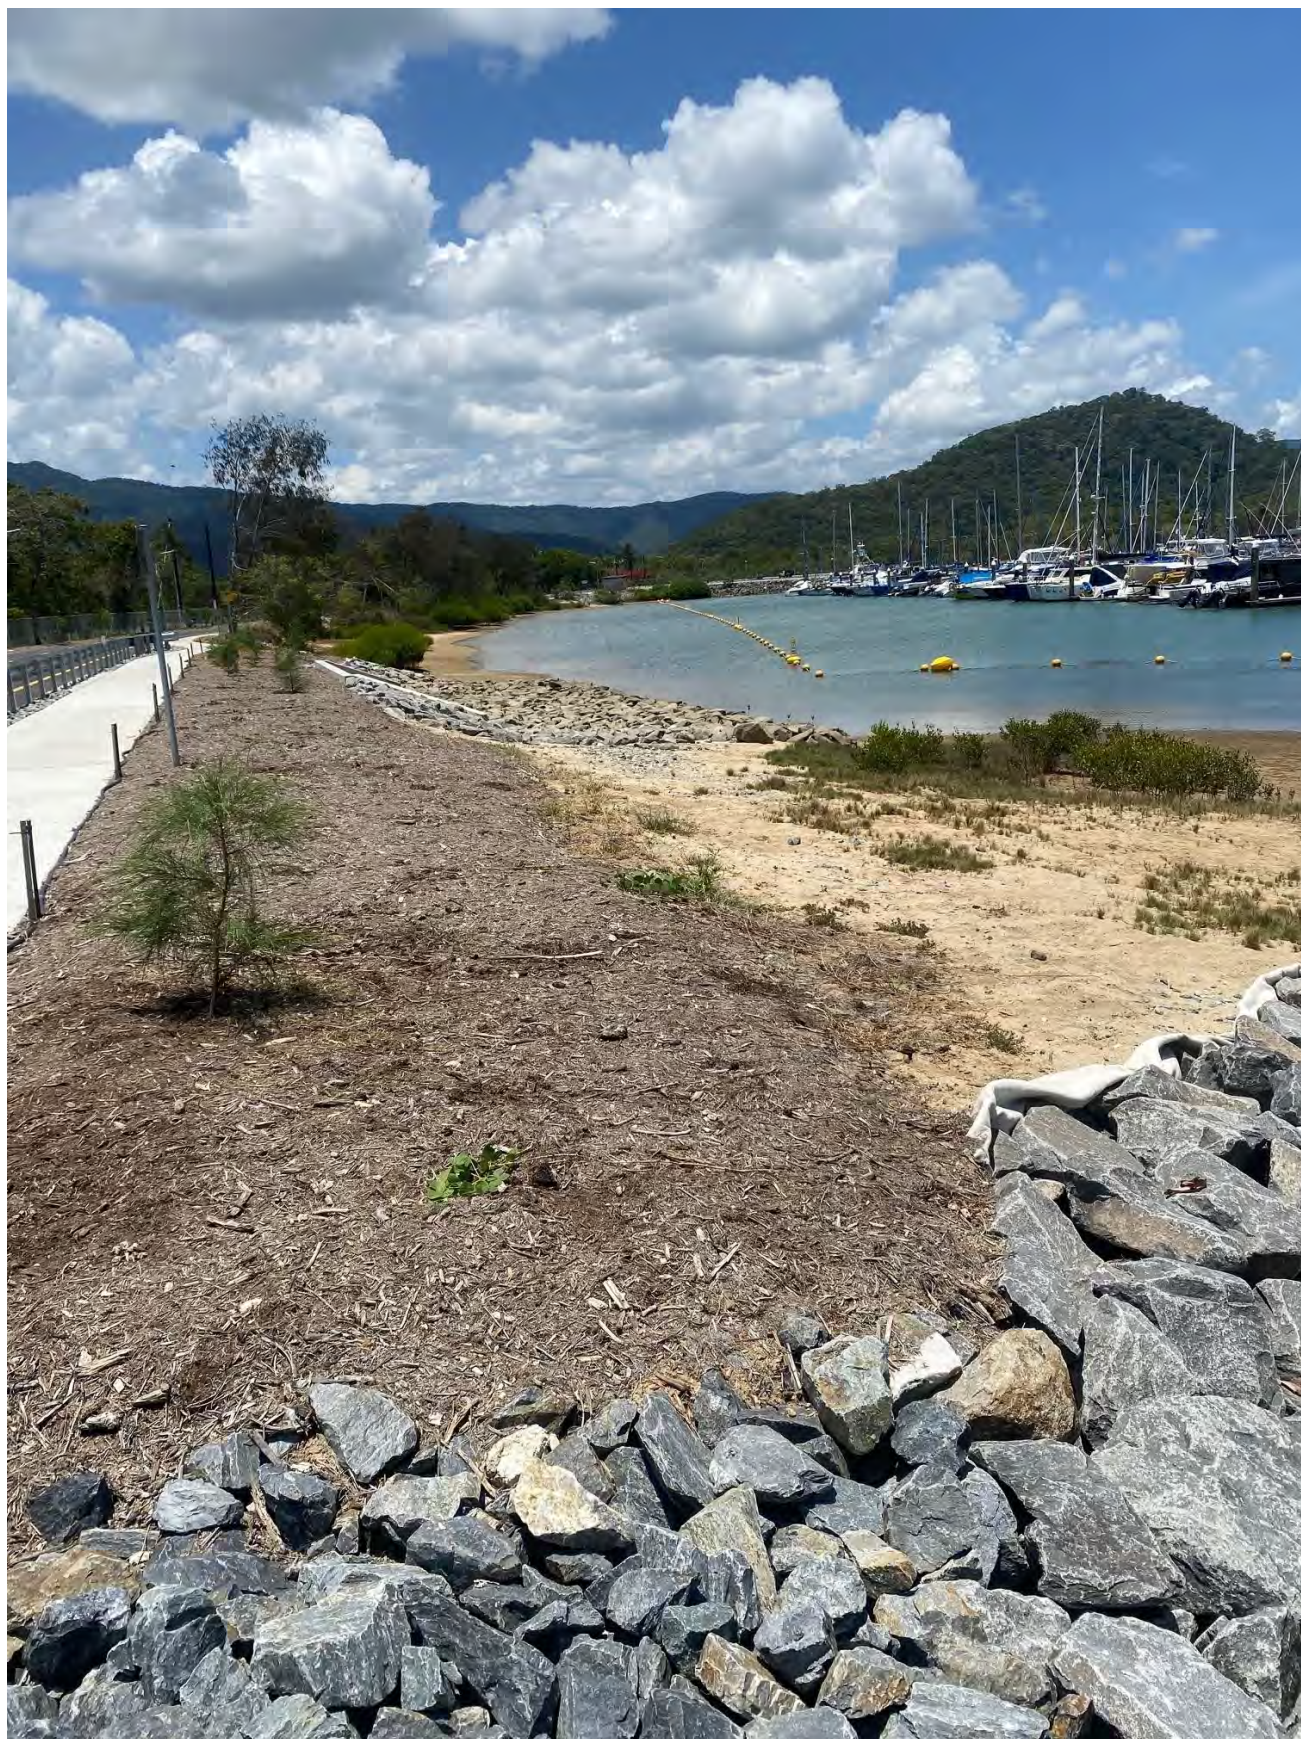
As noted, there are two discrete areas (A and B) requiring treatment (see Table 1. Plate 1). Area A encompasses two vegetation communities. Littoral vegetation would naturally occur on the upper portions of Area A, including the mulched and upper bare areas shown in Plate 1. This image shows mature beach she-oak (*Casuarina equisetifolia*) in the background and the same species planted in the foreground. As noted, pre-clearance vegetation is unknown, however littoral vegetation, of which beach she-oak is typical, would likely have extended to the area where tidal influence is minimal (as evidenced by the appearance of beach she-oak above tidal influence on Plate 1). Stands of black mangrove occur directly below the mature beach she-oak at the high tide mark, clearly indicating the influence of tidal inundation and the two ecological niches present. Accordingly, all the area above the stand of black mangrove in Area A will require replanting with littoral/strand species.

Plate 1: Littoral/strand zone vegetation in Area A.

Around 160m² of this community will require active restoration and plantings should commence adjacent to the existing mulched margin (see Plate 1). Planting of ca.45 trees and shrubs at random 1.5m x 1.5m spacings will be done during suitable weather conditions. For each planted stem, a slow-release fertiliser tablet (e.g., Agriform) will be provided at planting, along with the recommended quantity of water crystals to preserve soil moisture. All stems should be provided with 10l of water at planting, with follow-up watering during any extended dry period.

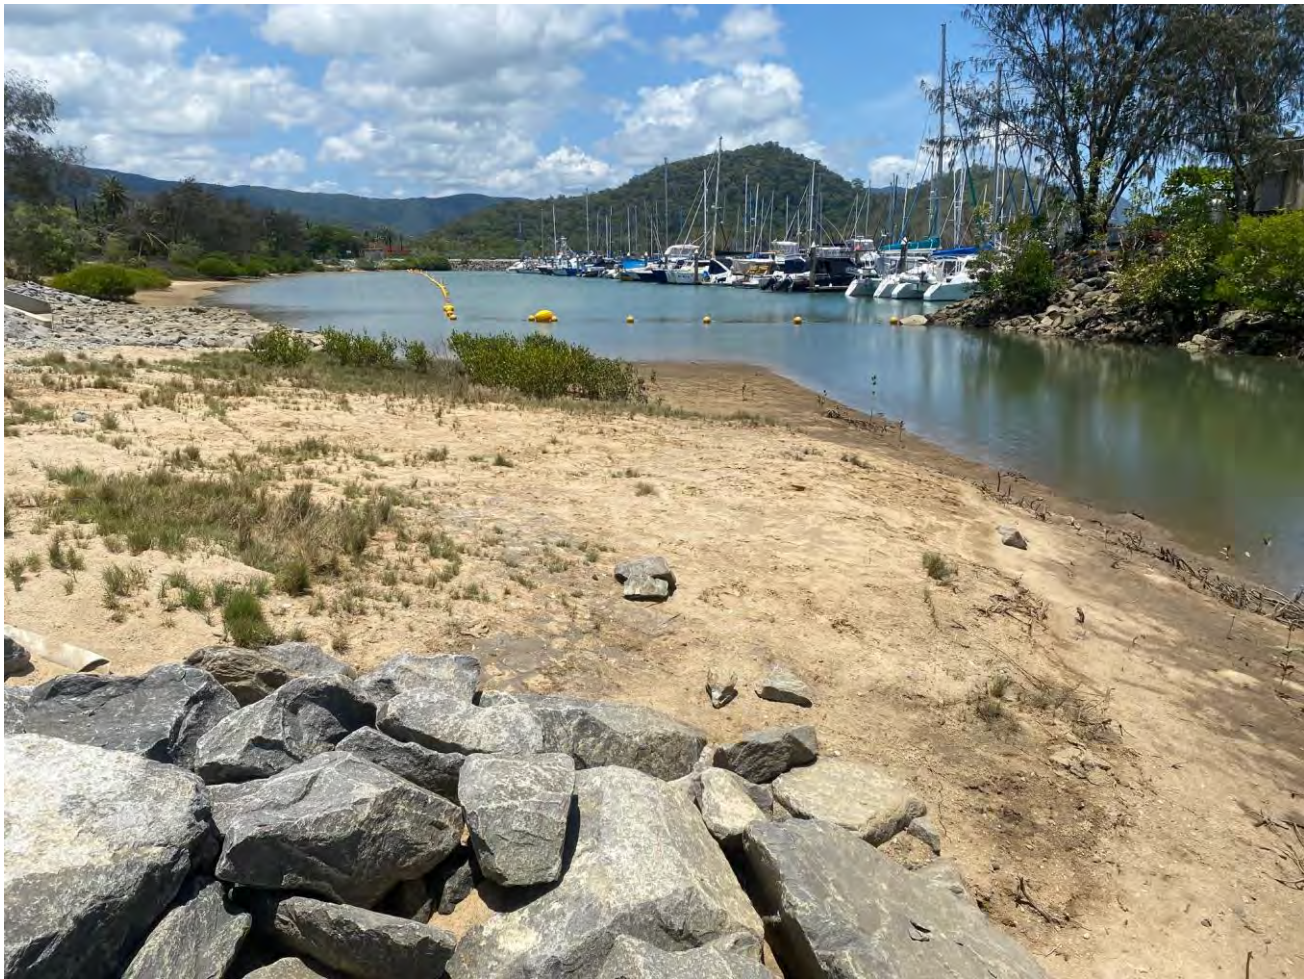
Plate 2 shows Area A in greater detail. Marine couch is more common in the tidally influenced area, becoming sparser as this influence diminishes. Black mangrove lines the high tide mark; regenerating stilt-root mangrove follows the low tide line, emphasising its tolerance of increased inundation. It is likely that stilt-root mangrove formerly extended from the low to high-water mark. Accordingly, stilt-root mangrove will require re-establishment across all the area between the low and high-water mark of Area A.

Plate 2: Area A, showing gradation of tidal inundation and vegetation responses.

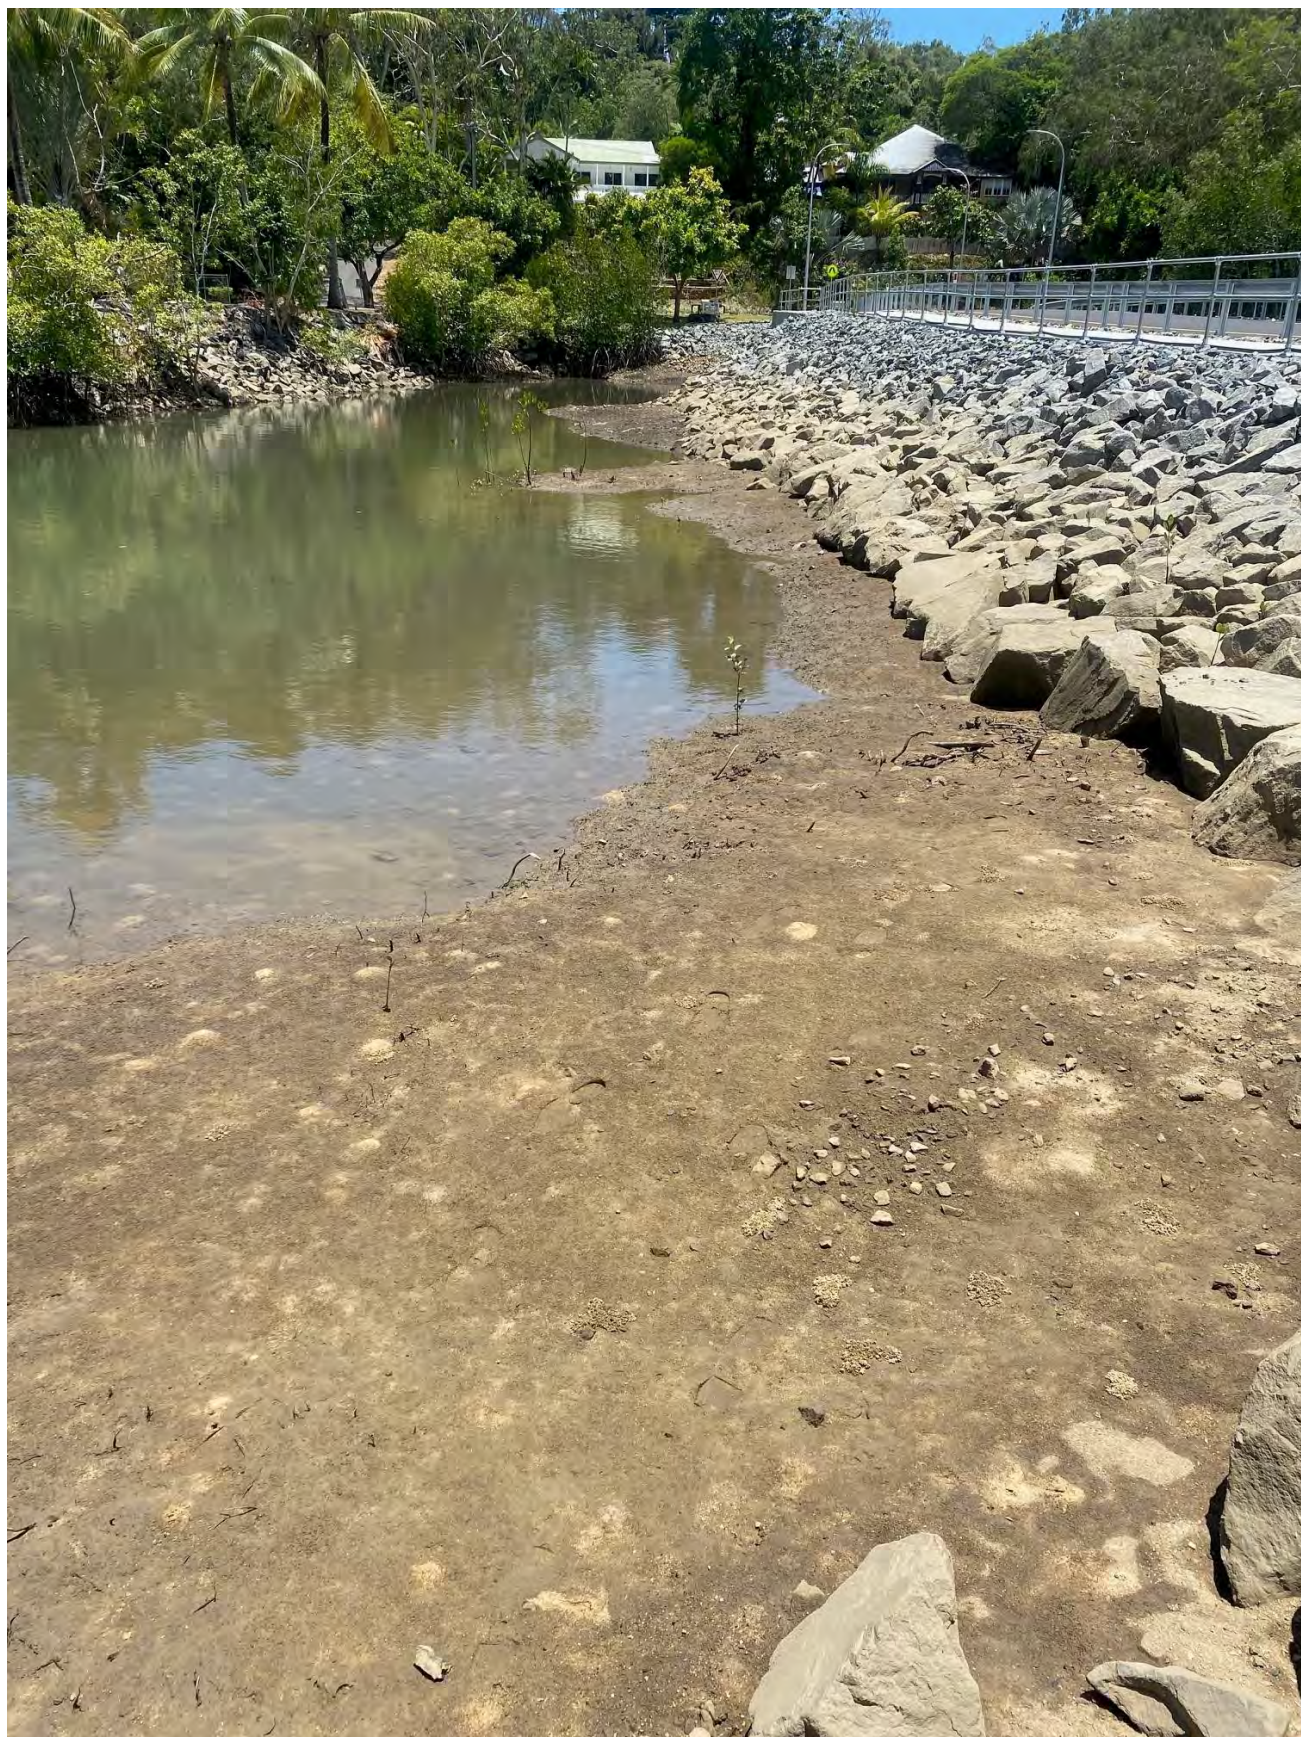
Area B contains the remainder of the site and consists of a narrow band of mud soil flanked by rip-rap (see Plate 3). Mud soils and tidal inundation indicate that mangroves only would have been present in this area. Occasional individuals of stilt-root mangrove only are regenerating, confirming the area will support mangroves and stilt-root mangroves are ecologically adapted to the tidal variation visible in Plate 2.

Plate 3: Area B showing mud soil with some regeneration of stilt-root mangrove.

As noted, natural regeneration will be relied upon to recover the mangrove-dominated Area B and will be accelerated by planting stilt-root mangrove hypocotyls during a low-tide. Mangrove hypocotyls will be established on 1m x 1m spacings. A fertiliser tablet should be provided to each stem at planting. An area of ca.90m² will require rehabilitation, so a minimum of 90 hypocotyls will be required. This is a one-off planting that is intended to provide a framework around which natural regeneration can be hastened. No supplementary planting would be required.

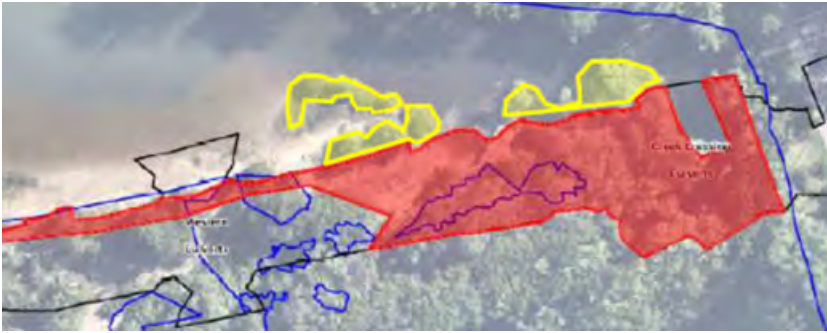
I regret to inform you that our contractor has in error undertaken works including the removal of a small number of shoreline mangrove trees that are outside of the specified impact footprint. See indicative image below with vegetation in question marked in yellow.

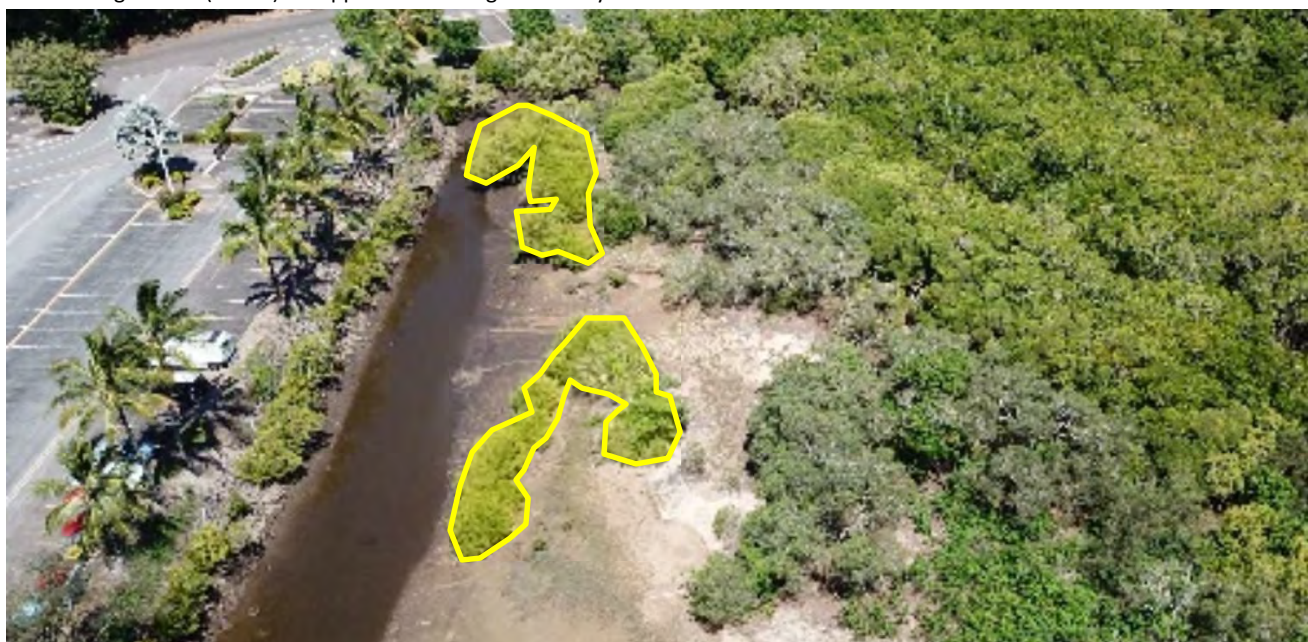
Pre-Clearing Picture (below). Unapproved Clearing shown in yellow at near low tide.

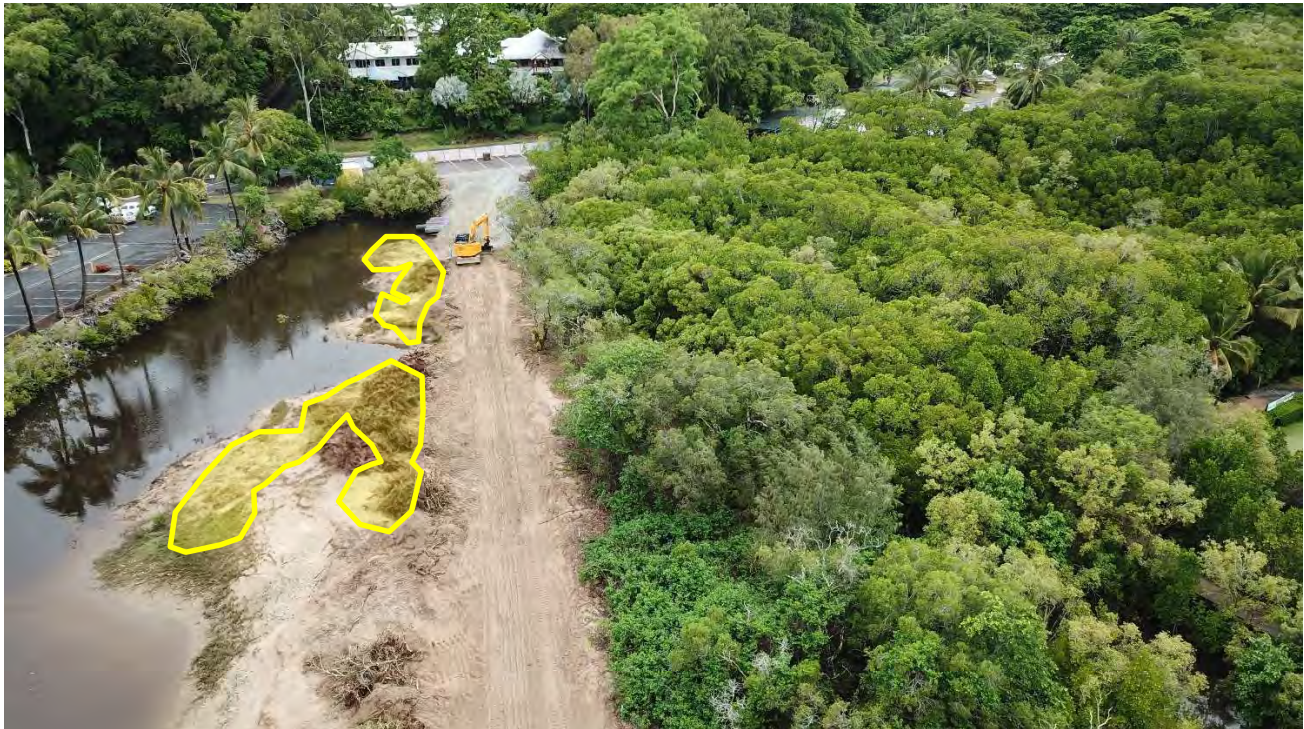
Post-Clearing Picture (below). Unapproved Clearing shown in yellow at near low tide.

1. The non-conformance causes an approval condition breach as clearing took place outside the approved clearing limits/project area.
2. The environmental impacts seem minor to moderate for the following reasons:

21. The projects overall offset area calculation should remain unchanged due to reduced actual clearing area across the site. The figure below indicates the area **not cleared in green**. The **yellow** area indicates the **additional clearing** which amounts to approximately 0.0244ha (244m²). We propose to provide a comparison image/drawing upon completion of the works to verify the actual offset.
