Wildlife Protection - Monitoring and Assessment Plan

Eton Range Realignment Project 2015/7552

Prepared by	Tim Dalton
Title	Wildlife Protection - Monitoring and Assessment Plan
District & Region	Mackay/Whitsunday
Branch & Division	Program Delivery and Operations
Project/program	Eton Range Realignment Project
Project number	242/33B/8
Project location	Isaac Regional Council
Status	Rev 02
DMS ref. no.	450/642

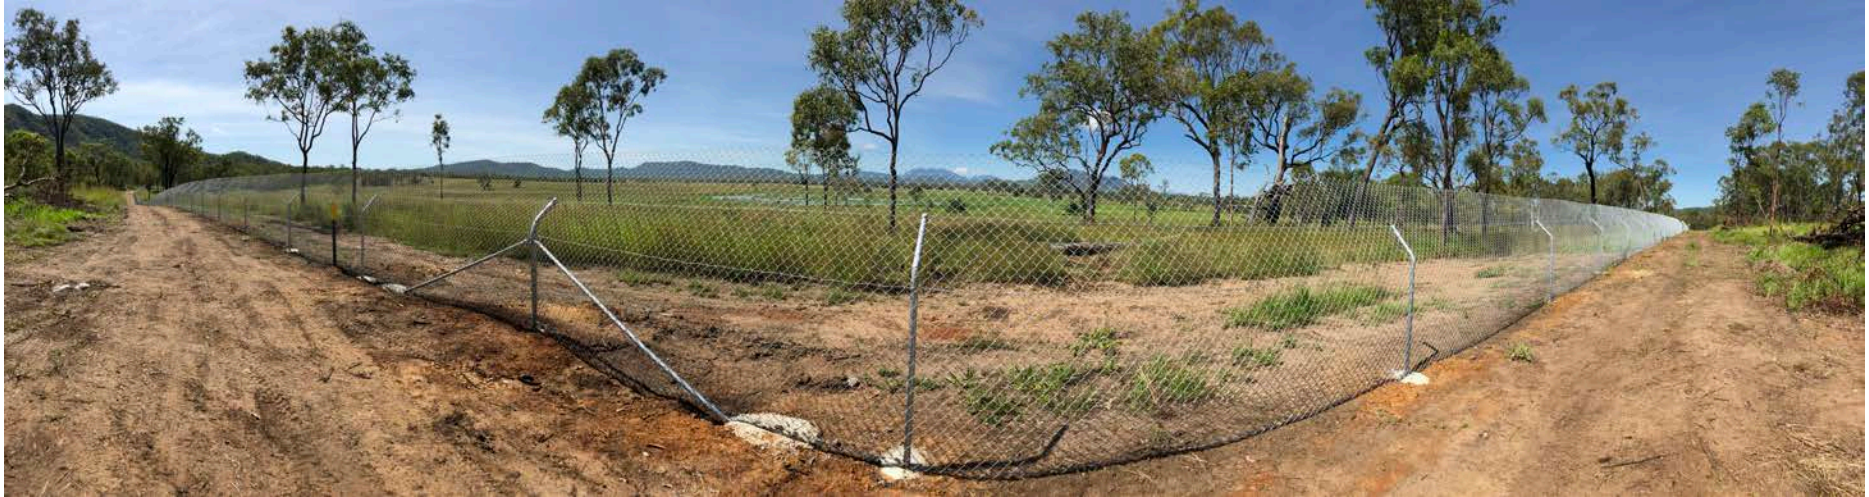
Plate 1: Floppy top fauna exclusion fencing erected immediately north of Denison Creek

Fauna fencing that was installed was the 'floppy top' design. This design was chosen due to its lower cost, effectiveness in past studies (Taylor and Goldingay 2003; Hayes and Goldingay 2009) and the rural setting (which meant that aesthetics was less important). Floppy top fauna fencing prevents koalas from climbing over the fence to access the road reserve. It is also effective for large macropods, dingos, and some species in the Dasyuridae and Potoroidae family (ie quolls, bettongs).

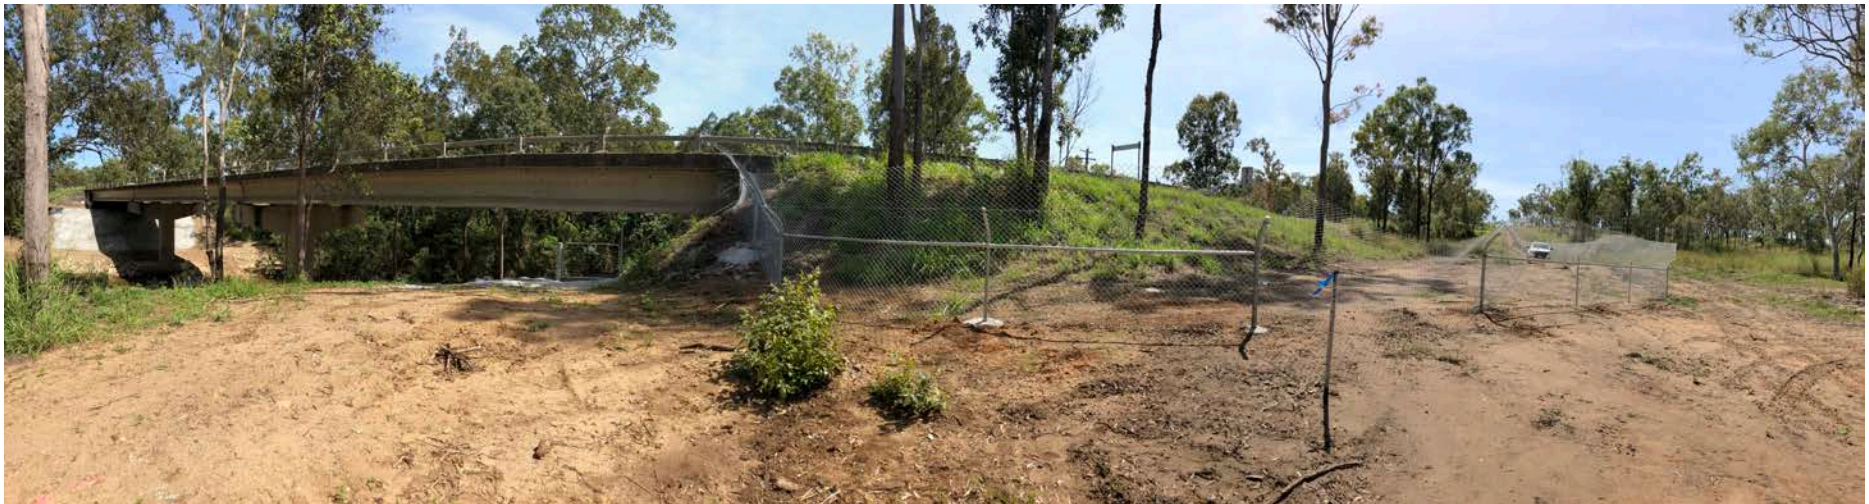
Plate 2: Fencing tied into Denison Creek bridge abutments to provide safe fauna passage

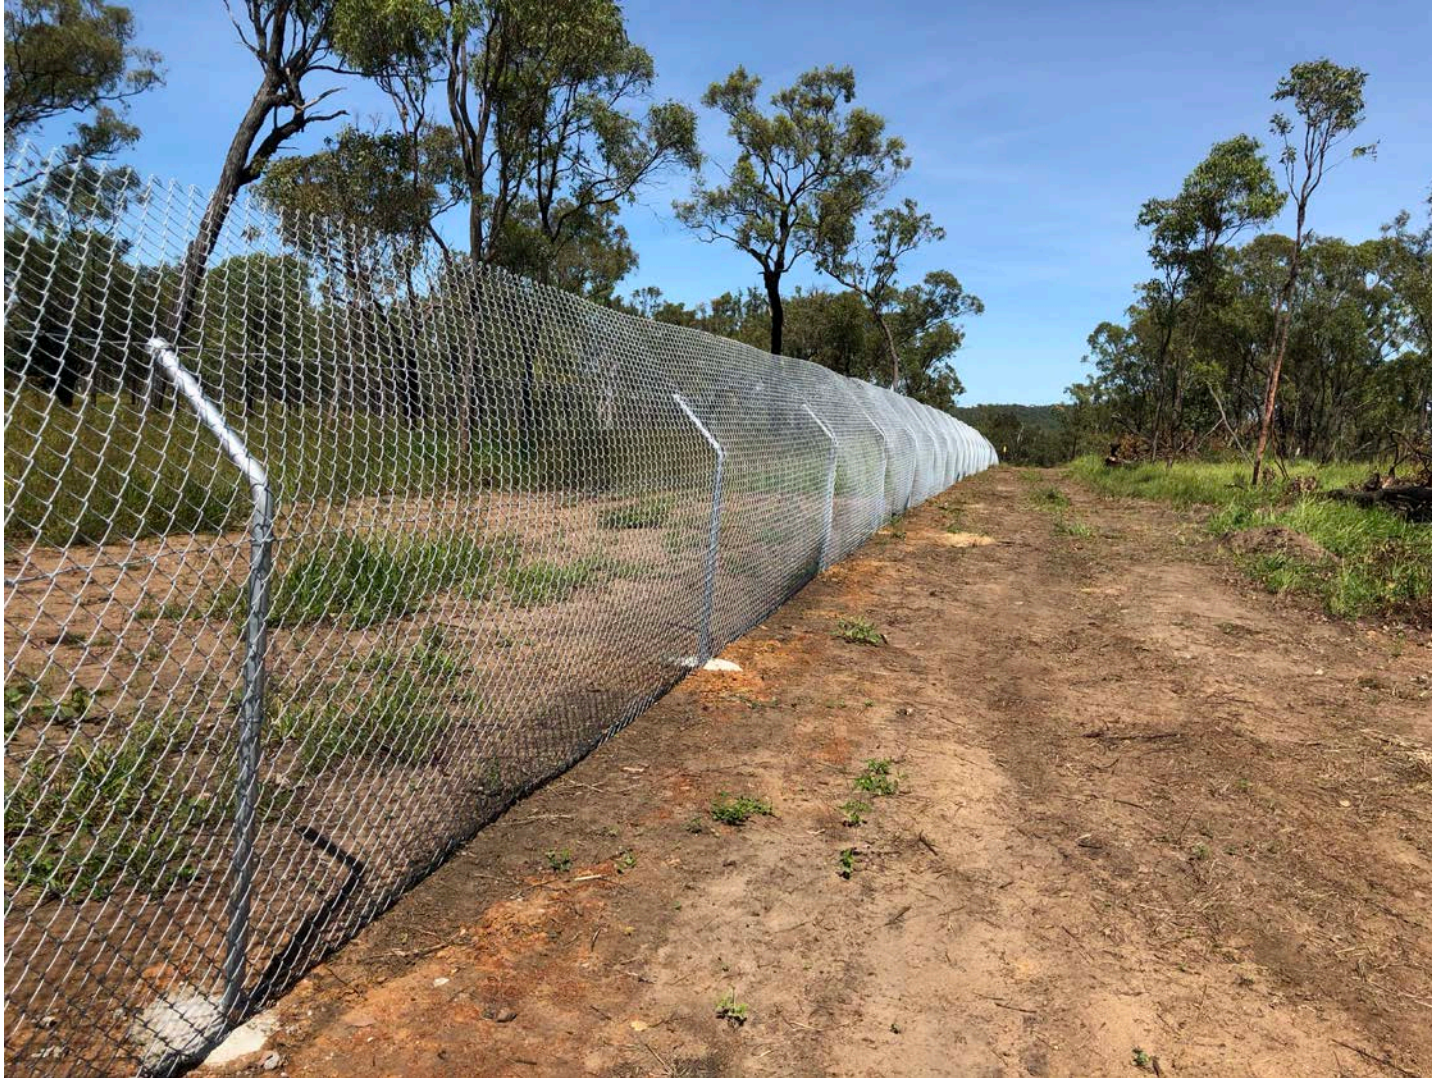
Plate 3: Floppy top fauna fencing design and grubbed fenceline

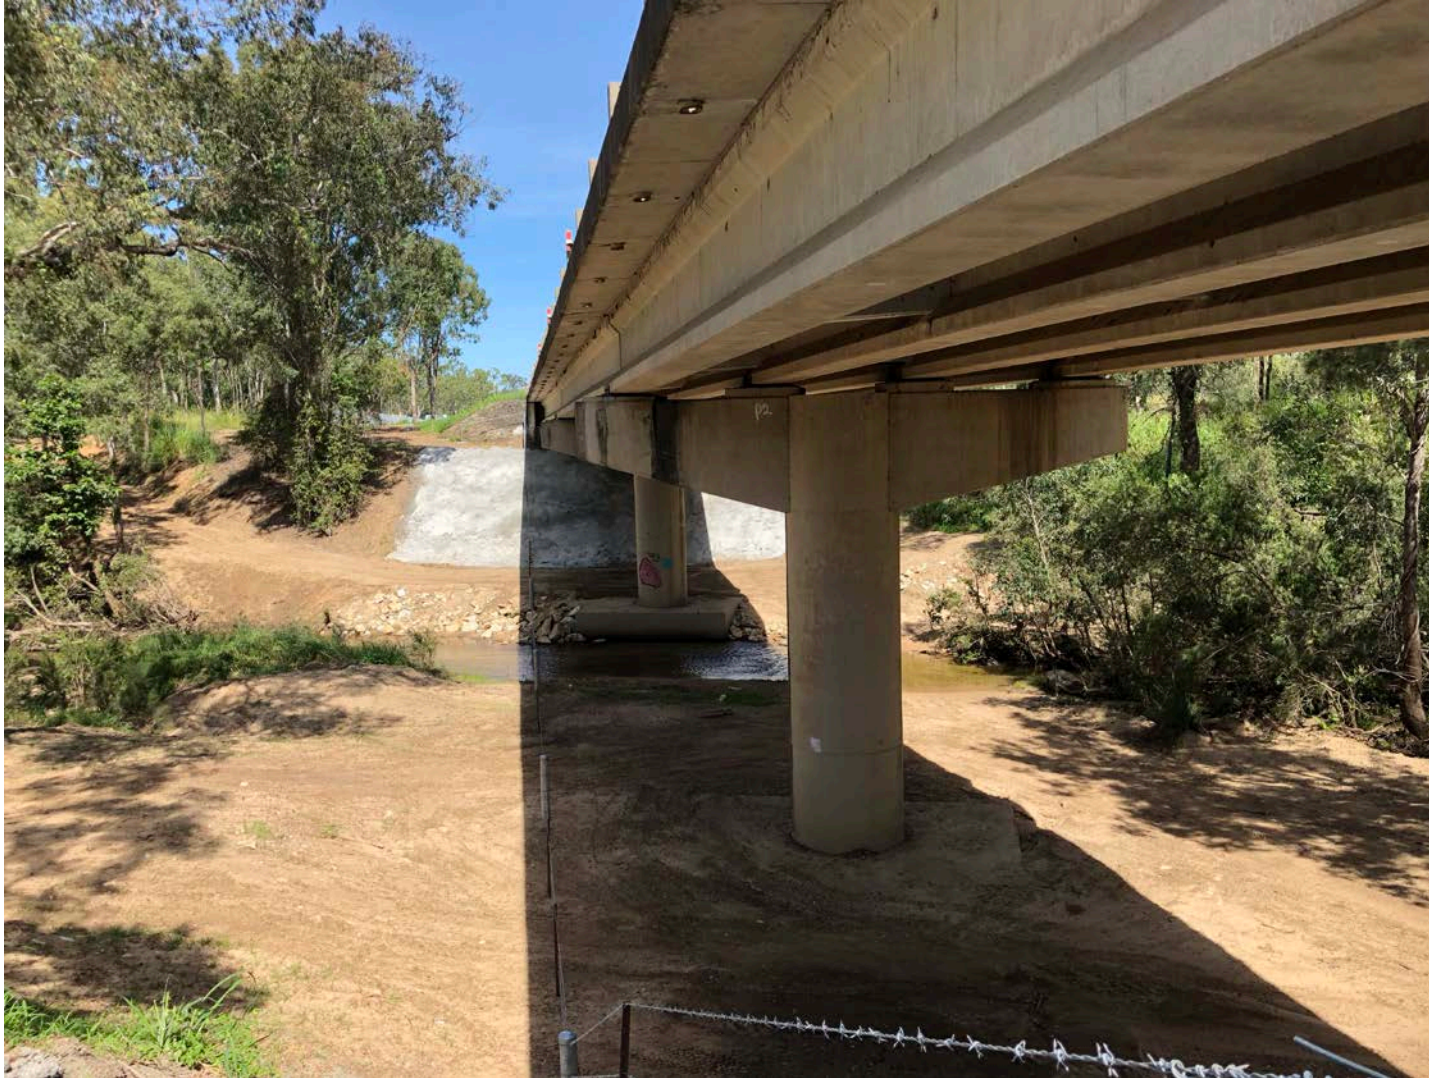
Plate 4: Denison Creek. The watercourse generally only receives considerable flows during the wet season, and was therefore determined to be an ideal crossing location during most of the Central Queensland koala breeding season (August – December)

Denison Creek was identified as a high priority due to the high number of koalas sighted and recorded near the watercourse. The flat, sandy creek bed also contains significant mature vegetation that is likely to be attractive to wildlife (Plate 4). The cross-sectional area underneath the bridge is large compared to the watercourse's narrow low flow channel. This meant that no further modifications were required to ensure suitable fauna passage for most of the year.

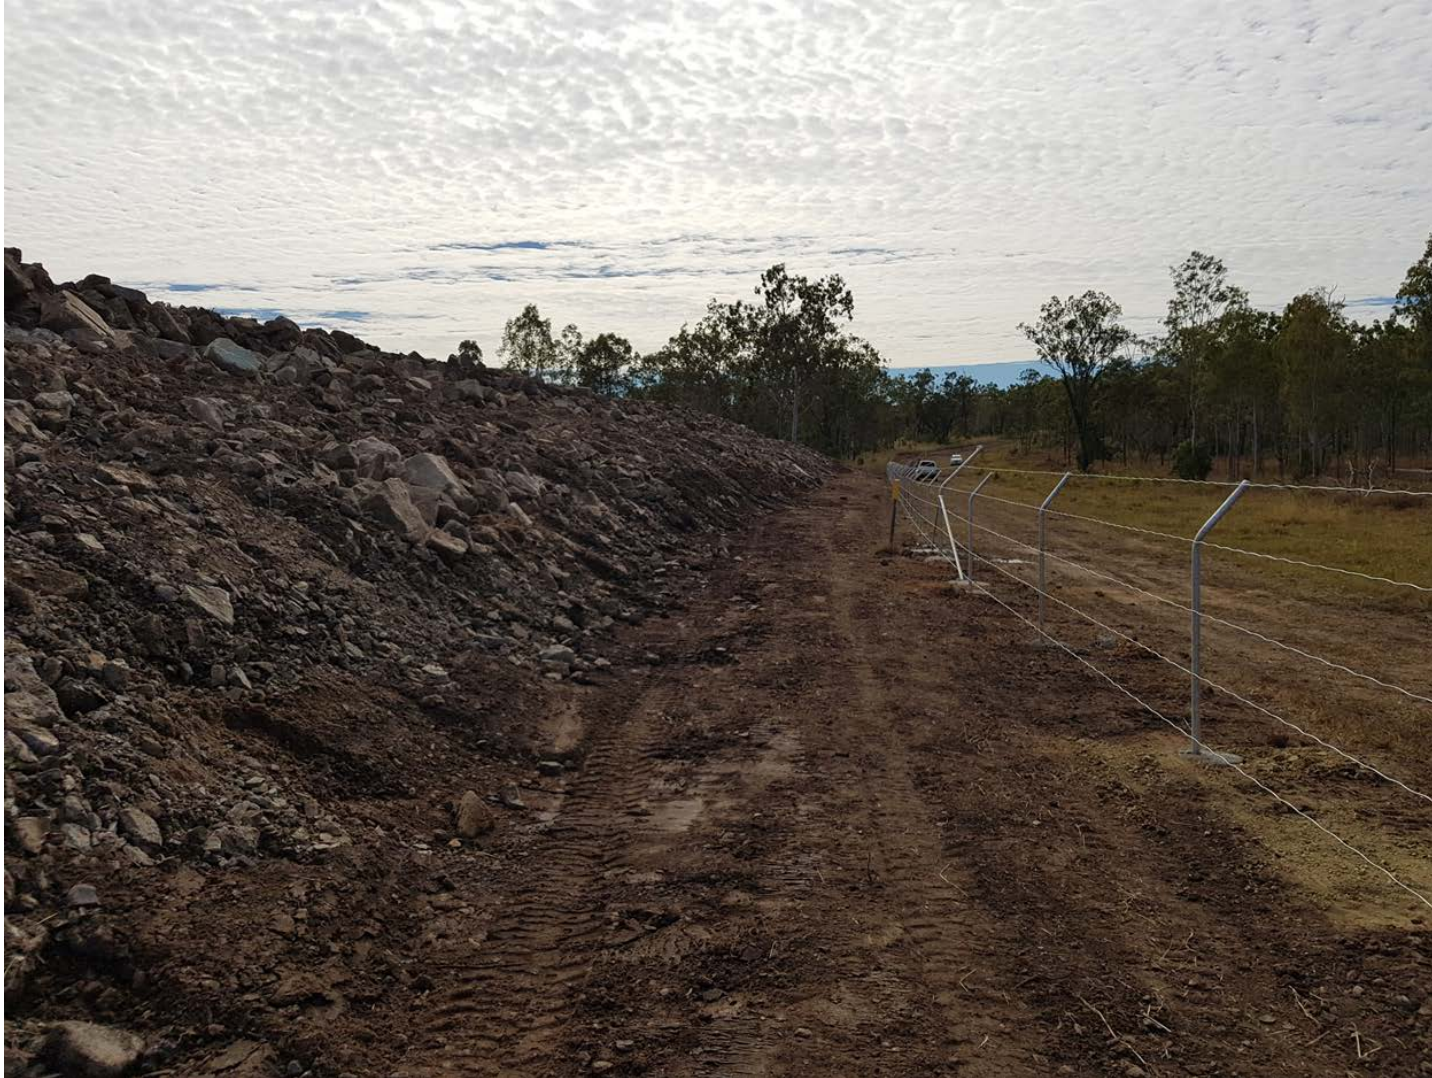
Plate 5: Stockyard Creek fence construction, facing east along the Peak Downs Highway.

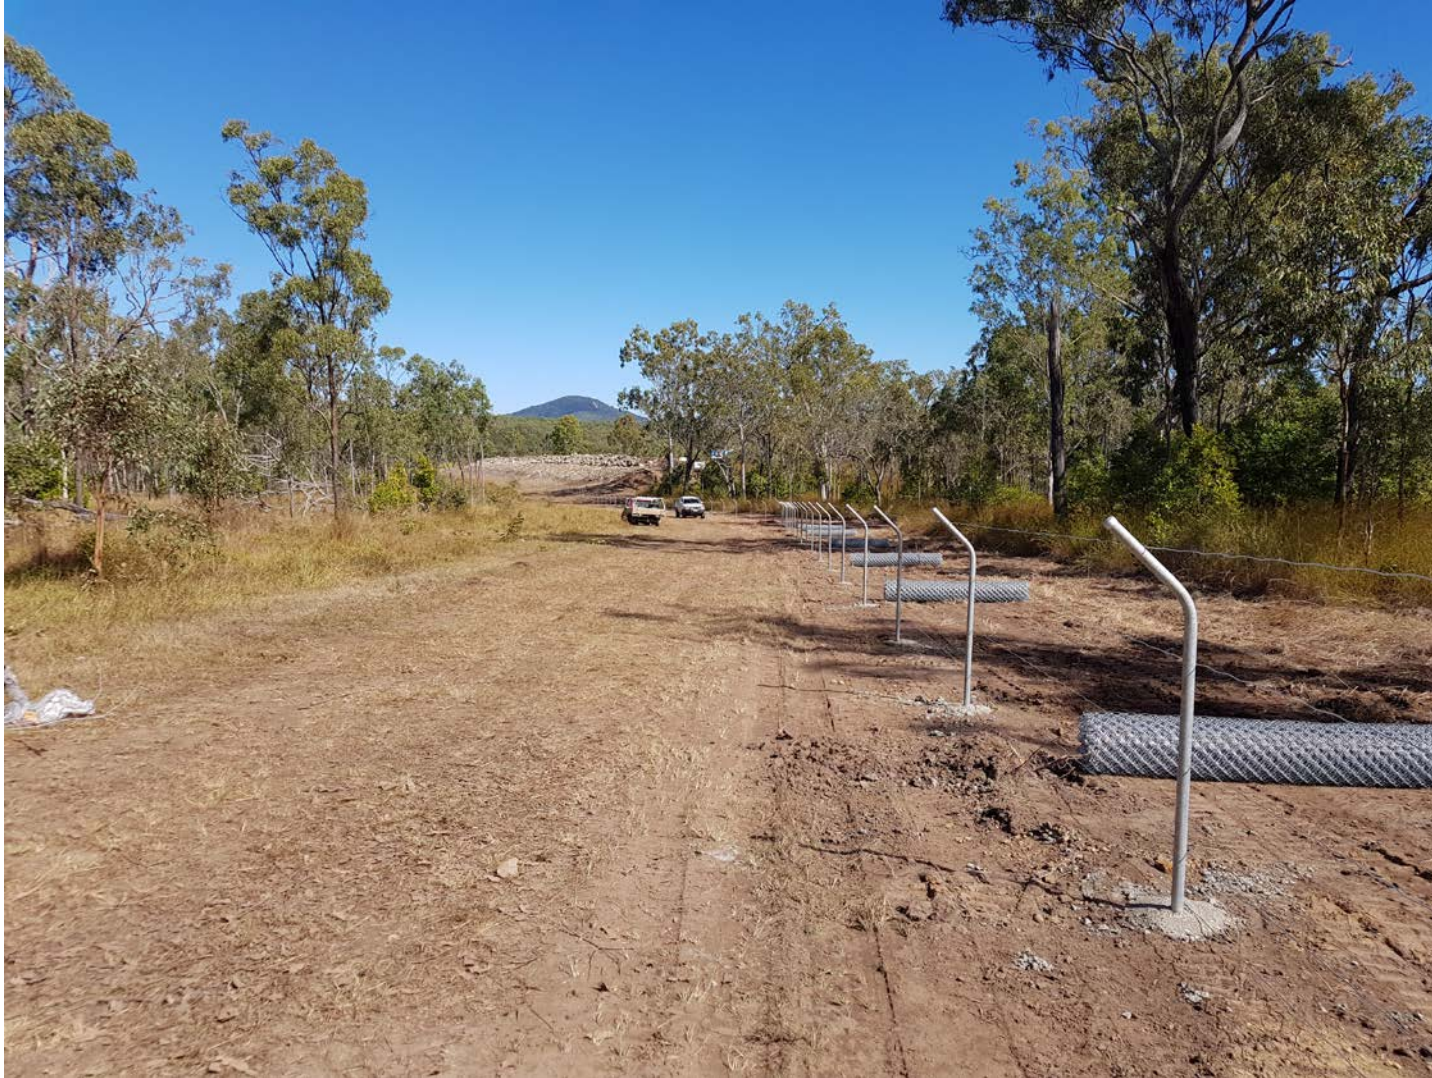
Plate 6: Stockyard Creek fence construction, facing west along the Peak Downs Highway.

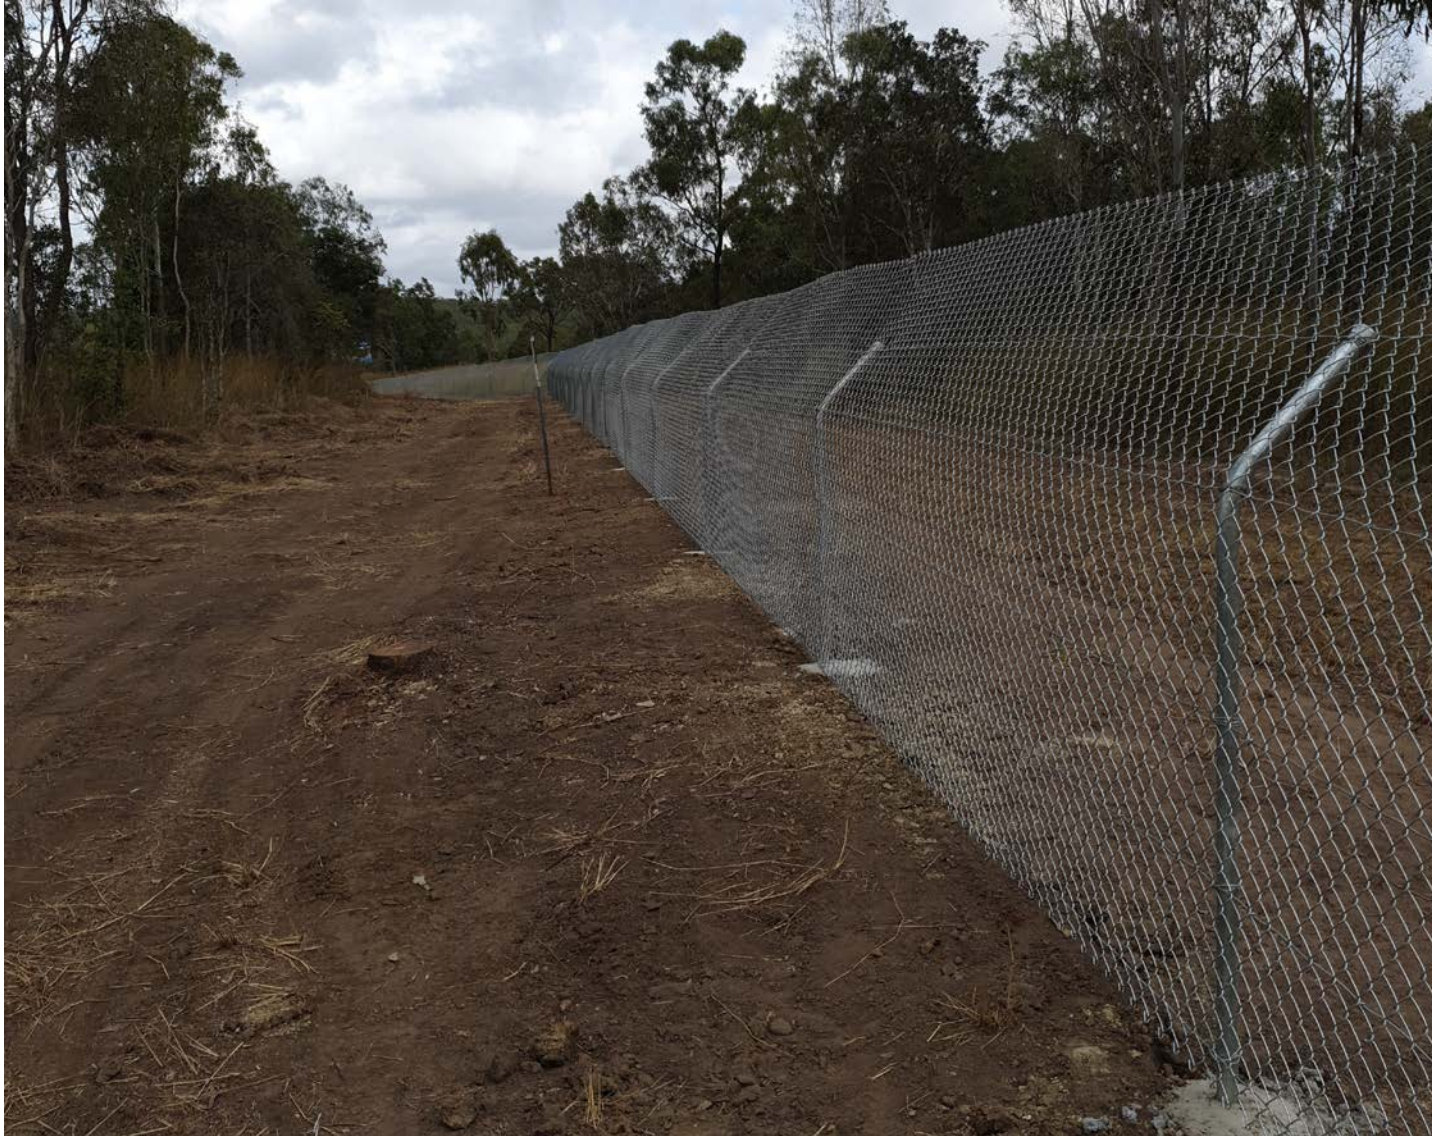
Plate 7: Completed fauna exclusion fencing at Stockyard Creek

Stockyard Creek was identified as a high priority due to the high number of koalas sighted and recorded near the watercourse. The narrow rocky creek bed underneath the bridge is separated into three openings, each separated by a bridge pier. The outer two openings only convey water during significant rainfall events, so they are expected to provide fauna passage during dry conditions. The creek also contains significant mature vegetation that is likely to be attractive to wildlife (Plate 7).

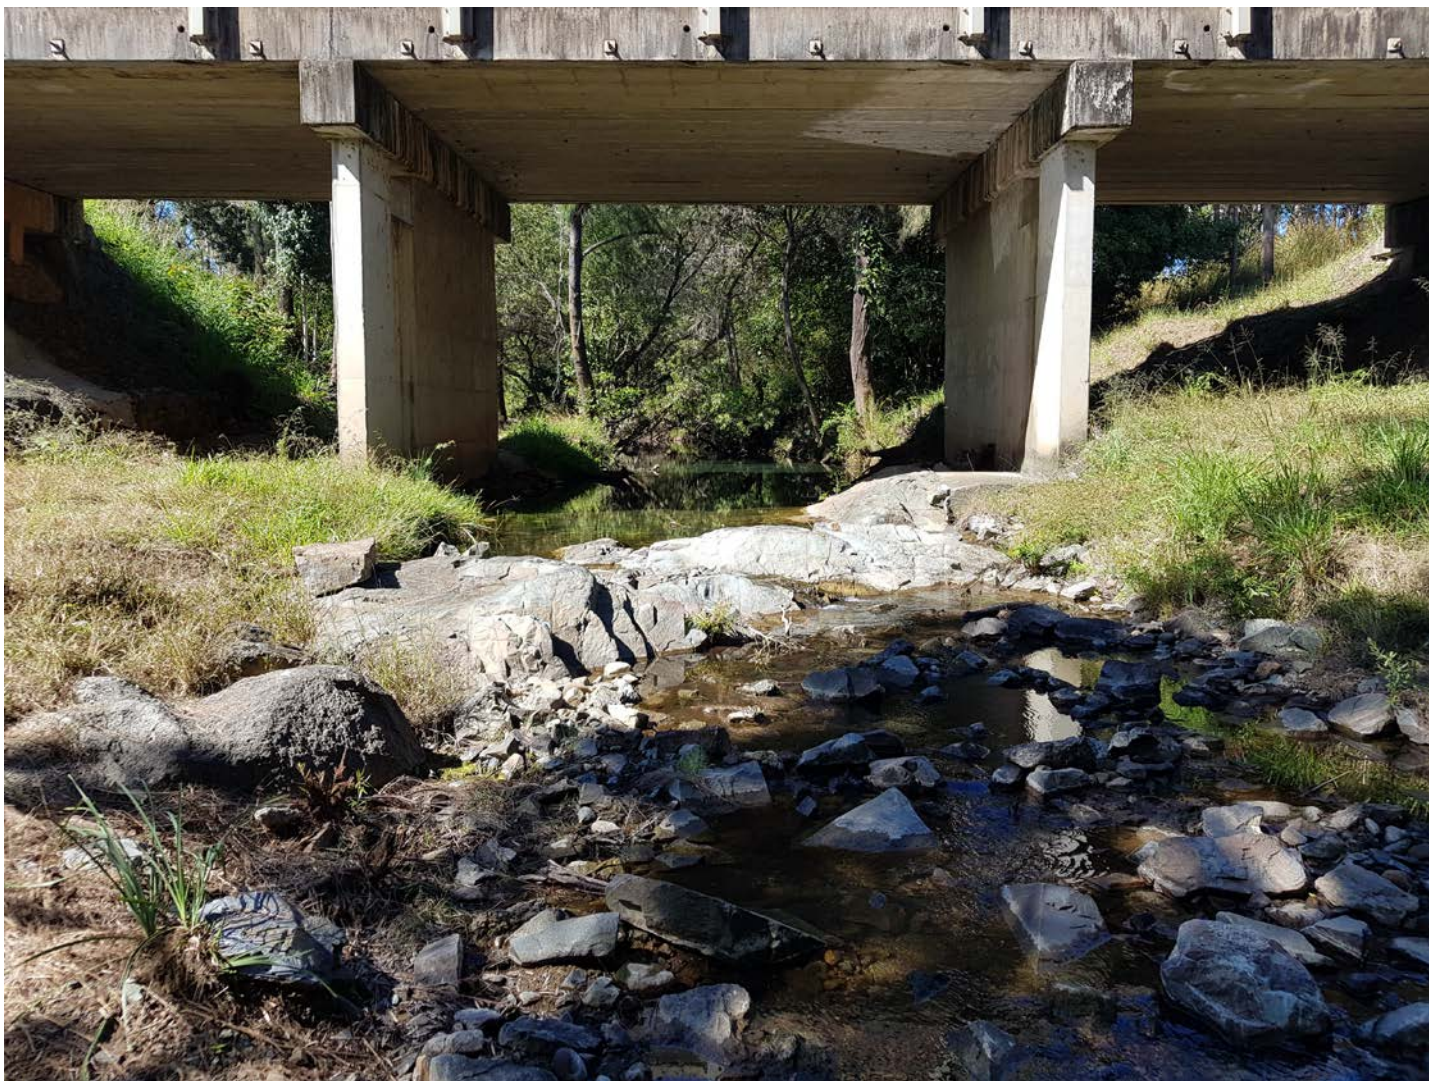
Plate 8: Stockyard Creek and the associated bridge structure. Note the steep banks and narrow low flow channels which forms the creek topography.

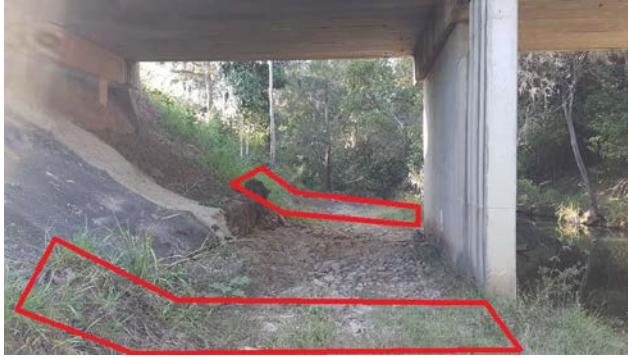
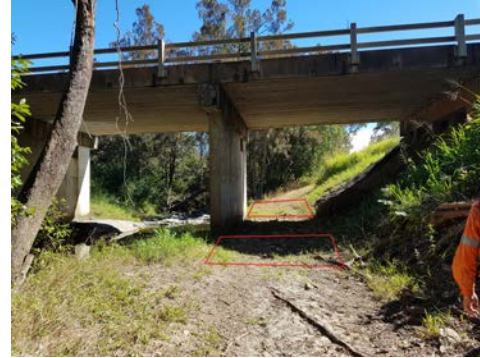
Plate 12 and 13: Approximate locations of sand plots underneath Stockyard Creek Bridge, northeast end of bridge and southwest end of bridge, respectively.

Six sand plots will be constructed at strategic locations underneath the Stockyard Creek bridge and perpendicular to the fauna exclusion fencing. Sand plots will be, in general, 3cm high and 1.0m wide. The four sand plots underneath the Stockyard Creek bridge will cover the both the eastern and western openings under the bridge but will not traverse the low-flow channel or extend beyond the bridge abutments (Plate 10). As with the Denison Creek fenceline sand plots, the additional plots along the fenceline will be 2-3m long. This is a similar design to other transects utilised in previous Transport and Main Roads monitoring regimes developed for other projects (Leopold-Wooldridge, K. 2008).

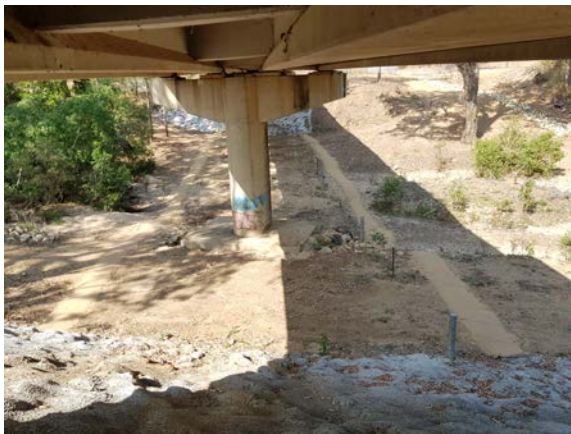
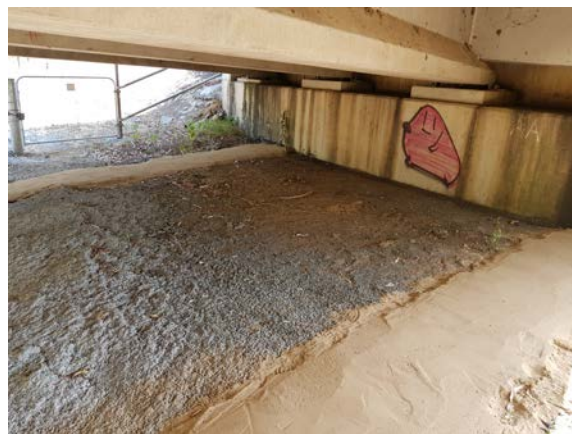
Plate 14 and 15: Locations of sand plots underneath the Denison Creek Bridge as implemented during the 2019 monitoring event

Ten sand plots will be constructed at strategic locations underneath the Denison Creek bridge and perpendicular to the fauna exclusion fencing. Sand plots will be, in general, 3cm high and 1.0m wide. The six sand plots underneath the Denison Creek bridge will cover the entire breadth of the underpass and the stepped abutments. The additional plots along the fenceline will be 2-3m long. This is a similar design to other transects utilised in previous Transport and Main Roads monitoring regimes developed for other projects (Leopold-Wooldridge, K. 2008).
