2022 Annual Compliance Report

Environment Protection and Biodiversity Conservation Act 1999

Yorkeys Knob Boating Facility

Appendix 4 - EPBC 2020-8692 non-conformance/corrective actions report

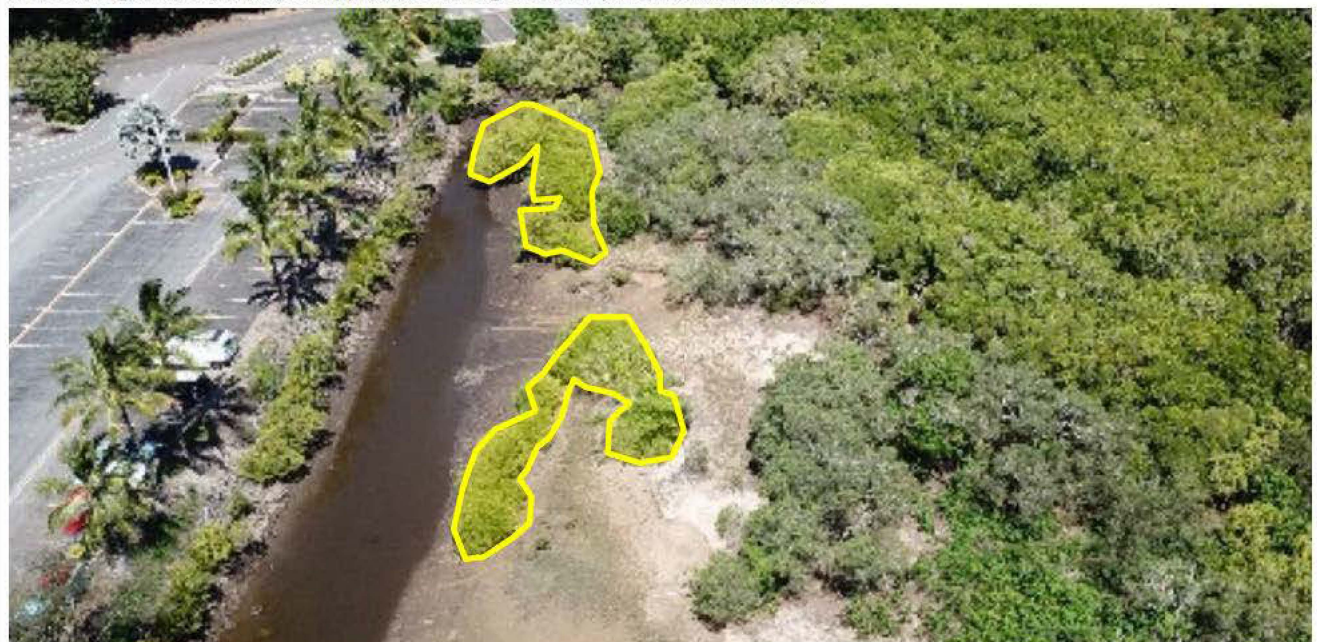
Pre-Clearing Picture (below). Unapproved Clearing shown in yellow at near low tide.

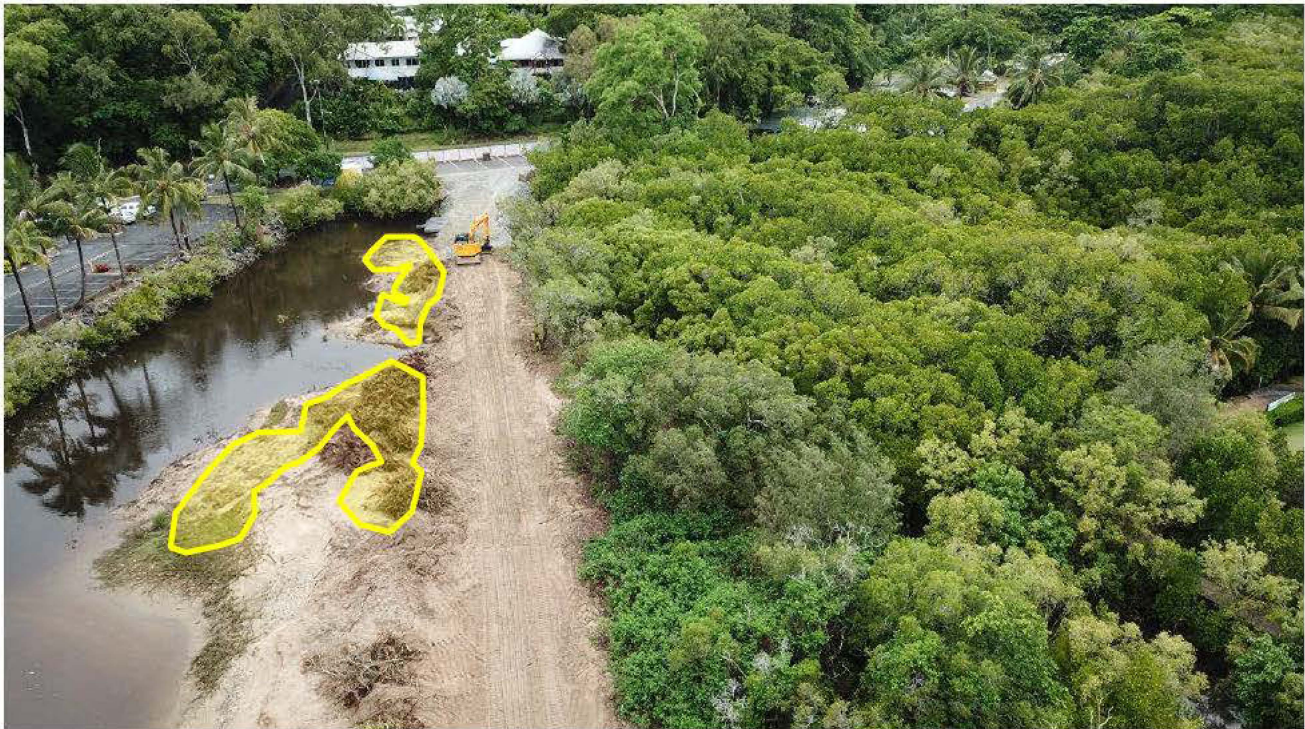
Post-Clearing Picture (below). Unapproved Clearing shown in yellow at near low tide.

14. The site supervisor and excavator operator were advised that the foreshore line in this area represented the extent of clearing works.
15. From approximately chainage 120m onwards, the northern alignment pegs were in place to guide the clearing works.
16. The clearing outside the approved boundary remained unnoticed until pointed out by a TMR representative following review of works photos at a later date.
17. The additional area cleared amounts to approximately 0.0244ha (244m²)

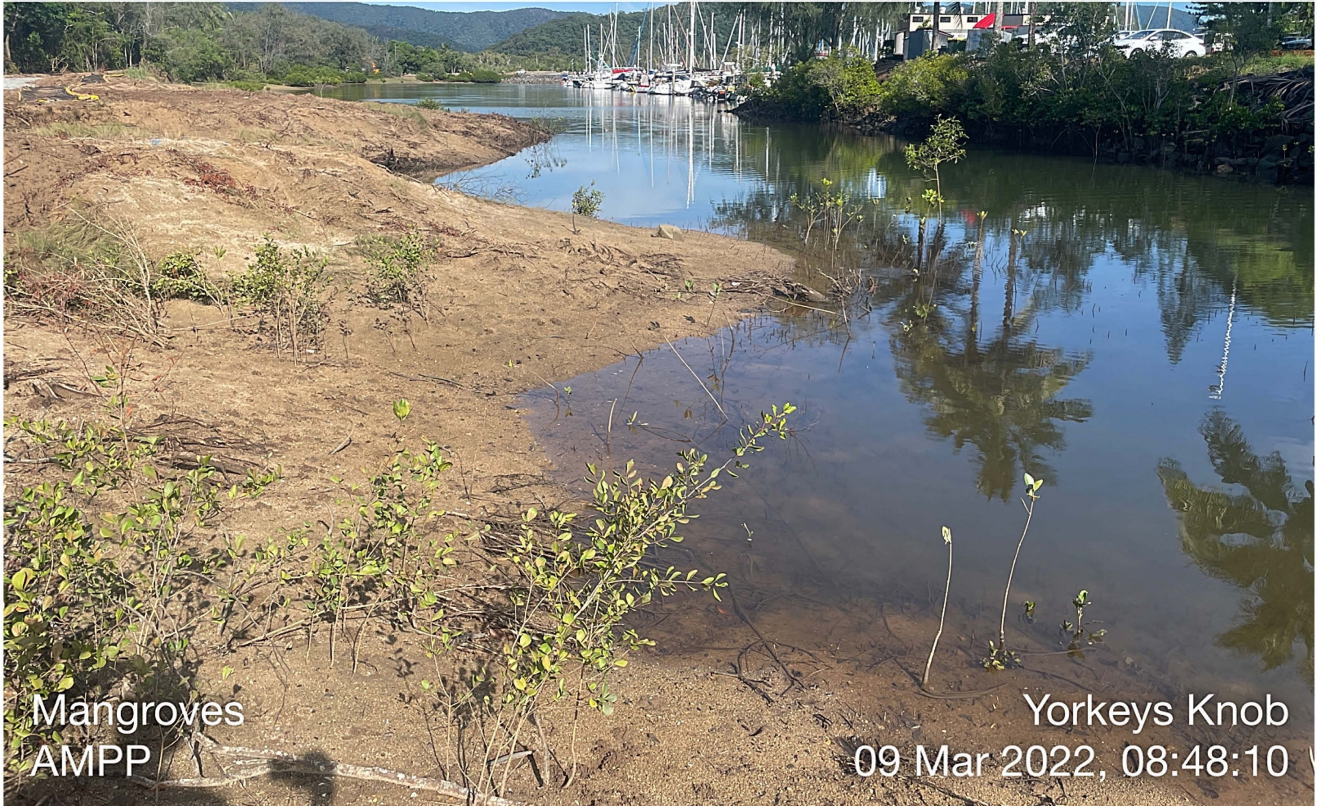
Yorkeys Knob
09 Mar 2022, 08:48:10

- c. The likelihood of rehabilitation (see corrective action section).
 - d. As per the vegetation clearing plan in the EMP the mangrove stands were removed cut off at ground level, so the ground was no disturbed. For this reason, the remaining stumps and root systems will continue to capture sediment, mitigate erosion and promote reshooting of mangroves (see attached photos).

Mangroves
AMPP

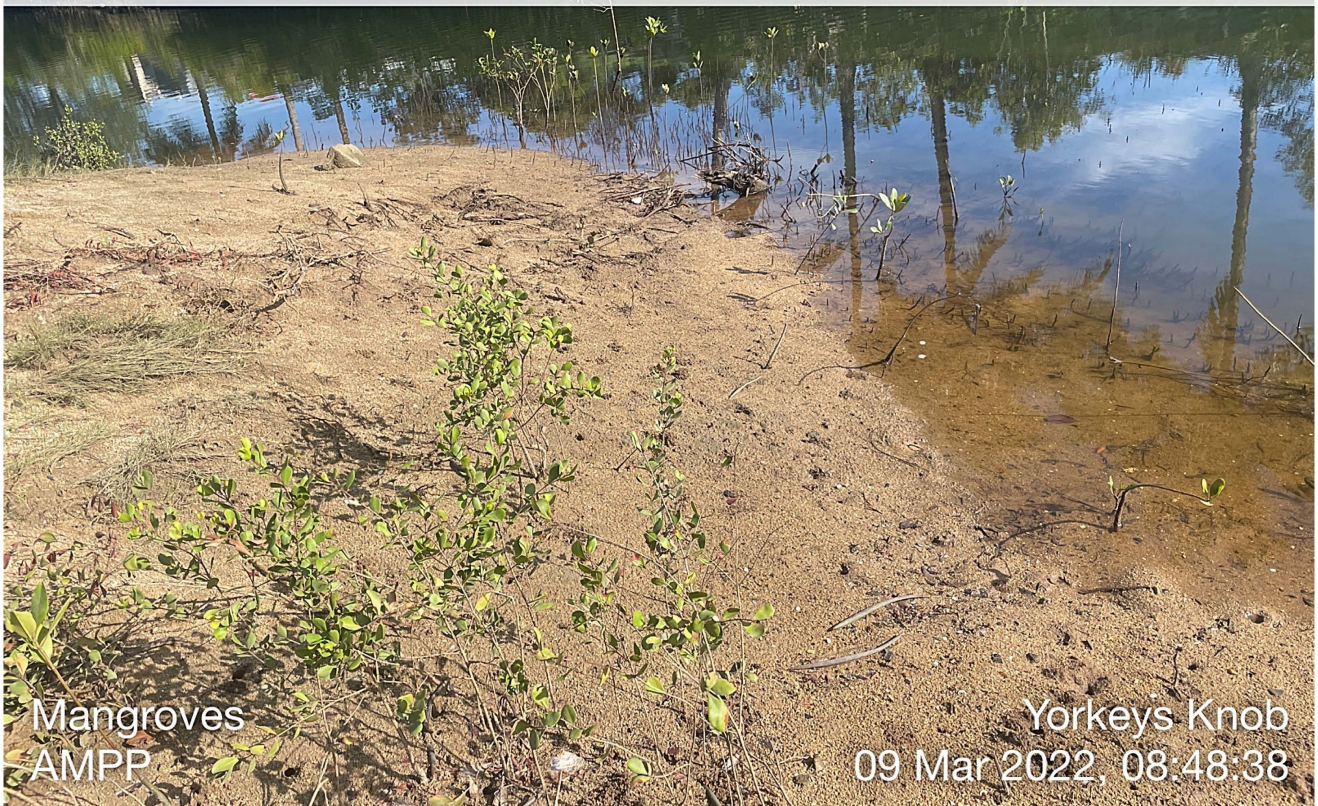
Yorkeys Knob
09 Mar 2022, 08:48:38

Mangroves
AMPP
