**Mission Beach Clump Point Boating
Infrastructure Project: Construction
Environmental
Management Plan**

Title:
Project Study Area and Concept Design

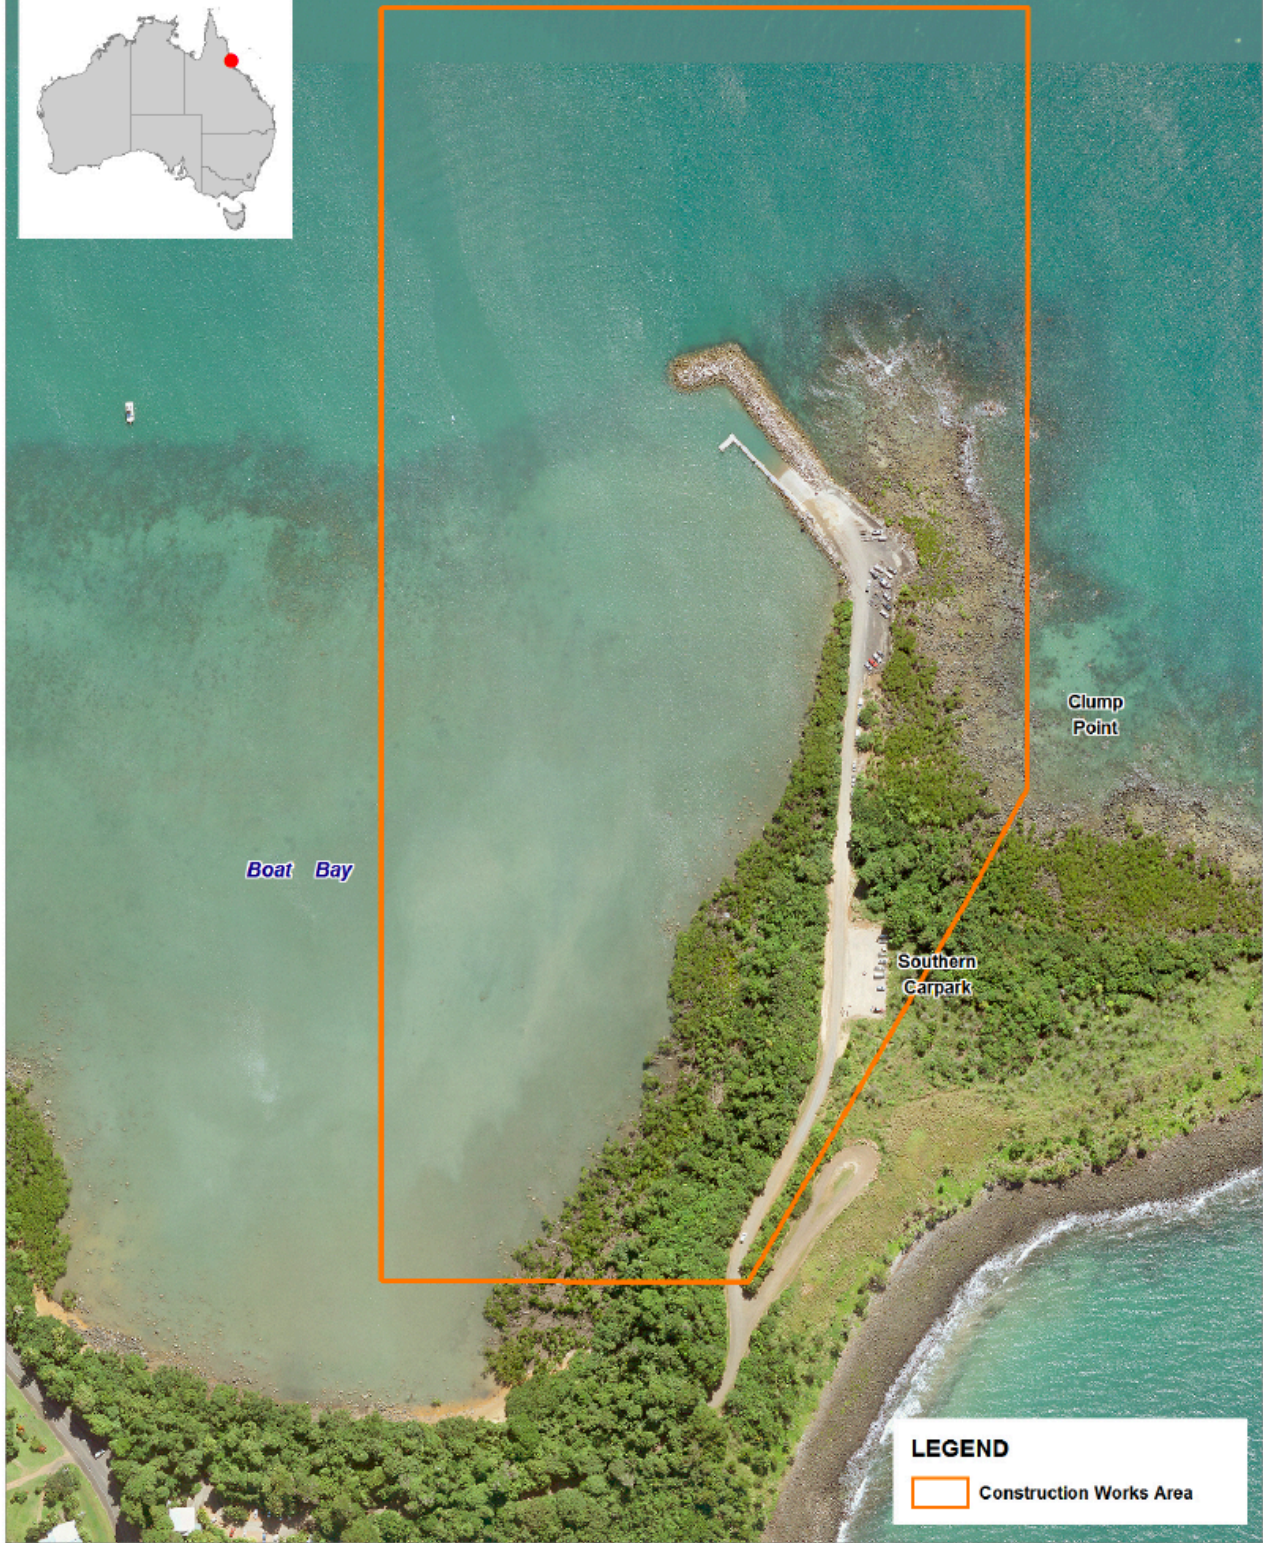
Figure:

Title:
Construction Works Area

- Construction of a temporary causeway with sufficient box culverts to maintain minimum flow at mean low water springs (MLWS) based on 25m crest gap modelled flows. The causeway will be removed at the end of works.

- During the construction phase, a stockpile and laydown area will be maintained in the existing car park near the boat ramp.
- During construction, works will also be undertaken to remove maritime debris from the works area, including the floating walkway modules within the nearby mangroves (being undertaken by CCRC) and anchor chains in coral reefs of Boat Bay (where appropriate).

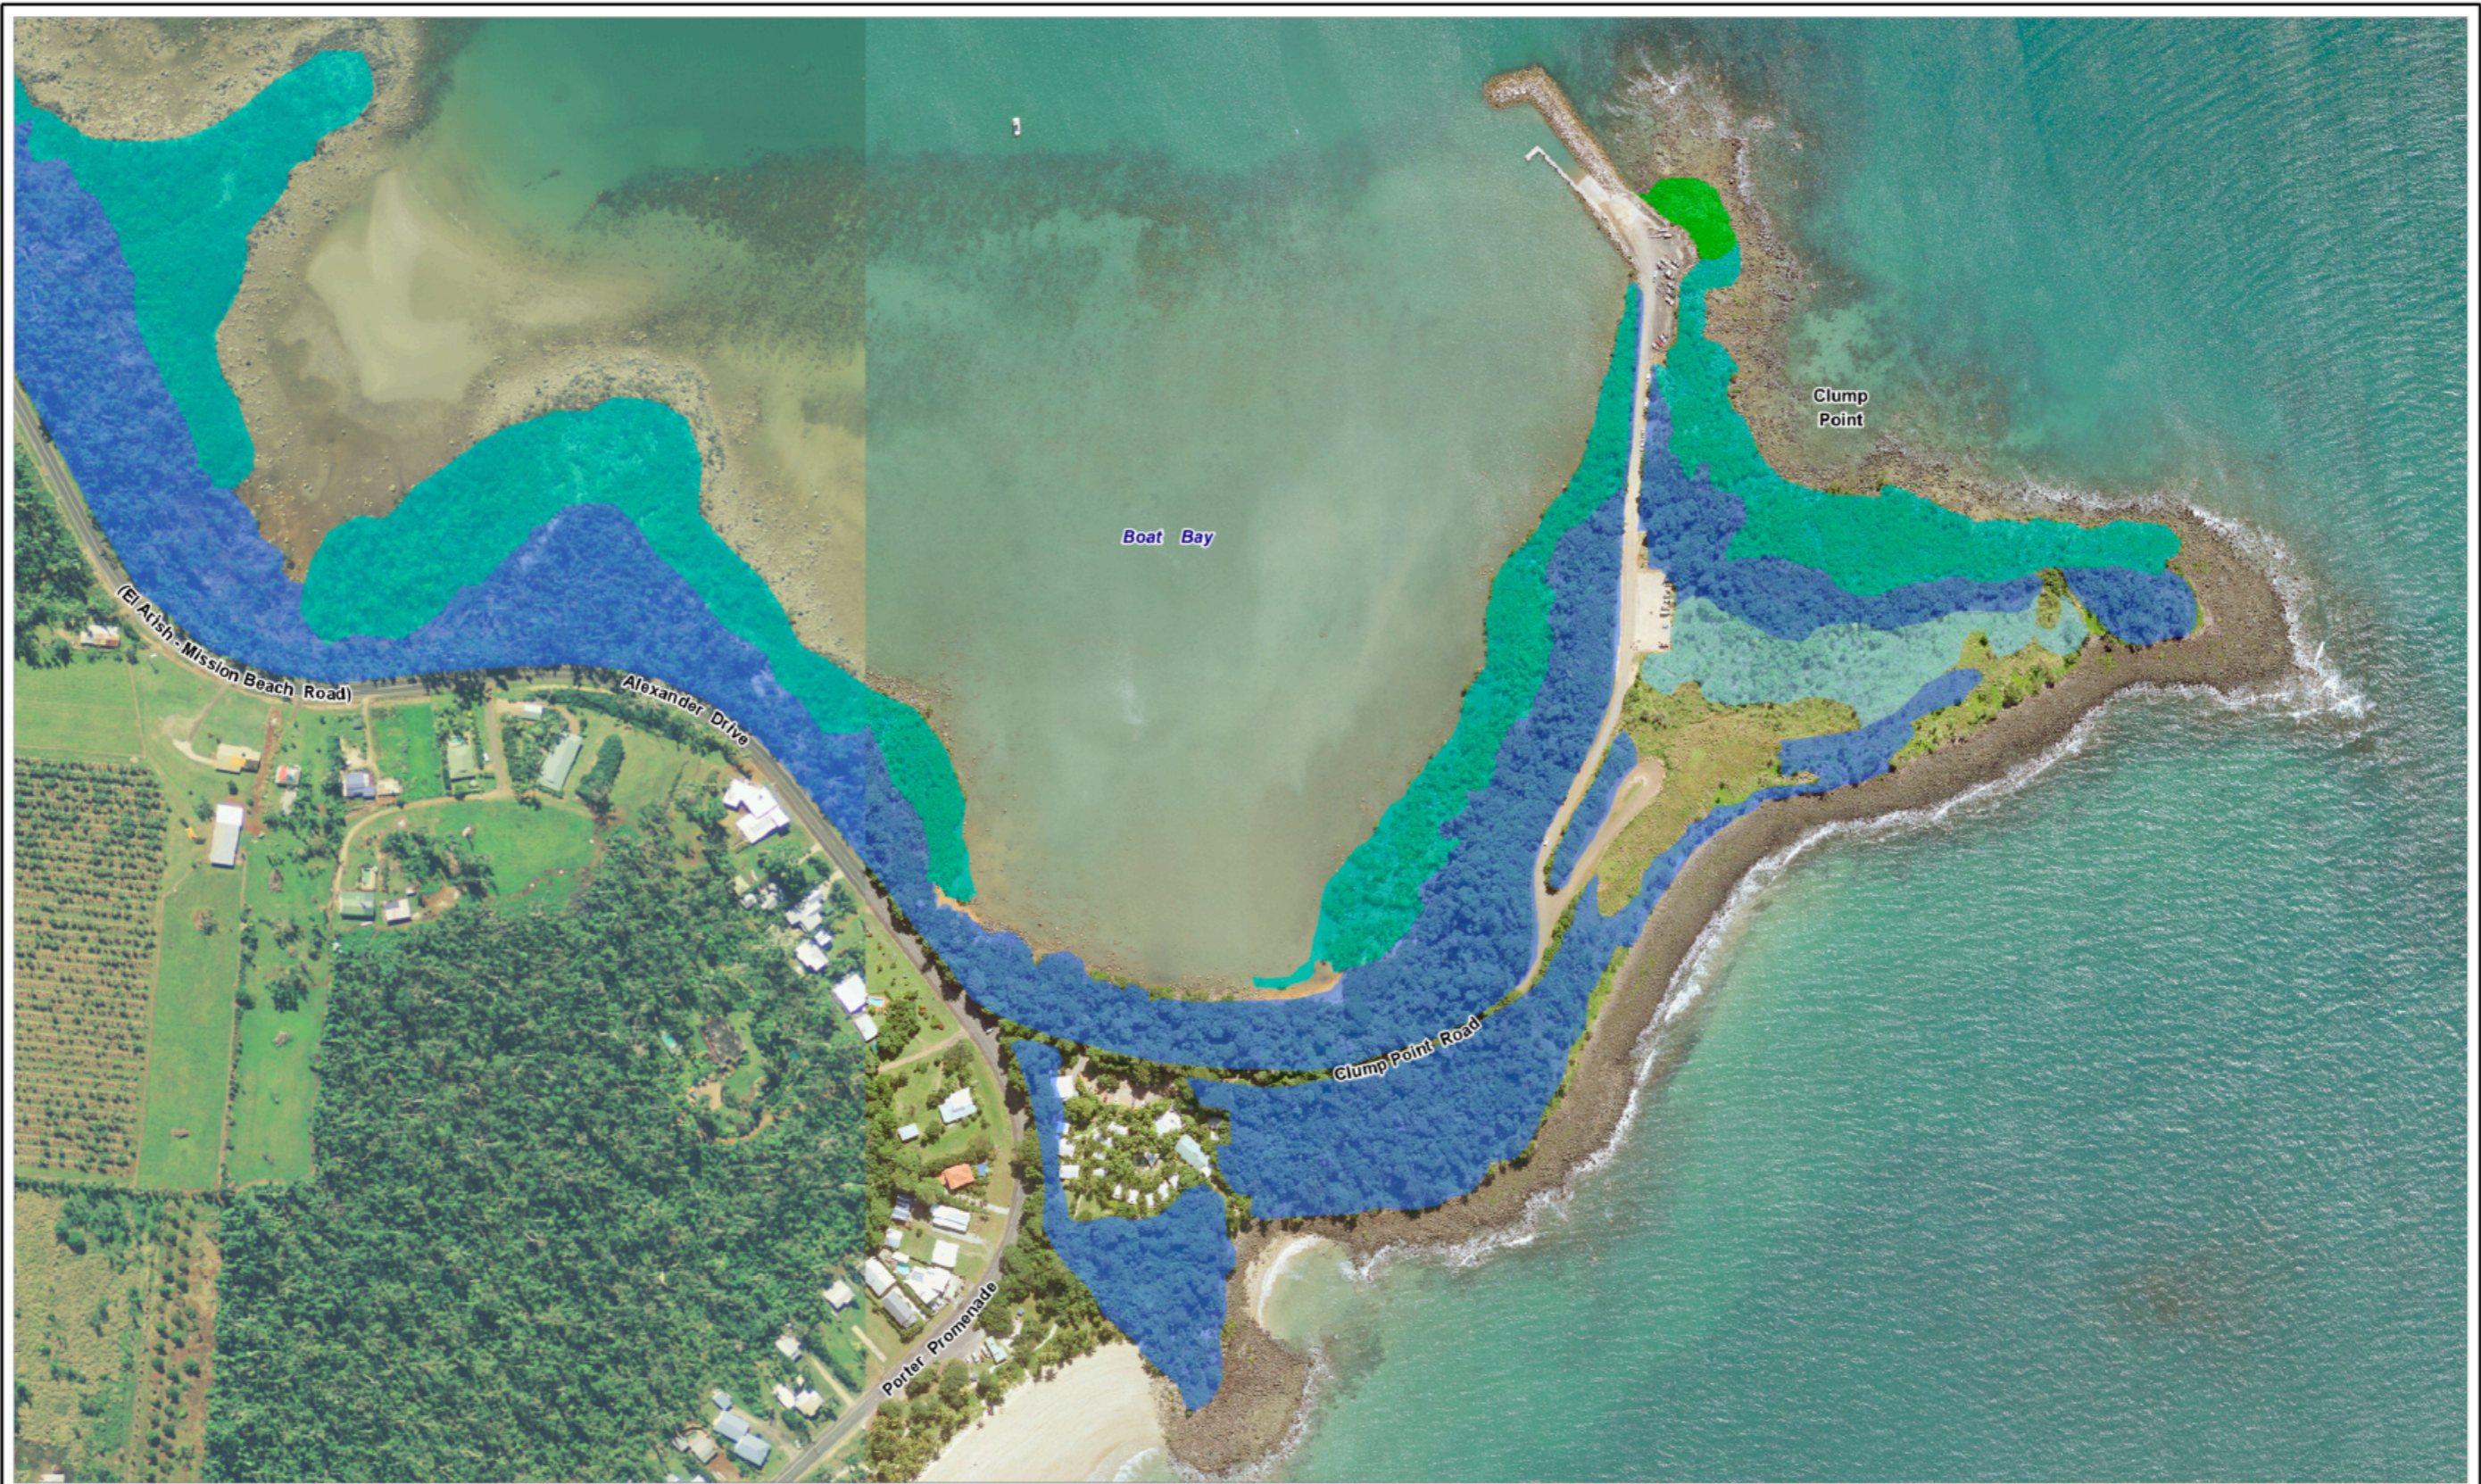
RE 7.8.1a is an Endangered community under the VM Act and corresponds to the littoral rainforest and coastal vine thicket of eastern Australia threatened ecological community (TEC), listed as Endangered under the EPBC Act. No flora species listed as threatened under the NC Act or EPBC Act have been identified within this area of the community based on 2016 surveys, although the Arenga palm (*Arenga australasica*) grove and individual trees are known to occur in this community within the Project area (see Figure 4-2) (BMT WBM, 2016b).
