DTMR M1 UPGRADE

FLOOD EVENTS OF FEBRUARY AND MARCH 2022 ADDITIONAL FLOODING ANALYSES BASED ON NEW DATA

SLR Ref: 620.31045-R03
Version No: -v0.1
April 2023

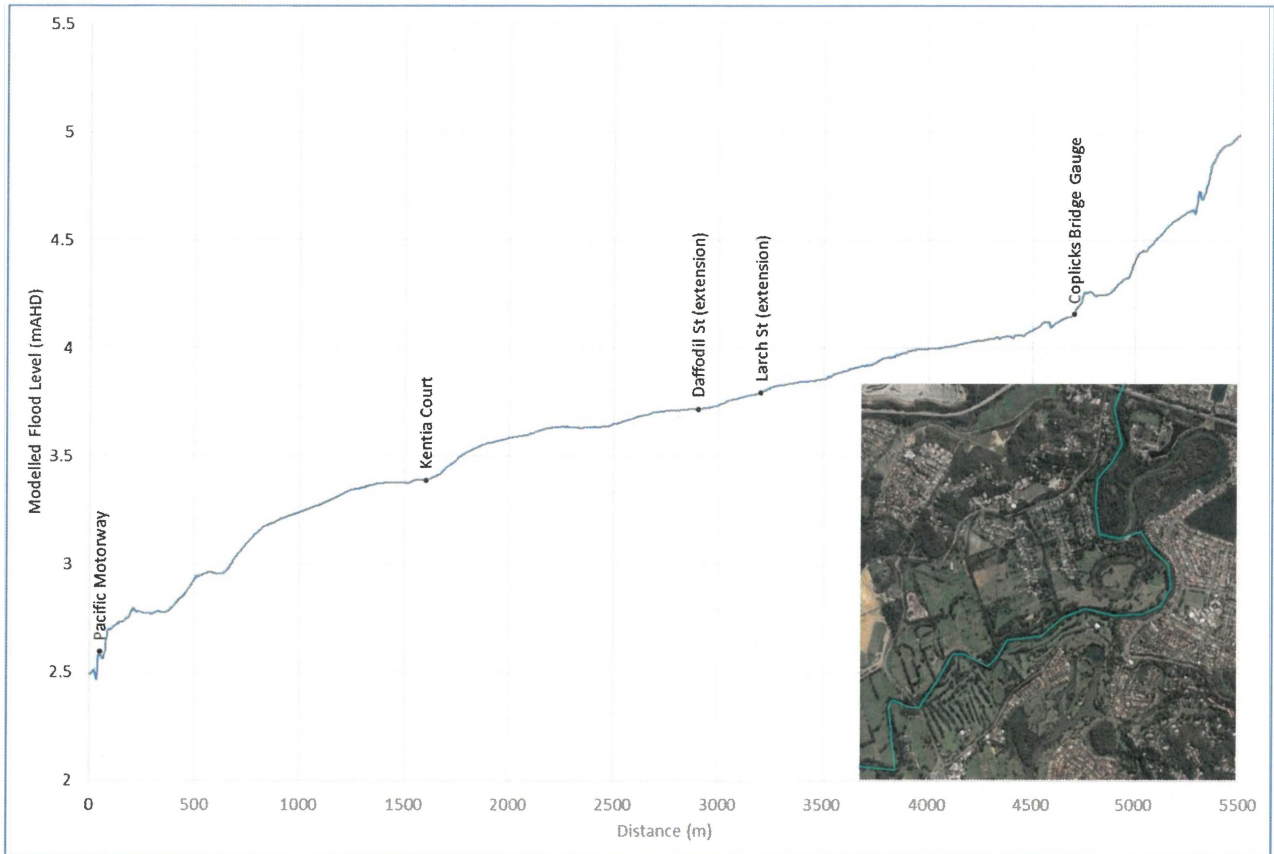
- 17 As noted above and included in this table, the model verification process also used data provided by .
- 18 This comparison demonstrates good consistency between measured and calculated flood levels. The TUFLOW model is considered to accurately replicate actual catchment behaviour which validates the hydraulic modelling. It is noted that the inclusion of the flood level information upstream of Kentia Court has resulted in increased predicted flood levels which are consistent with recorded data. The change in flood level with increasing upstream distance is illustrated in the figure on the next page.

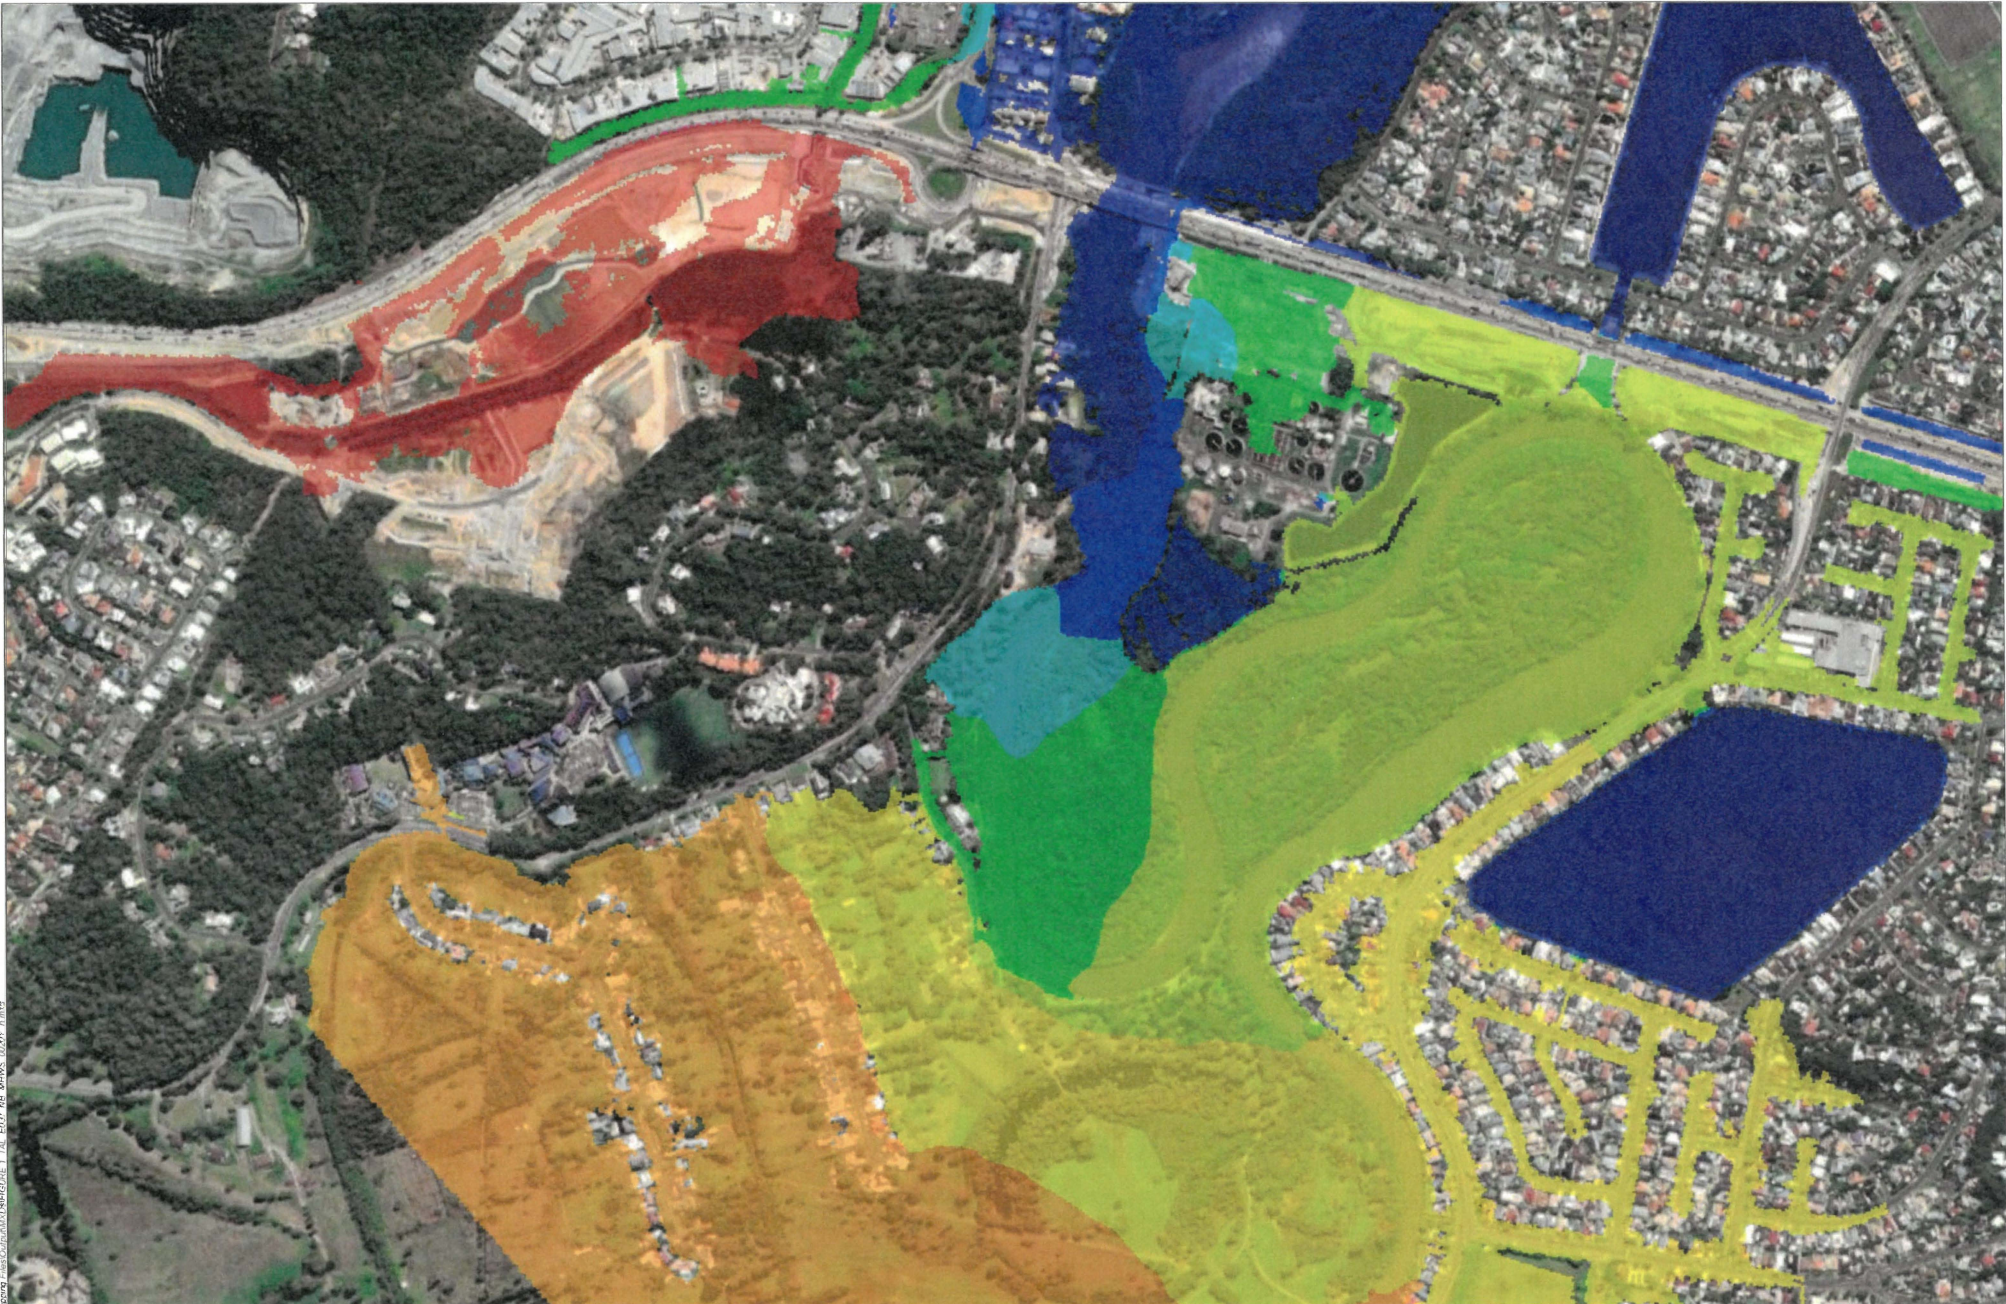
M1 B2PB - Tallebudgera Creek
 Construction Flood Impact Assessment
 Pre-Construction Conditions (E037)
 Peak Flood Levels - 5% AEP

13 A comparison of Figures 1 (5% AEP), 2 (2% AEP) and 10 (February 2022 event for pre-construction conditions) shows that the flood event which occurred in late February 2022, in the absence of any construction works, would have fitted comfortably between a 2% and 5% AEP event. This is entirely consistent with the rainfall and hydrologic analysis reported on above. That is, if the construction works has not been underway, the flood levels experienced throughout the catchment would have been lower than those for a 2% AEP event, but higher than those for a 5% event.

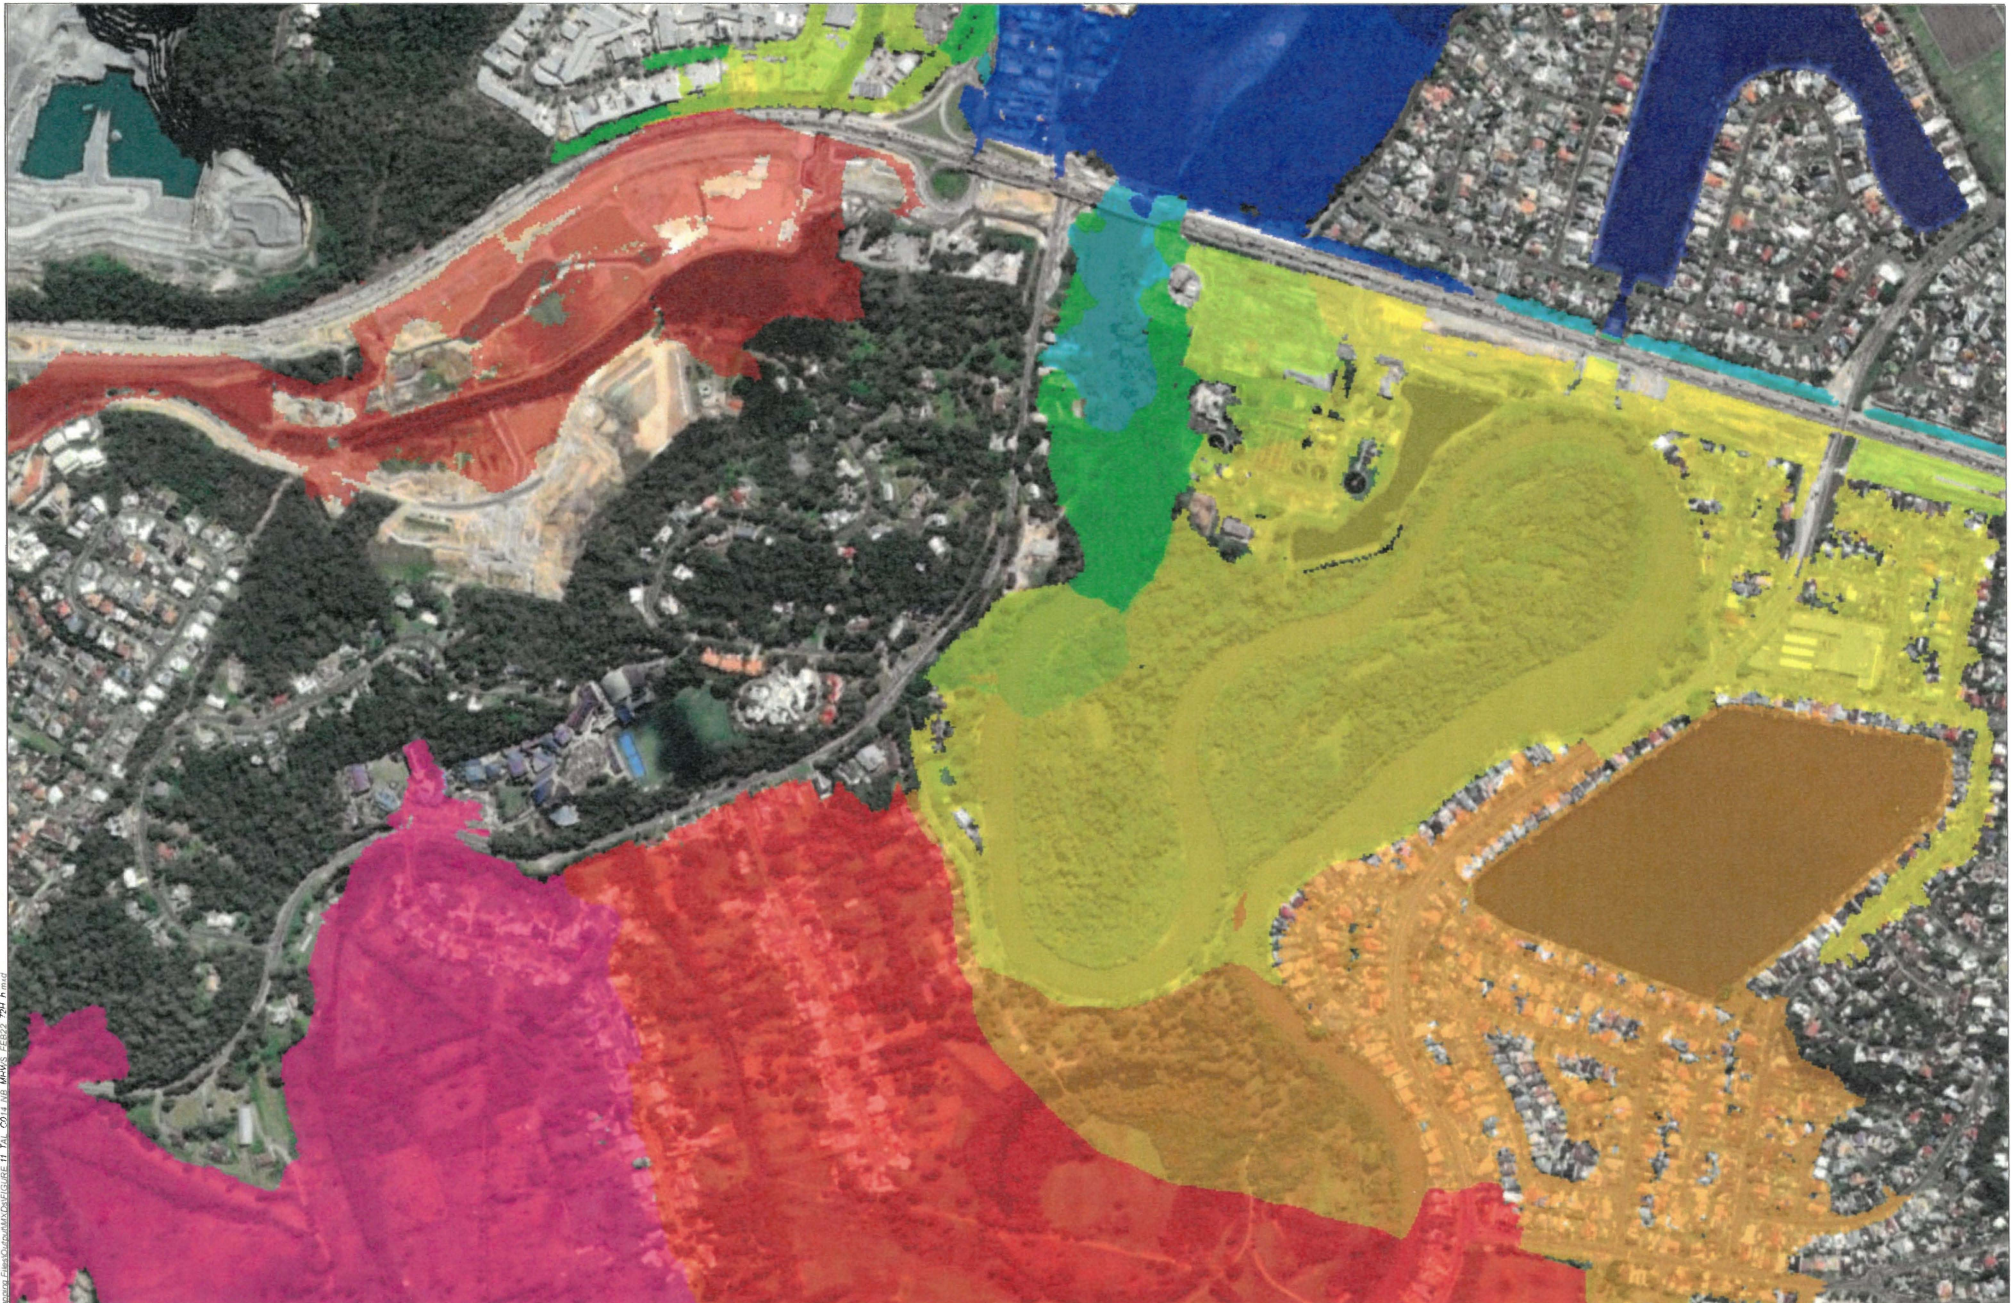
FIGURE 11

M1 B2PB - Tallebudgera Creek
Construction Flood Impact Assessment
February 2022 Construction Conditions (C014)
Peak Flood Levels - February 2022 Event
