# Moreton Bay Rail Project

## Independent Hydraulic Review

Prepared for: Department of Transport and Main  
Roads  
Date: 7 August, 2015

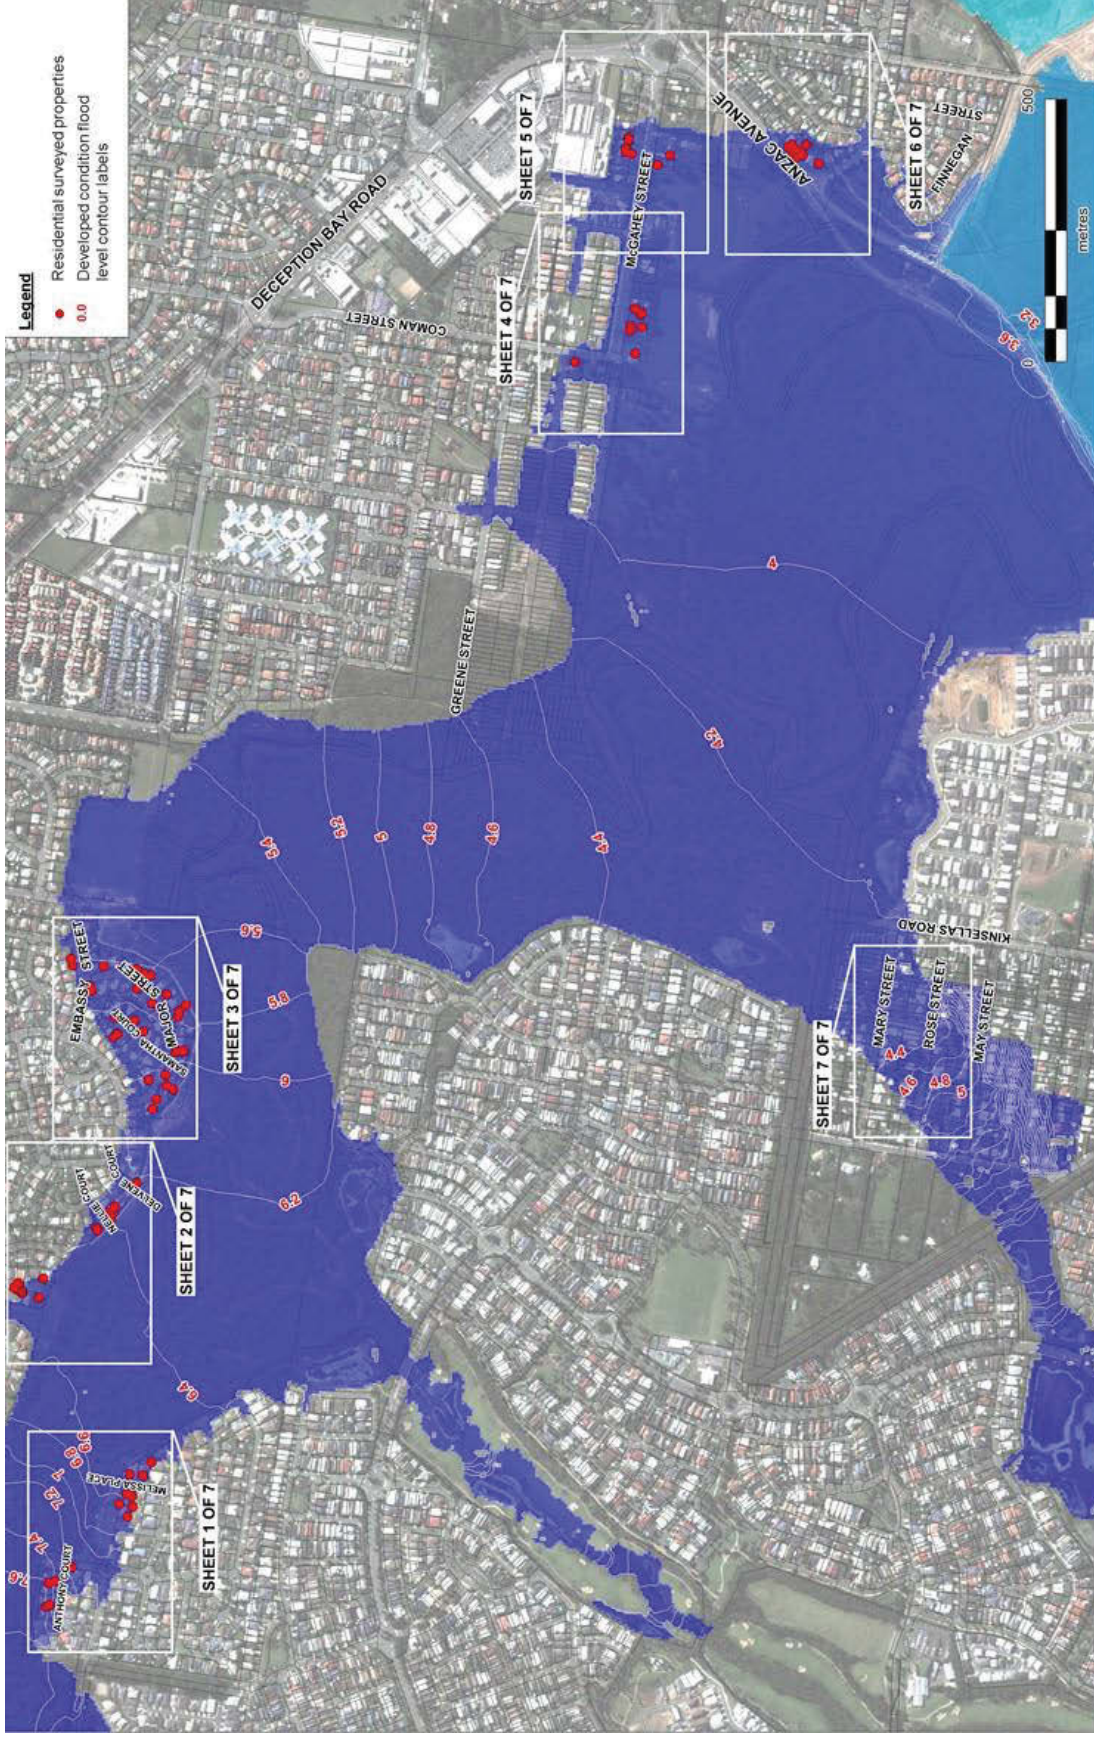
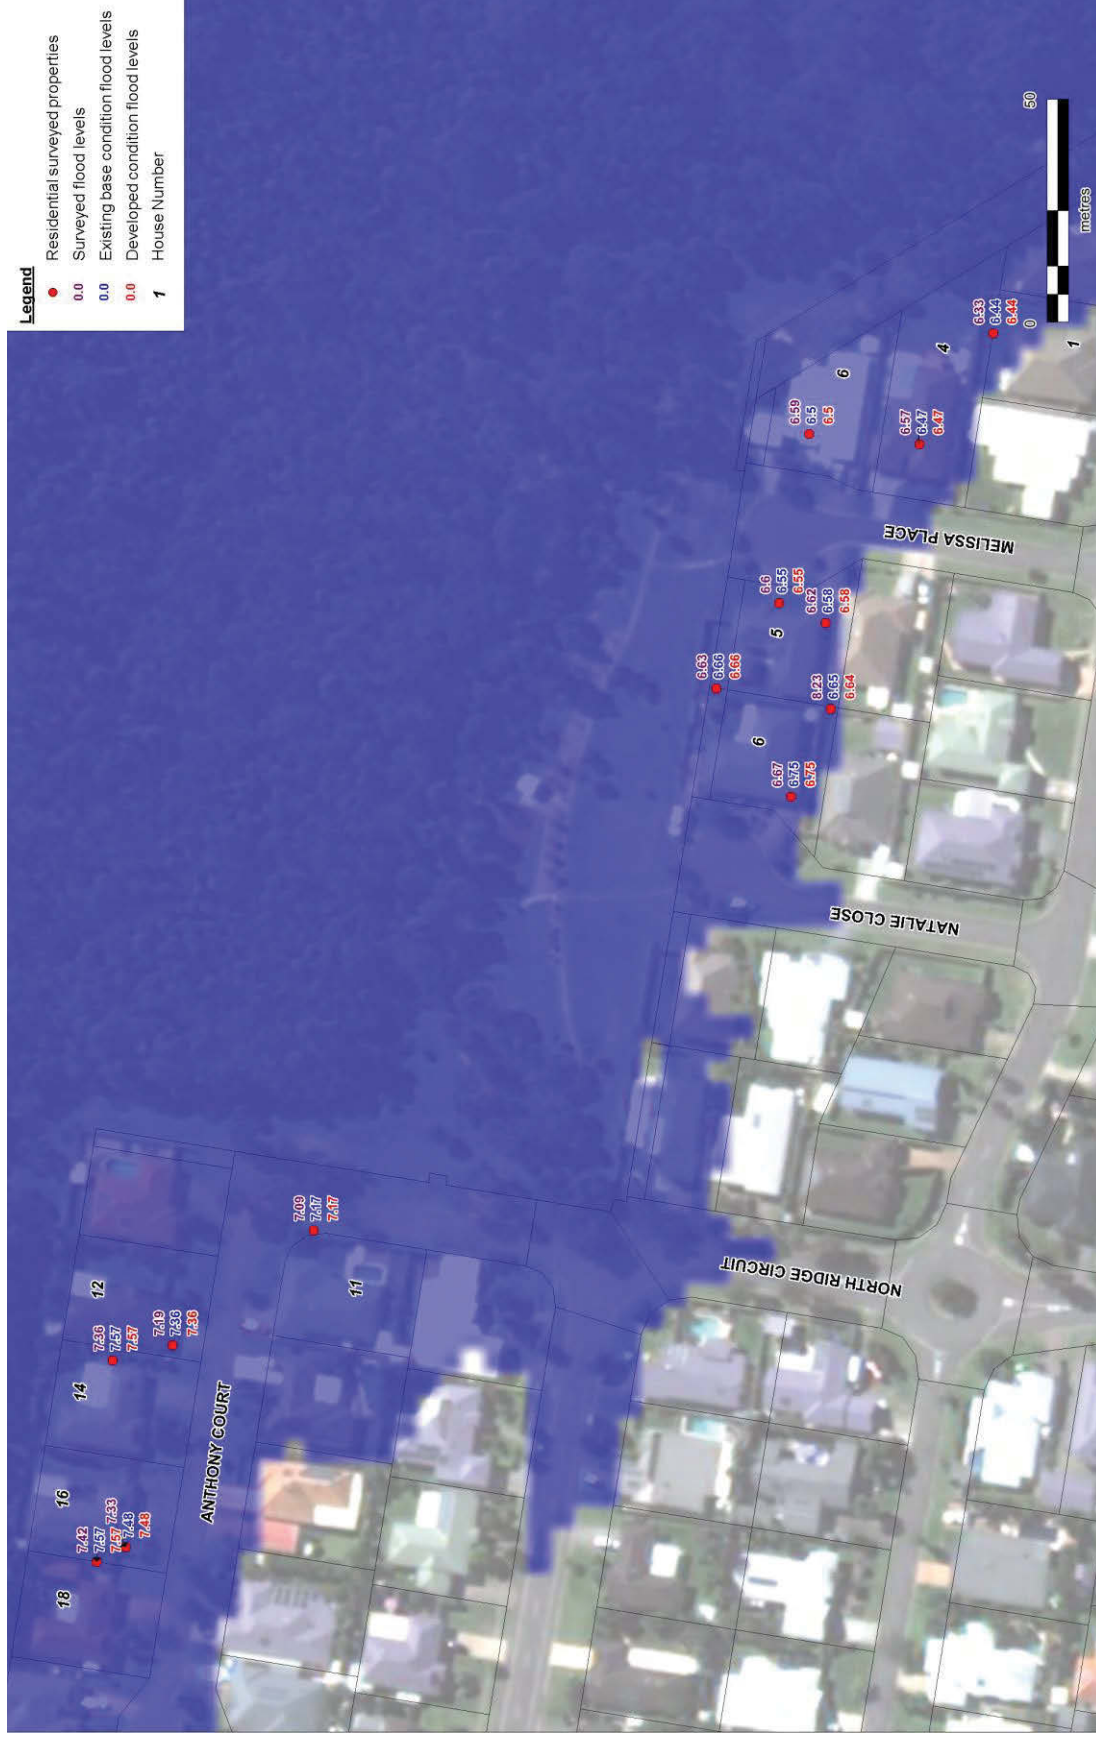
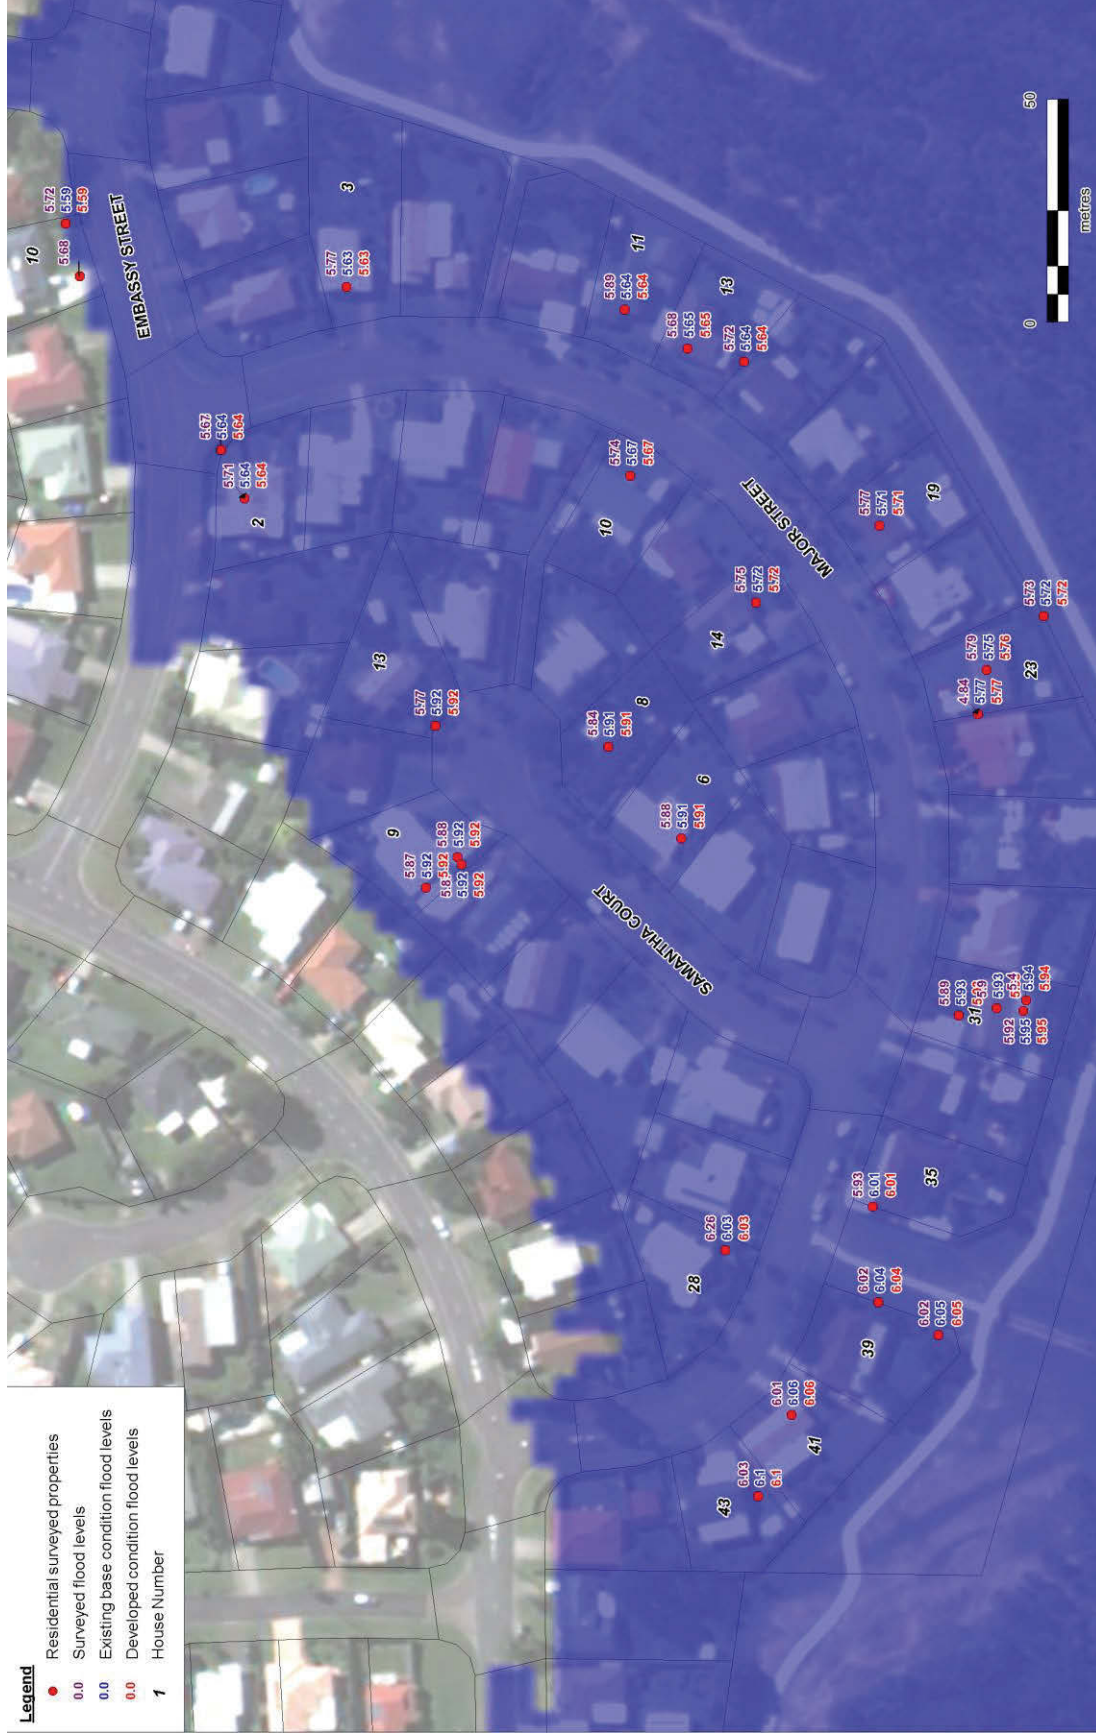
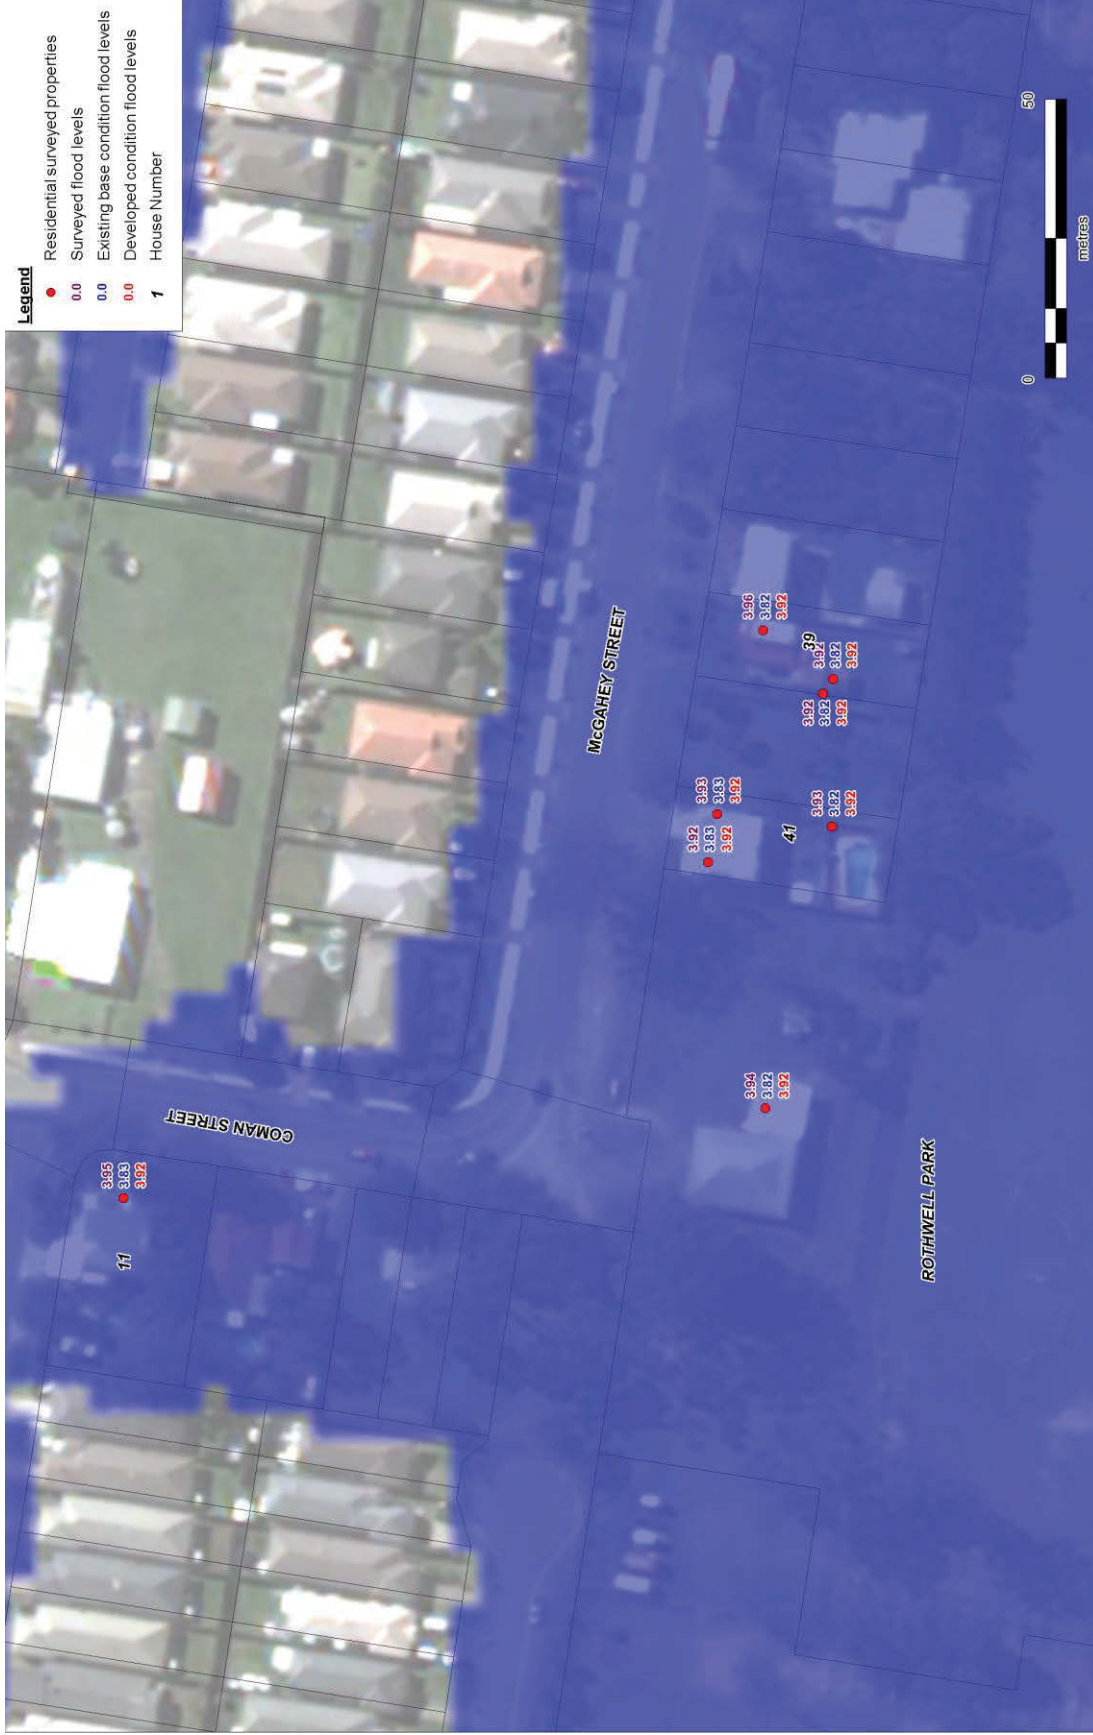
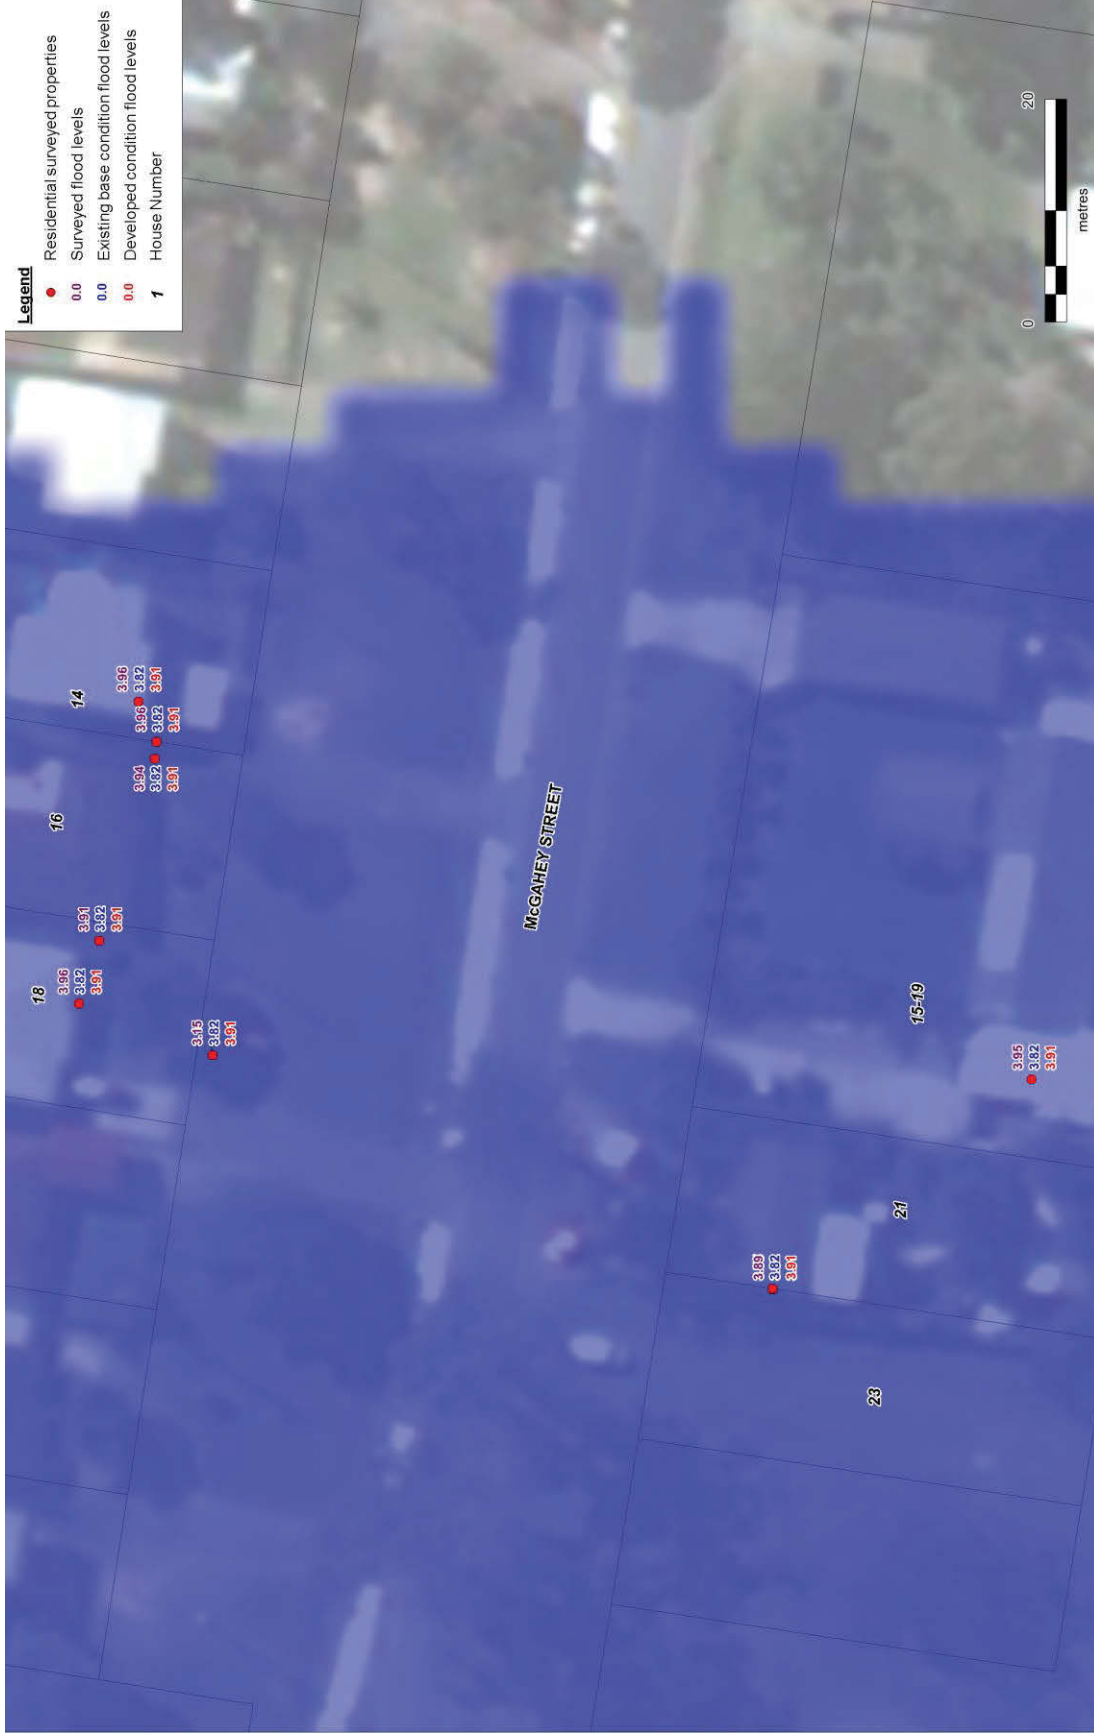
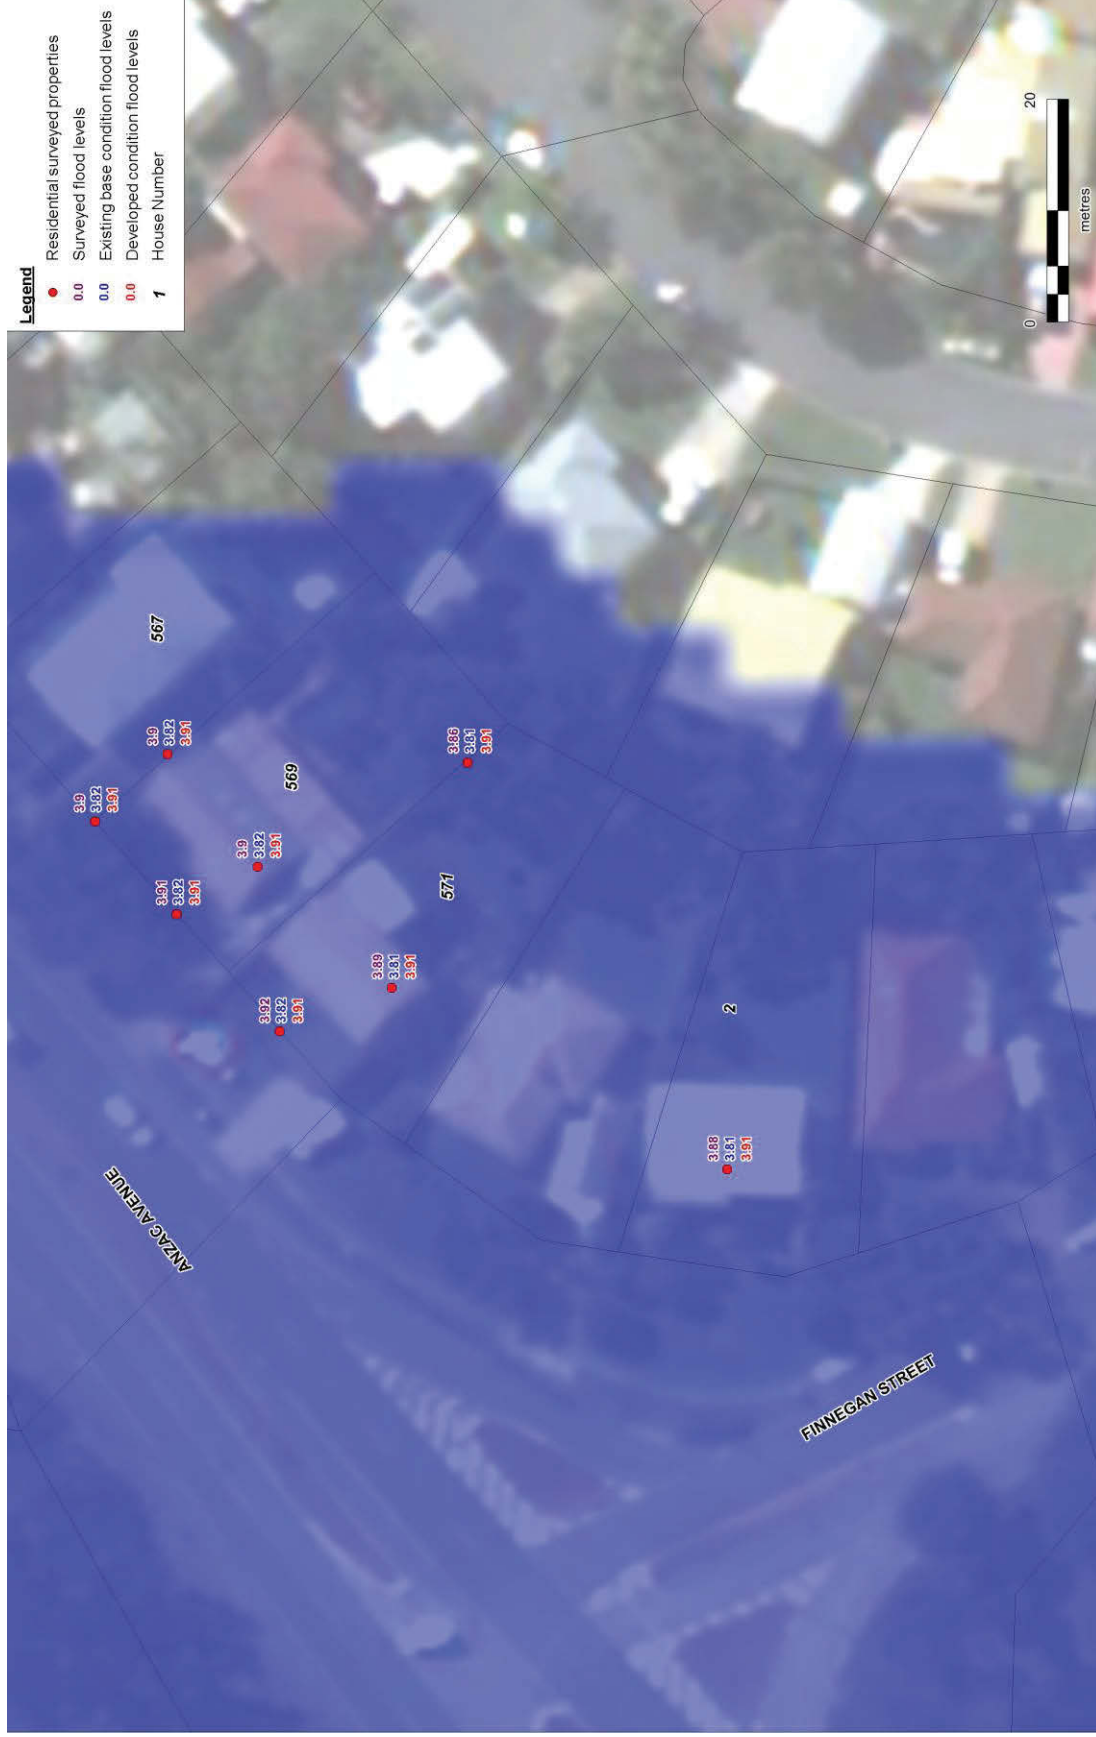
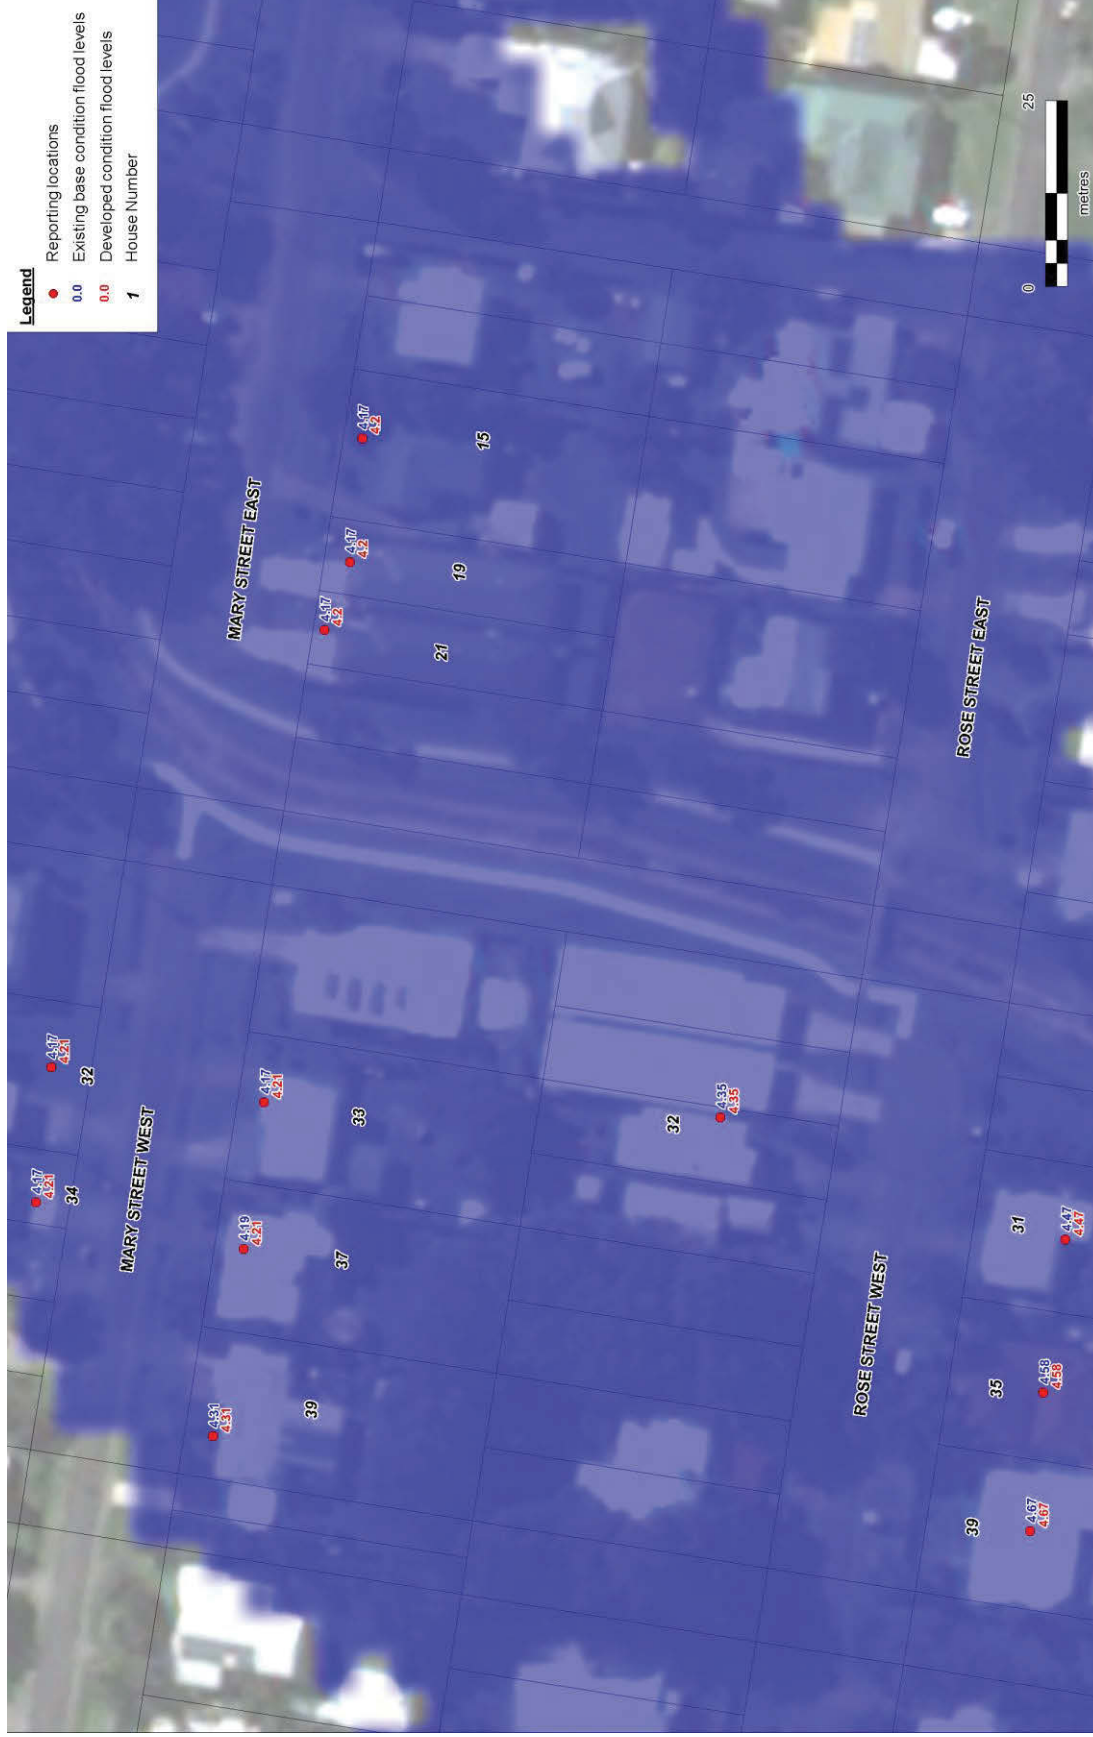
Figure 31 – Comparison of modelled and surveyed levels, 1<sup>st</sup> May 2015 Event, Existing Base condition vs Developed condition

The comparison indicates that the Developed condition model closely replicates the observed flood levels during the 1<sup>st</sup> May 2015 flood event at most locations. A maximum difference of +/- 30 mm is achieved for most locations. In places where the model does not match surveyed levels (i.e. Anthony Court, Deception Bay), a maximum 186 mm average difference in levels is observed. This location is outside the area of impact of the MBR project (refer to Section 5.5).

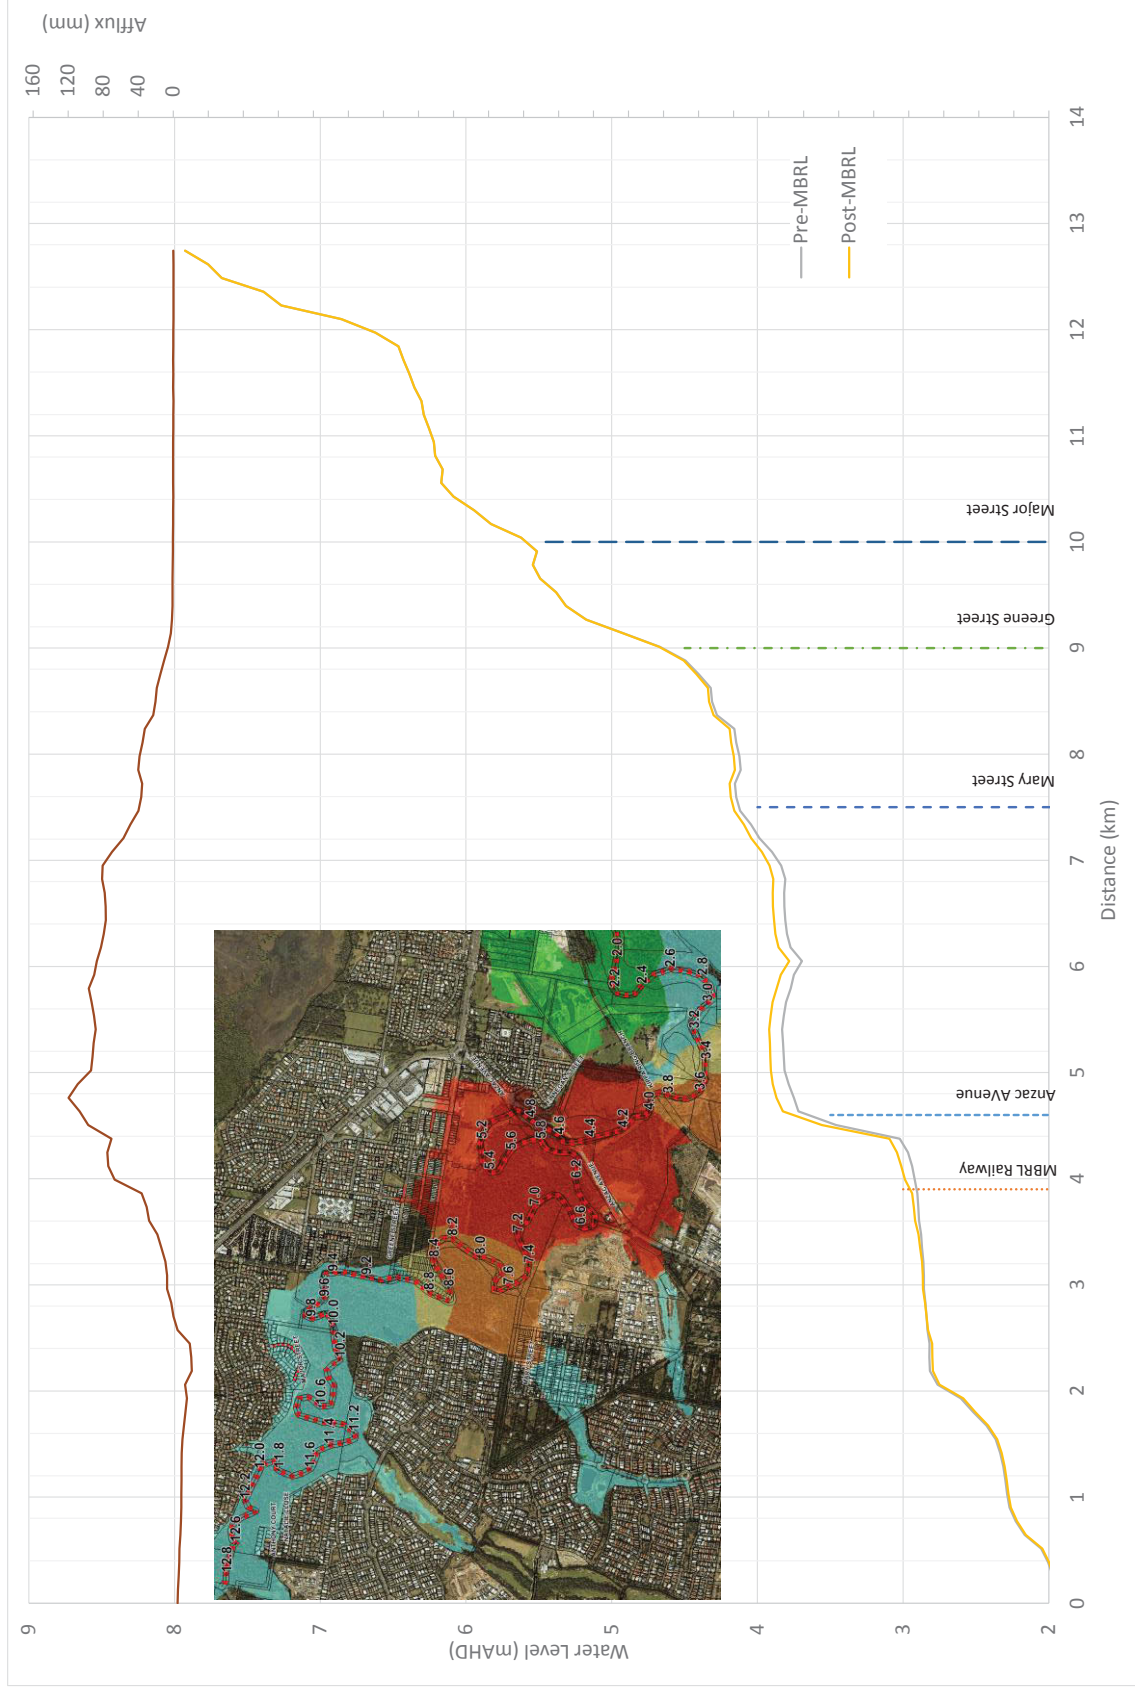
Figure 34 –Water level and Afflux profiles along Creek centreline, 1<sup>st</sup> May 2015 event, Existing Base and Developed conditions

The afflux experienced upstream of Anzac Avenue as a result of the MBR project dissipates approximately within 4.5 km (at Greene Street, Rothwell), where a steep section of the flood profile is observed and the afflux does not extend upstream into Major Street and other areas.

The slope of the Saltwater Creek flood profile between Greene Street and Major Street is approximately 0.1% (1 m in 1000 m) in comparison to the much flatter slope of 0.015% (1 m in 6500 m) observed further downstream between Greene Street and Anzac Avenue (refer to Figure 34).
