Manual

**Structures Inspection Manual
Part 2: Deterioration Mechanisms**

September 2016

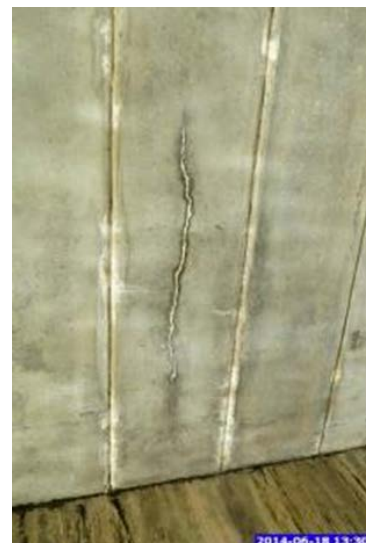
Figure 2.2.2d – Example ASR crack pattern in prestressed deck unit soffit

ASR cracking most commonly occurs in prestressed deck units in Queensland (Figure 2.2.2d). Vertical cracking has also been detected in some prestressed octagonal piles which is the result of Alkali-Silica Reaction (ASR). The risk of this type of cracking has been minimised in new construction by the use of an appropriate mass of fly ash in the approved mix designs.

can take the form of extensive map cracking and/or cracking aligned with the major stress direction or reinforcement. White or colourless exudations around some of the cracks are also an indicator that AAR may be occurring. The appearance of concrete components affected by AAR is shown in Figure 2.2.2a – Figure 2.2.2d.

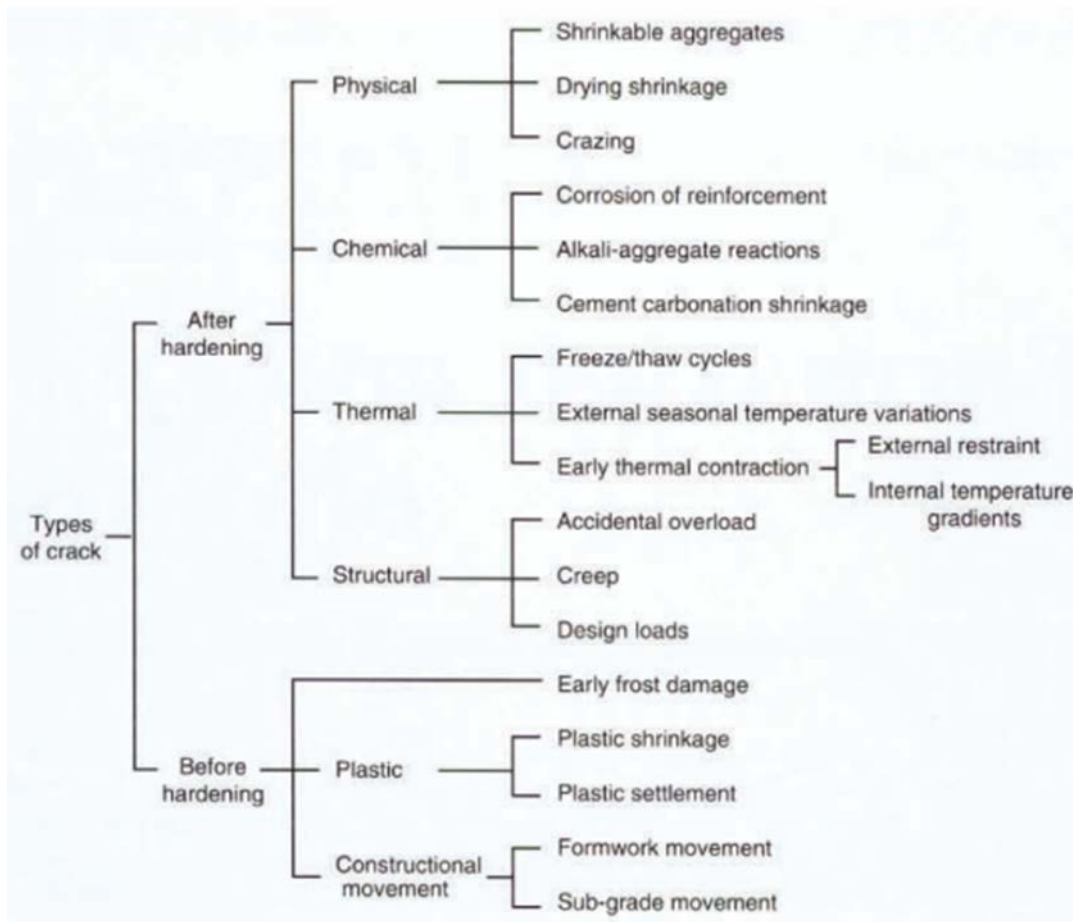
Figure 2.2.3 – Types of cracking in concrete

The build-up of tensile stresses and, therefore, cracks in the concrete may be due to any number of causes and occur at different stages of the concrete development. Figure 2.2.3 summarises the possible crack types and the stages at which they may develop (plastic state and after hardening). Figure 2.2.3.1a illustrates typical crack patterns and locations.

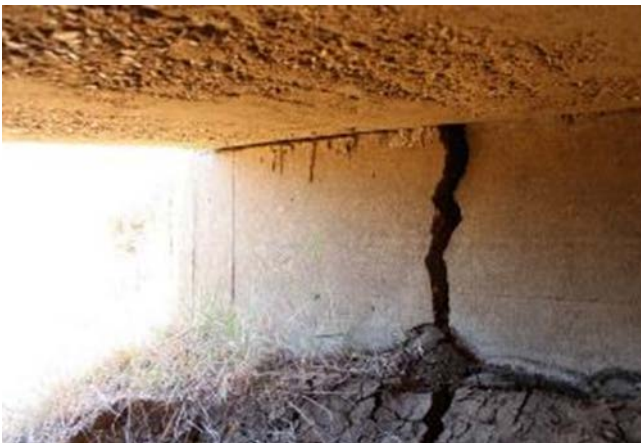
Figure 2.2.3.2c – Crack/separation in abutment wall due to differential settlement

- Differential movement/settlement - differential movements or settlements result in the redistribution of external reactions and internal forces in the structure. This may in turn result in the introduction of additional tensile stresses and, therefore, cracking in the concrete components of the structure. Movement cracks may be of any orientation and width, ranging from fine cracks above the reinforcement due to formwork settlement, to wide cracks due to foundation or support settlement.

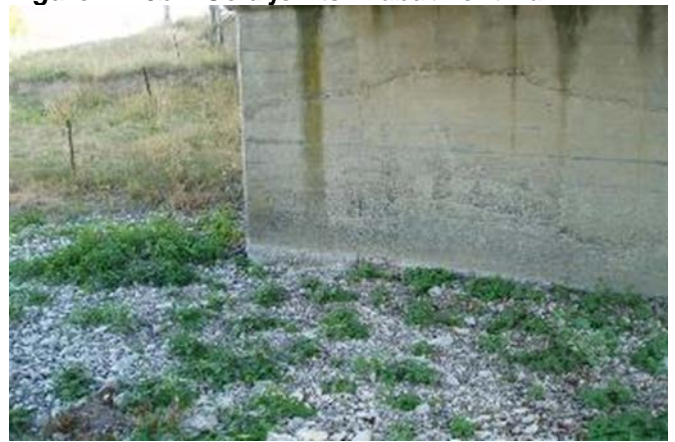
Figure 2.2.6b – Cold joints in abutment wall

- Segregation - the differential concentration of the components of mixed concrete resulting in non-uniform proportions in the mass. Segregation is caused by concrete falling from a height, with coarse aggregates settling to the bottom and the fines on top. Another form of segregation occurs where reinforcing bars prevent the uniform flow of concrete between them. Segregation is more likely to occur in higher slump concrete.
- Cold joints – these are produced if there is a delay between placement of successive pours of concrete, and if an incomplete bond develops at the joint due to the partial setting of concrete in the first pour (refer Figure 2.2.6b).

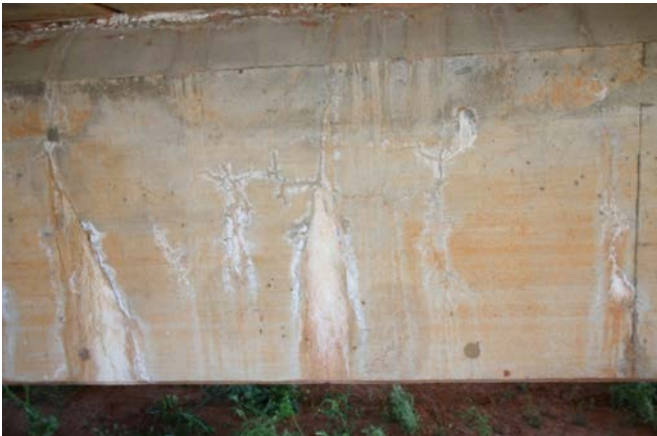
Figure 2.2.6c – Efflorescence evident on concrete headstock

- Deposits – staining/accumulation of material on concrete surfaces where water percolates through the concrete and dissolves or leaches chemicals from it and deposits them on the surface. Deposits may appear as:
 - efflorescence – a deposit of salts, usually white. Over time can result in stalactites forming (refer Figure 2.2.6c)
 - exudation – a liquid or gel-like discharge through pores or cracks in the surface (refer Figure 2.2.6d)
 - encrustation - a hard crust or coating formed on the concrete surface.

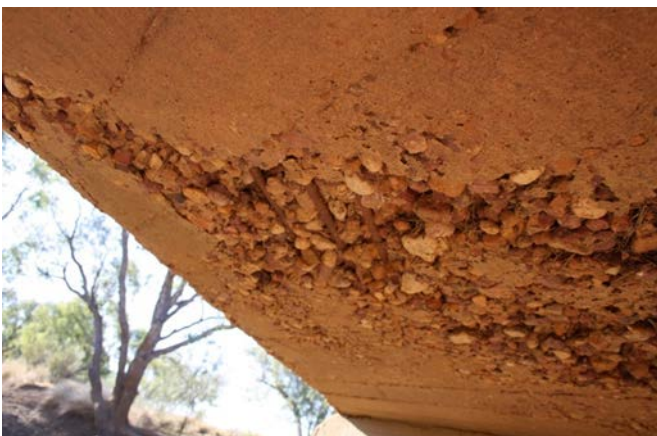
Figure 2.2.6e – Concrete honeycombing

- Honeycombing – produced due to the improper or incomplete vibration of the concrete which results in voids being left in the concrete where the mortar failed to completely fill the spaces between the coarse aggregate particles (refer Figure 2.2.6e).

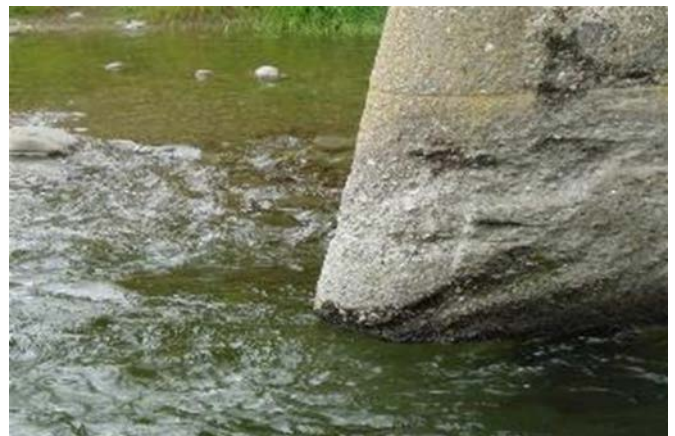
Figure 2.2.6f – Abrasion of concrete

- Abrasion - the deterioration of concrete brought about by vehicles scraping against concrete surfaces, such as decks, kerbs, barrier walls, piers or the result of dynamic and/or frictional forces generated by vehicular traffic, coupled with abrasive influx of sand, dirt and debris. It can also result from friction of waterborne particles against partly or completely submerged members (refer Figure 2.2.6f). This phenomenon is also known as water wash.

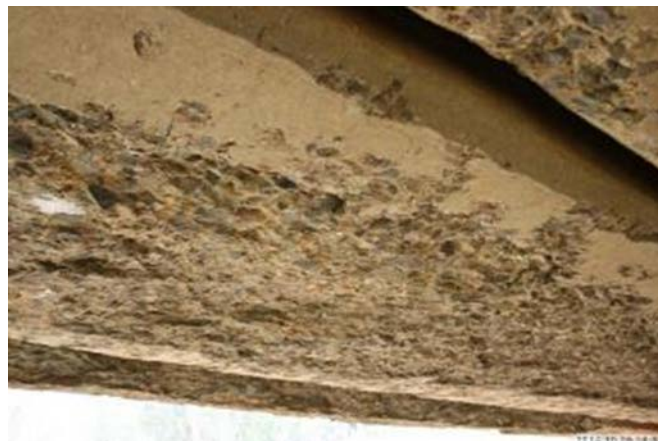
Figure 2.2.7b – Concrete disintegration

Disintegration is the physical deterioration or breaking down of the concrete into small fragments or particles. The deterioration usually starts in the form of scaling and, if allowed to progress beyond the level of very severe scaling, is considered as disintegration. Disintegration of concrete is illustrated in Figure 2.2.7b.

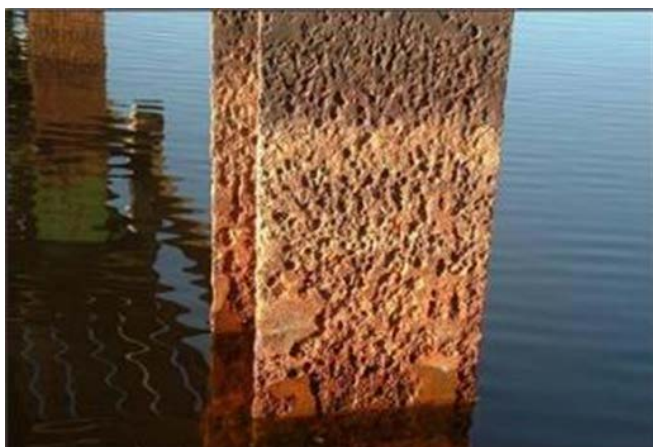
Figure 2.3.1c – Pitting of steel

Pitting corrosion is a local large reduction in parent metal and can cause a serious reduction in load-carrying capacity (refer Figure 2.3.1c). It can also lead to local high stresses, which may increase the risk of fatigue failure.

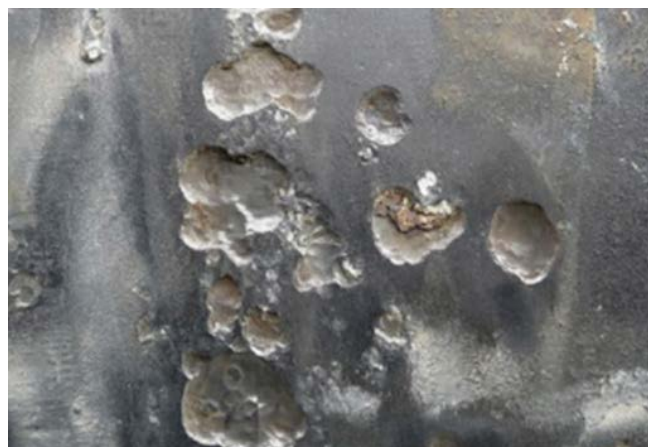
Figure 2.3.1d – Corrosion of steel by SRB

Sulphate Reducing Bacteria (SRB) is a corrosion mechanism of galvanised steel components in contact with soil water. The reduction of the sulphate content on the steel surface results in a highly acidic environment within and under the affected area which causes steel corrosion (refer Figure 2.3.1d). Favourable conditions for SRB growth include oxygen-depleted, marine or freshwater pervious soils (sediments) containing sulphate at a neutral pH. Further information relating to this phenomenon can be found in Technical Note 99 *Sulphate Reducing Bacteria on Steel Structures*.

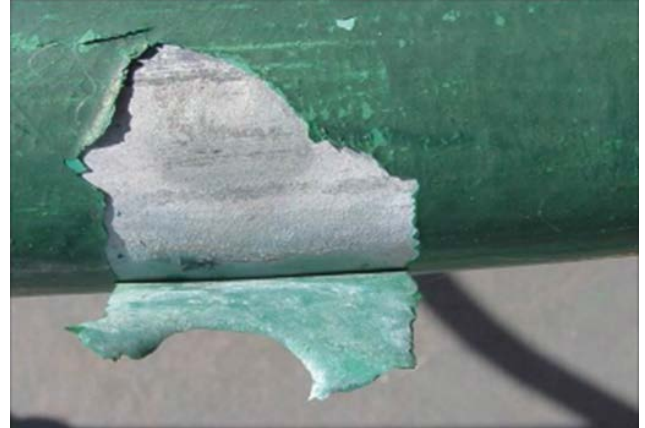
Figure 2.3.2b – Failure of paint system over galvanising

Breakdown of paint over galvanising is often due to the poor adhesion of a wrongly selected paint system (refer Figure 2.3.2b).

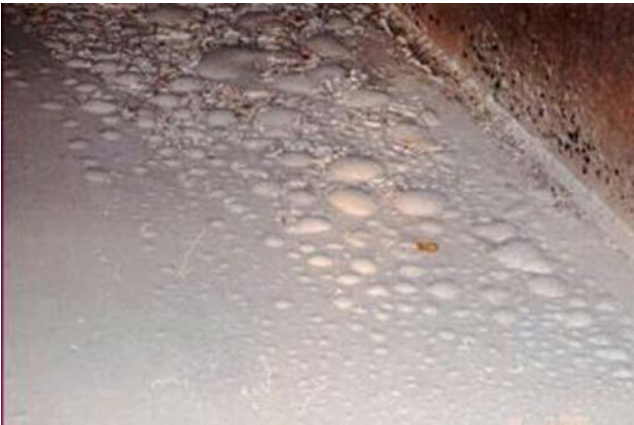
Figure 2.3.2c – Blistering of paint system

- Blistering - generally caused either by solvents which are trapped within or under the paint film, or, by water which is drawn through the paint film by the osmotic forces exerted by hygroscopic or water soluble salts at the paint/substrate interface. The gas or the liquid then exerts a pressure stronger than the adhesion of the paint (refer Figure 2.3.2c).

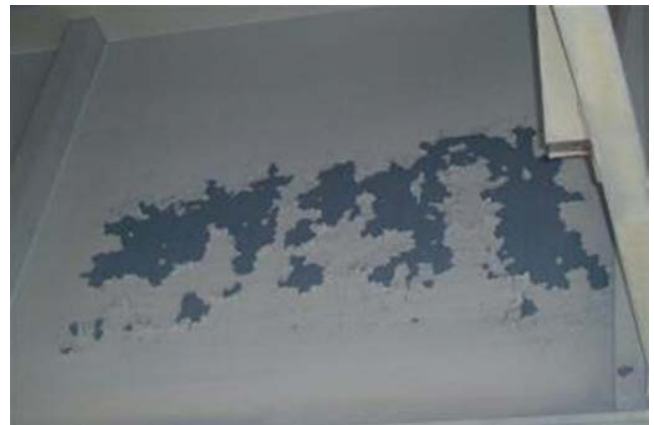
Figure 2.3.2d – Flaking of paint system

- Flaking - flaking or loss of adhesion is generally visible as paint lifting from the underlying surface in the form of flakes or scales (refer Figure 2.3.2d). If the adhesive strength of the film is strong then the coating may form large shallow blisters. Causes include:

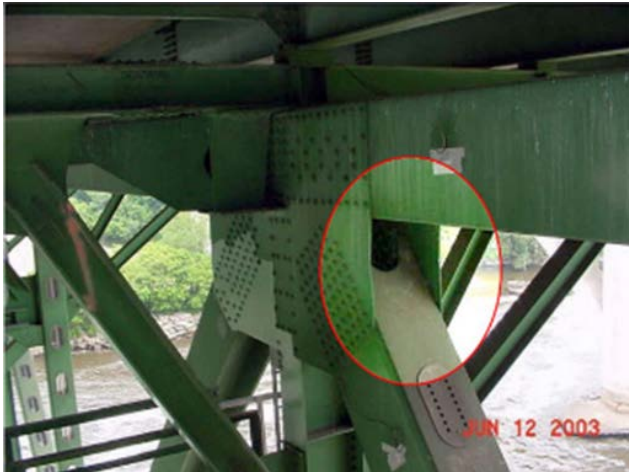
Figure 2.3.3a – Buckling of gusset plate

Permanent deformations may be caused by initial distortion, residual stresses, lack of fit, inadequate design, overloading, impact damage, or inadequate or damaged intermediate lateral supports or bracing (refer to Figure 2.3.3a and Figure 2.3.3b).

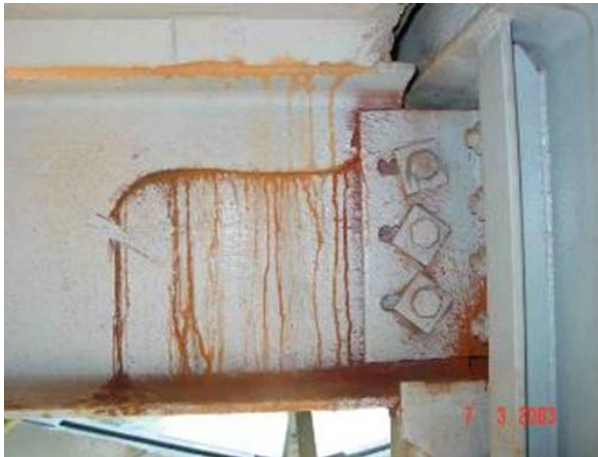
Figure 2.3.4a – Fatigue cracking in web

Fatigue failure is the most common cause of cracking and fracture of steelwork structures. Fatigue is the process by which a structural member or element eventually fails after repeated applications of cyclic stress. Failure may occur even though the maximum stress in any one cycle is considerably less than the fracture stress of the material. Characteristically, a fatigue fractured surface displays two distinct zones: a smooth portion indicating stages in the growth of the fatigue crack, and a rough surface, which represents the final ductile tearing or cleaving. Typically, fatigue failures do not exhibit any significant ductile 'necking' and occur without prior warning or plastic deformation (refer Figure 2.3.4a and Figure 2.3.4b).

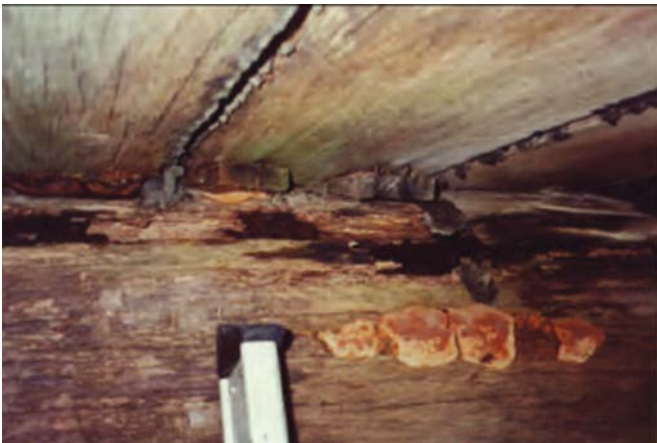
Figure 2.4.1a – Fungal fruiting body and decay of girder

Figure 2.4.1a and Figure 2.4.1b show rotting of members. The most common rotting areas in timber bridges are internally in log girders, corbels, headstocks and piles (piping), and in sawn decking at the exposed ends and interface with kerbs. Decay is often more pronounced at the ends of members.

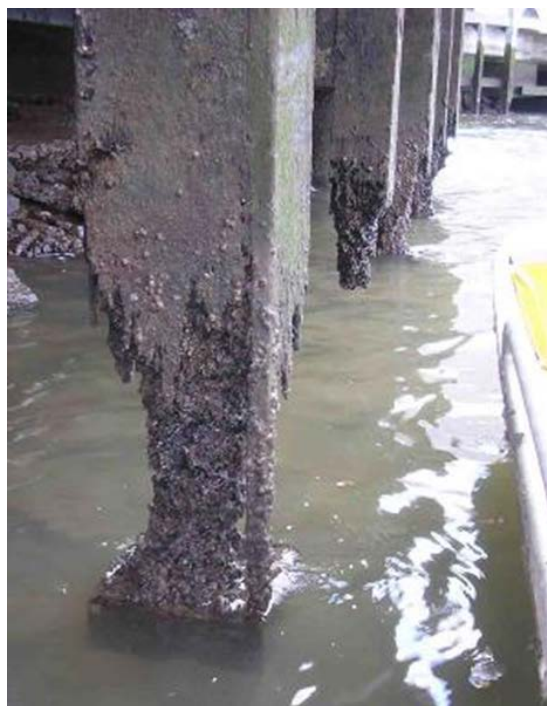
Figure 2.4.3b – Timber piles subject to *Sphaemora* attack

- Crustaceans - this group includes species of *Sphaeroma* (pill bugs), *Limnoria* (gribbles), and *Chelura*. They attack the wood on its surface, making many narrower and shorter tunnels than those made by the teredines. The timber so affected is steadily eroded from the outside by wave action and the piles assume a wasted appearance or "hourglass effect" (refer Figure 2.4.3b). Attack by *Sphaemora* is limited to the zone between tidal limits, with the greatest damage close to half-tide level. They cannot survive in water containing less than 1.0 - 1.5 percent salinity, but can grow at lower temperatures than the teredines.

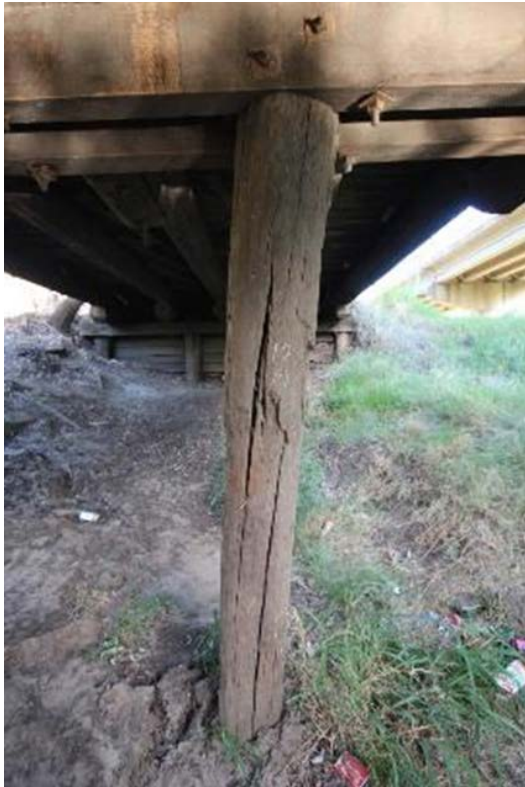
Figure 2.4.4.1a – Splitting in timber pile

The relatively large cross section timbers used in bridges lose their moisture through their exterior surfaces so that the interior of the member remains above the fibre saturation point while the outer layers fall below and attempt to shrink. This sets up tensile stresses perpendicular to the grain and when these exceed the tensile strength of the wood, a check or split develops, which deepens as the moisture content continues to drop. As timber dries more rapidly through the ends of the member than through the sides, more serious splitting occurs at the ends. Deep checks provide a convenient site for the start of fungal decay. Figure 2.4.4.1a and Figure 2.4.4.1b show longitudinal splitting of timber headstocks and piles.

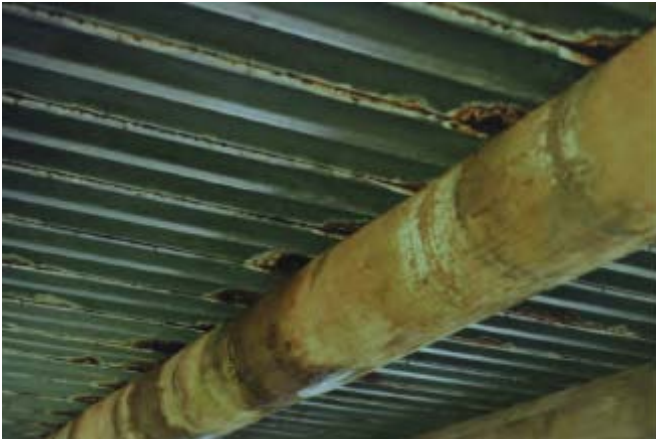
Figure 3.3.3.4a – Corrosion of joints between trough sections

that the trough sections are deflecting excessively under load or are not being effectively held down to the girders. Refer to Figure 3.3.3.4a and Figure 3.3.3.4b for commonly visible defects.

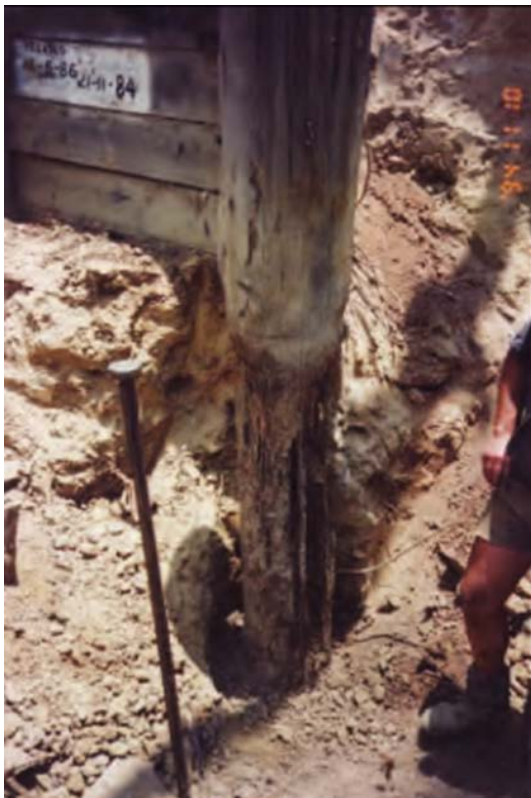
Figure 3.3.5a – Decay of pile below ground level

Piles which take moments are particularly susceptible at ground or normal water level where maximum stress and suspected rot areas coincide. If pipe rot has been detected in these critical areas the extent of decay needs to be defined so the length of repair or replacement of the pile can be determined (refer Figure 3.3.5a).

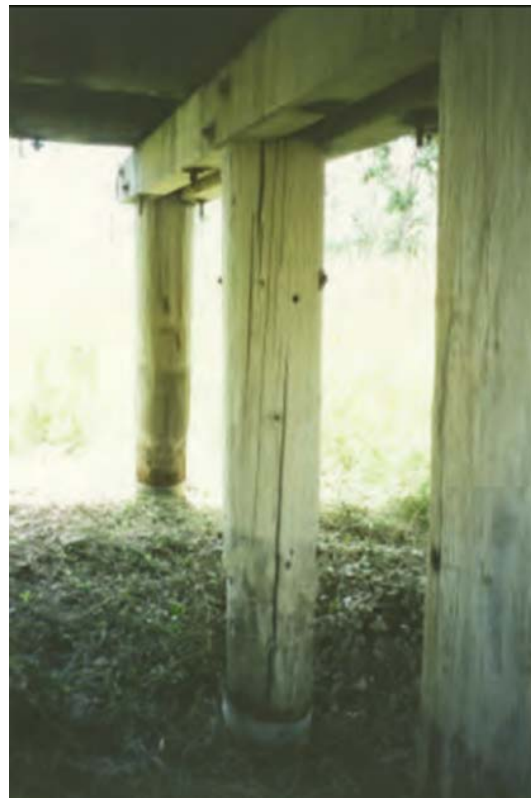
Figure 3.3.5b – Splitting of pile beneath headstock

Piles should be visually checked for areas of rot or splitting in the loaded areas at the top, especially splits originating beneath the headstocks (refer Figure 3.3.5b).

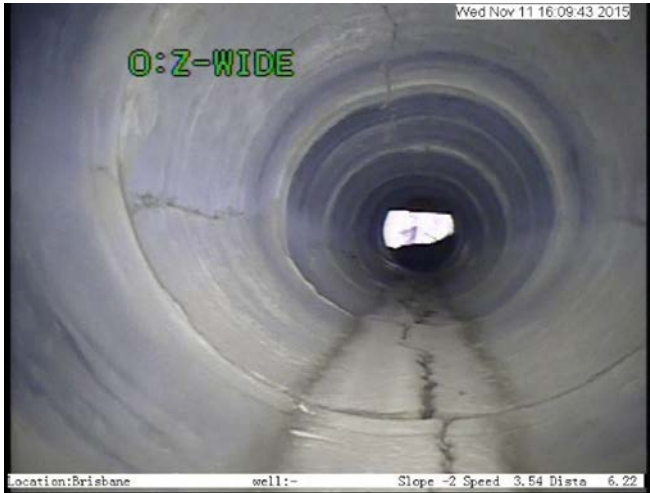
Figure 3.4.2.1a – Cracking of pipe walls

Figure 3.4.2.1a and Figure 3.4.2.1b illustrate examples of cracking and spalling in precast concrete pipe culverts.

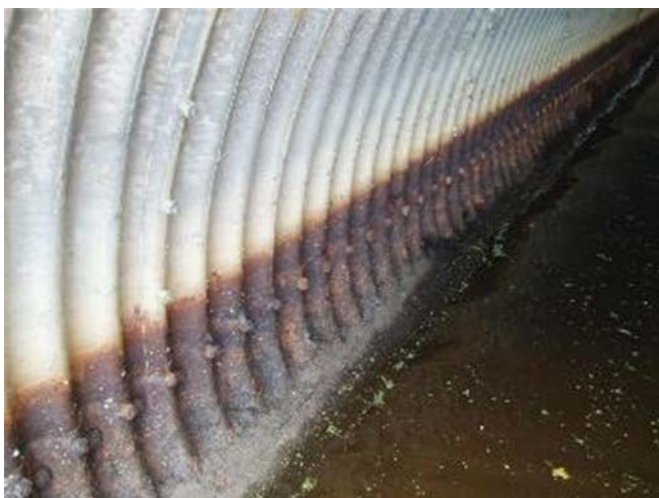
Figure 3.4.2.2a – Typical location of wall corrosion in BCM culvert

Buried corrugated metal (BCM) culvert structures are recognised worldwide as a high risk structure, comprising a thin wall section of steel or aluminium that is prone to corrode longitudinally at the top of the wetted area or in the invert. If left unattended the corrosion can lead to perforation of the corrugations. Figure 3.4.2.2a and Figure 3.4.2.2b illustrate the typical location of corrosion while Figure 3.4.2.2c and Figure 3.4.2.2d show examples of perforated culverts.

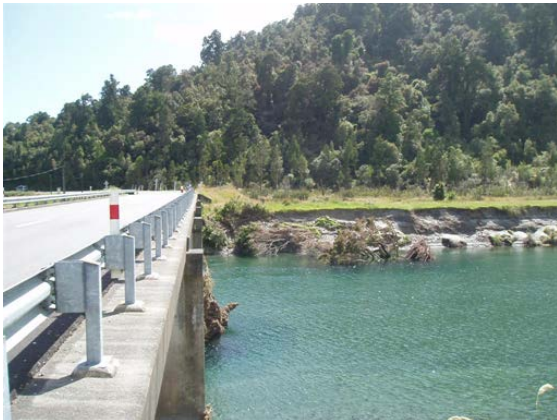
Figure 3.5.7a – Example of recent bank erosion

Scour can result in a general lowering (degradation) or raising (aggradation) of the river bed, lateral erosion of river banks or the development of localised scour holes around piers/piles and abutments.

- loss of vegetation/exposed roots on waterway bank (refer Figure 3.5.7a)
- exposed piles (refer Figure 3.5.7b and Figure 3.5.7c).
- undermining/voiding to toe of bank or provided batter protection
- evidence of batter protection settlement such as cracking in rigid protection or slumping in flexible/semi-rigid protection (refer Figure 3.5.7d)
- loss of abutment batter protection
- undermining/voiding beneath abutment/piers
- accumulation of loose sediment adjacent river banks around piers (the latter may be indicative of localised scour holes being backfilled with loose material as water levels recede).

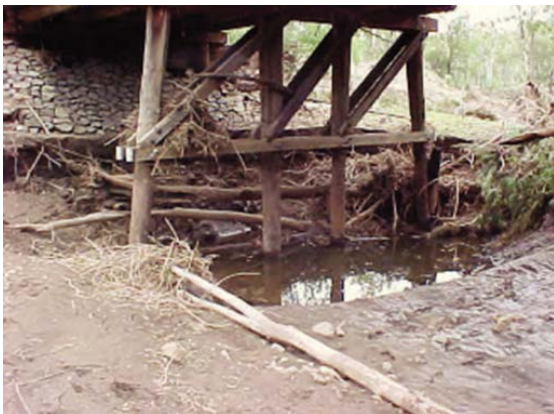
Figure 3.5.7c – Localised scour around pier piles and debris build-up

The build-up of debris on the upstream side of structures can cause the following adverse effects:
