**Structures Inspection Manual
Part 1: Structures Inspection Policy**

September 2016

**Structures Inspection Manual
Part 2: Deterioration Mechanisms**

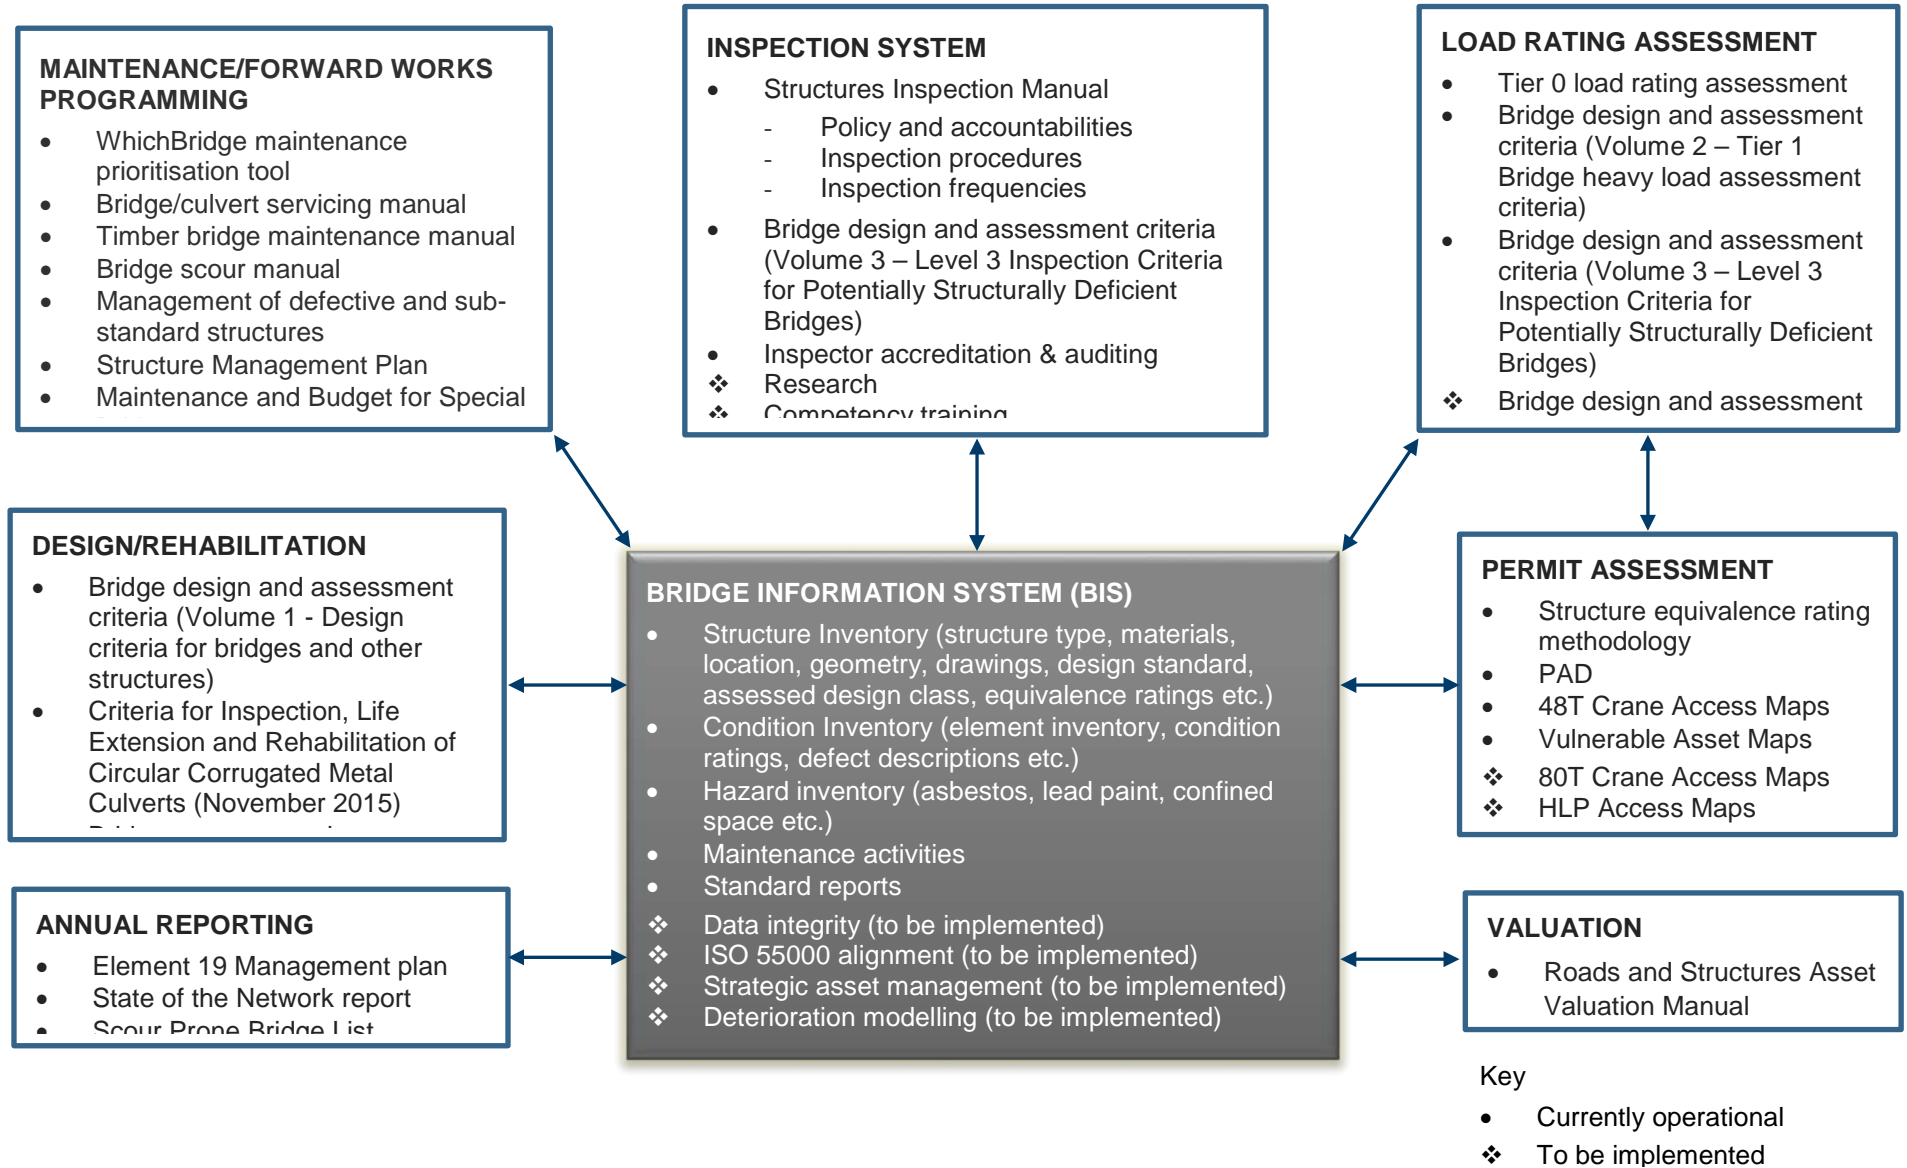
Figure 1 – Structures Asset Management System Framework

The SAMS has been developed to ensure that the department's structures are managed effectively and efficiently. Inspection and condition rating is an integral component of the SAMS and its relationship with other principal components of the system is shown in the system framework diagram (refer Figure 1) and in the mechanisms used to deliver desired outcomes (Figure 2).

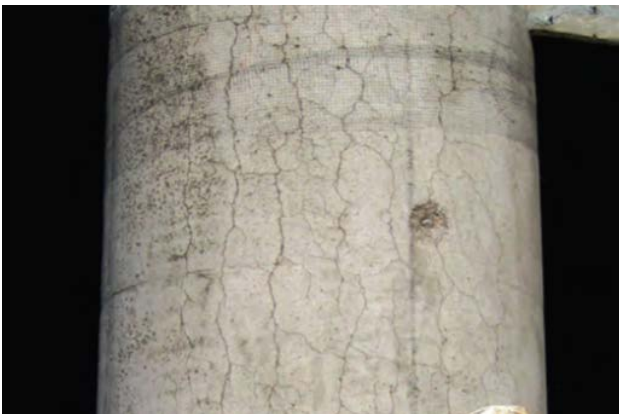
Figure 2.2.2a – Example ASR crack pattern in pier column

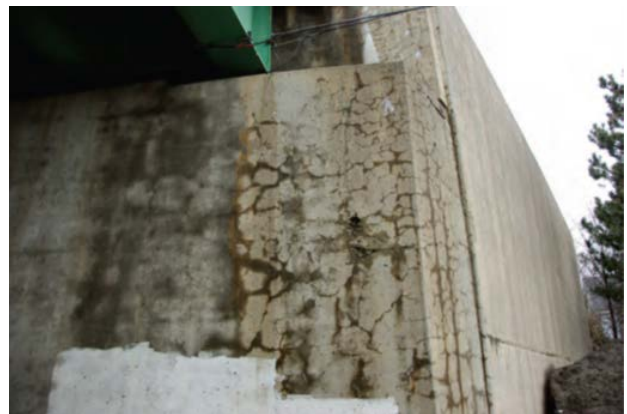
Figure 2.2.2b – Example ASR crack pattern in abutment wall

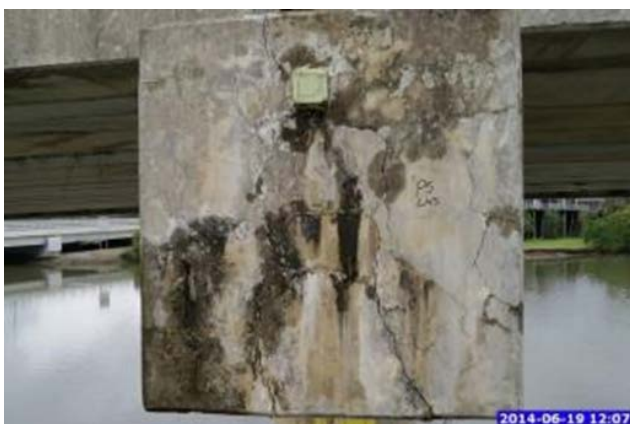
Figure 2.2.2c – Example ASR crack pattern in pier headstock

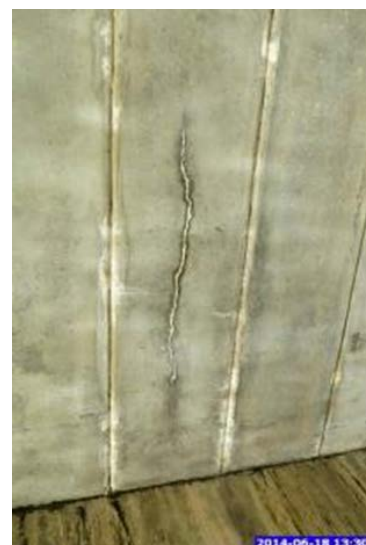
Figure 2.2.2d – Example ASR crack pattern in prestressed deck unit soffit

ASR cracking most commonly occurs in prestressed deck units in Queensland (Figure 2.2.2d). Vertical cracking has also been detected in some prestressed octagonal piles which is the result of Alkali-Silica Reaction (ASR). The risk of this type of cracking has been minimised in new construction by the use of an appropriate mass of fly ash in the approved mix designs.

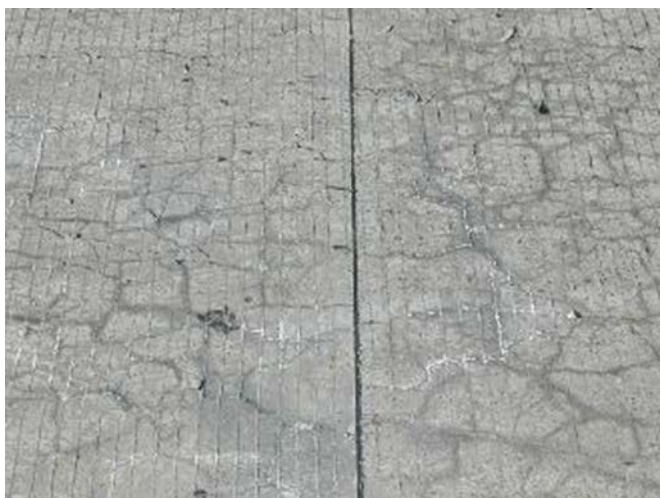
Plastic shrinkage cracks (refer Figure 2.2.3.1b) are typically short and random, forming a map pattern (crazing), a series of parallel lines or over reinforcement. These cracks, together with those resulting from thermal effects (in the plastic state) are typically shallow and are dormant. However, if a slab is significantly affected by plastic shrinkage cracking the cracks may continue through the depth of the slab.

Figure 2.2.3.1b – Plastic shrinkage cracking in bridge deck

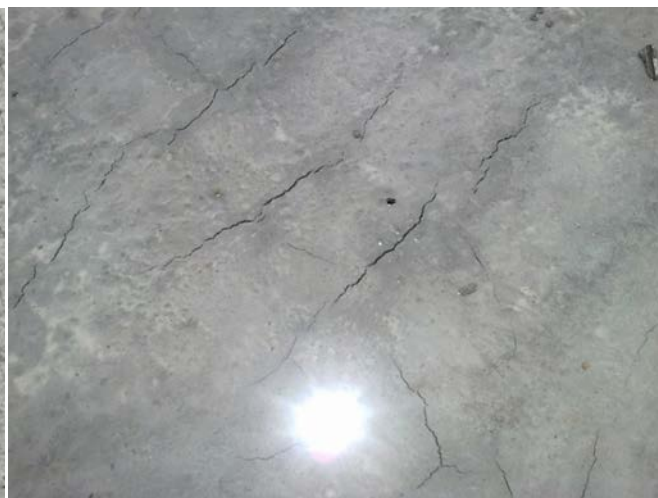
Plastic settlement cracks (refer Figure 2.2.3.1c) occur opposite rigidly supported reinforcement or other embedded items. They may also occur at pronounced changes in section depth. They present as cracks following the direction of reinforcement on the tops of deep beams and slabs or stirrups in columns. The cracks can be wide at the surface but are rarely deep enough to affect the structural integrity.

Figure 2.2.3.1c – Plastic settlement crack in slab

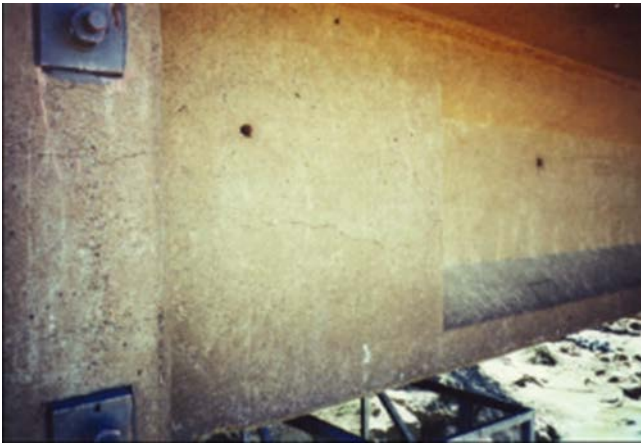
Figure 2.2.3.2a – Bursting cracks in under-reinforced anchorage zone of post-tensioned girder

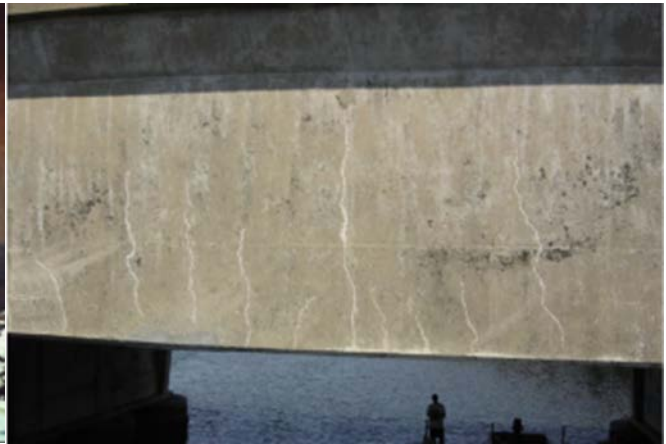
Figure 2.2.3.2b – Typical flexural cracks at mid-span of girder

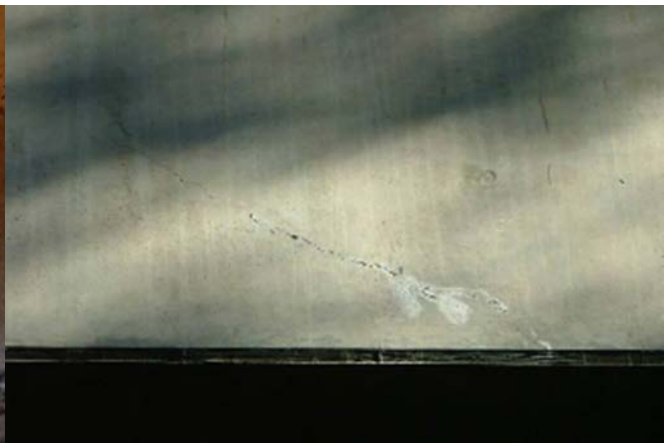
Figure 2.2.3.2d – Shear crack in girder adjacent to support

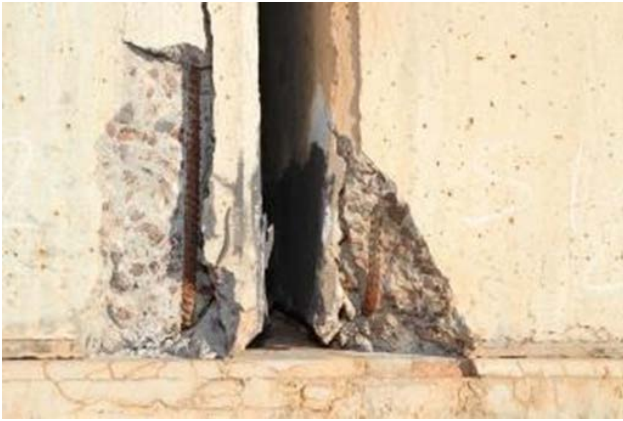
Figure 2.2.4a – Spalling of concrete at ends of deck units

Examples of concrete spalling are shown in Figure 2.2.4a to Figure 2.2.4d.

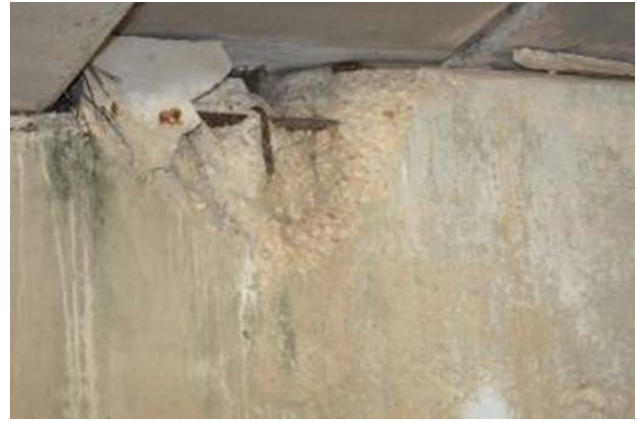
Figure 2.2.4b – Spalling to front face of headstock

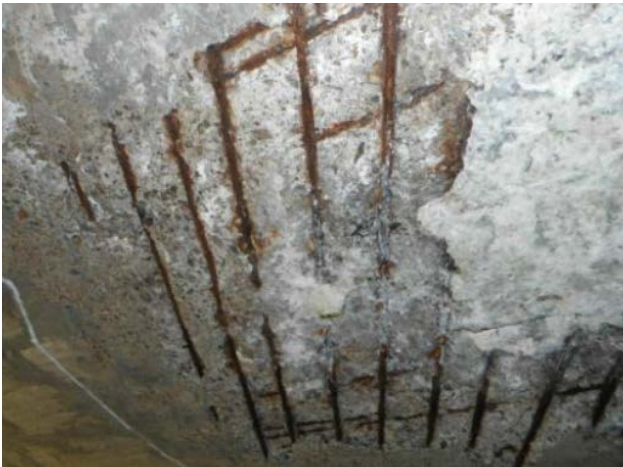
Figure 2.2.4c – Spalling of slab soffit

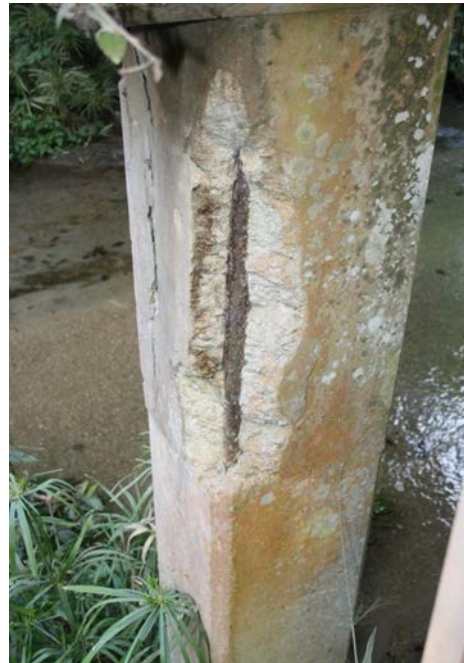
Figure 2.2.4d – Corner spalling of square pile

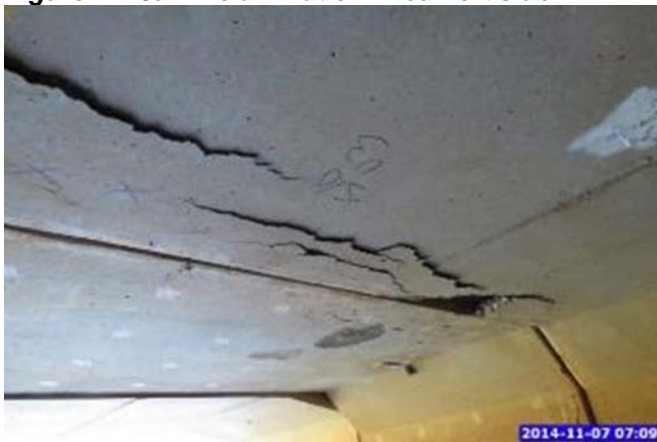
Delamination is defined as a discontinuity in the surface concrete which is substantially separated but not completely detached from concrete below or above it. Visibly, it may appear as a solid surface but can be identified as a hollow sound by tapping. Delamination begins with the corrosion of reinforcement and subsequent cracking of the concrete. However, in the case of closely spaced bars, the cracking extends in the plane of the reinforcement parallel to the exterior surface of the concrete (refer Figure 2.2.6a).

Figure 2.2.6a – Delamination in culvert slab

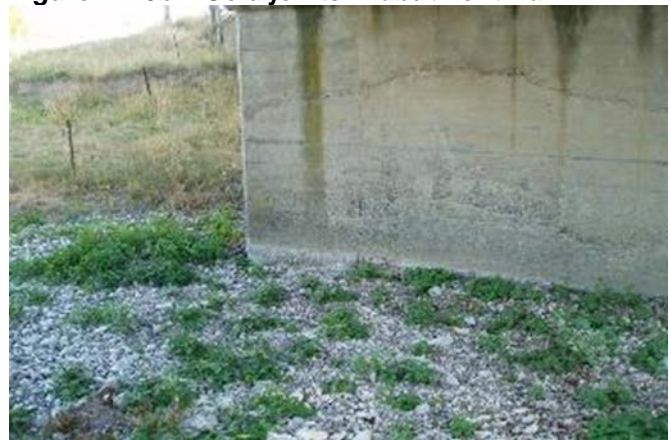
- Segregation - the differential concentration of the components of mixed concrete resulting in non-uniform proportions in the mass. Segregation is caused by concrete falling from a height, with coarse aggregates settling to the bottom and the fines on top. Another form of segregation occurs where reinforcing bars prevent the uniform flow of concrete between them. Segregation is more likely to occur in higher slump concrete.
- Cold joints – these are produced if there is a delay between placement of successive pours of concrete, and if an incomplete bond develops at the joint due to the partial setting of concrete in the first pour (refer Figure 2.2.6b).

Figure 2.2.6b – Cold joints in abutment wall

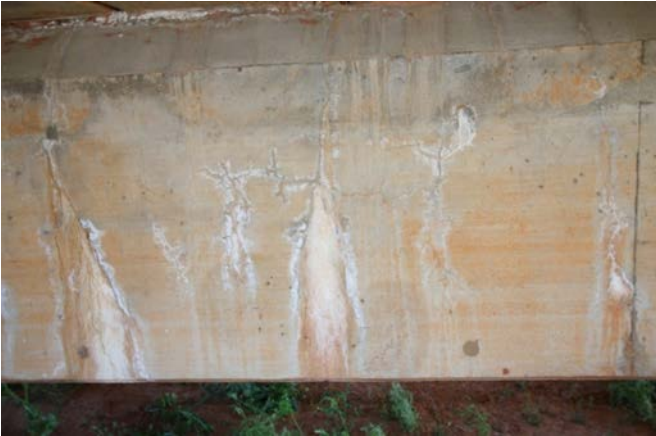
- Deposits – staining/accumulation of material on concrete surfaces where water percolates through the concrete and dissolves or leaches chemicals from it and deposits them on the surface. Deposits may appear as:
 - efflorescence – a deposit of salts, usually white. Over time can result in stalactites forming (refer Figure 2.2.6c)
 - exudation – a liquid or gel-like discharge through pores or cracks in the surface (refer Figure 2.2.6d)
 - encrustation - a hard crust or coating formed on the concrete surface.

Figure 2.2.6c – Efflorescence evident on concrete headstock

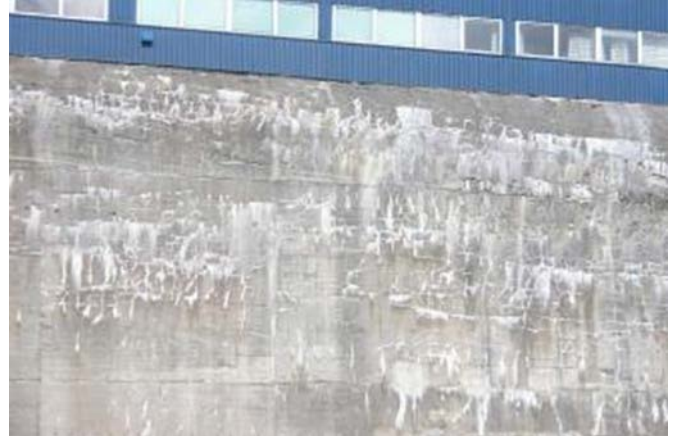
Figure 2.2.6d – Discharge through cracks in concrete surface

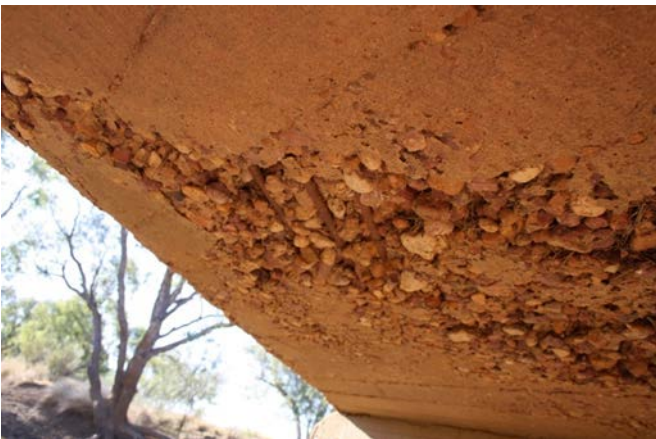
- Honeycombing – produced due to the improper or incomplete vibration of the concrete which results in voids being left in the concrete where the mortar failed to completely fill the spaces between the coarse aggregate particles (refer Figure 2.2.6e).

Figure 2.2.6e – Concrete honeycombing

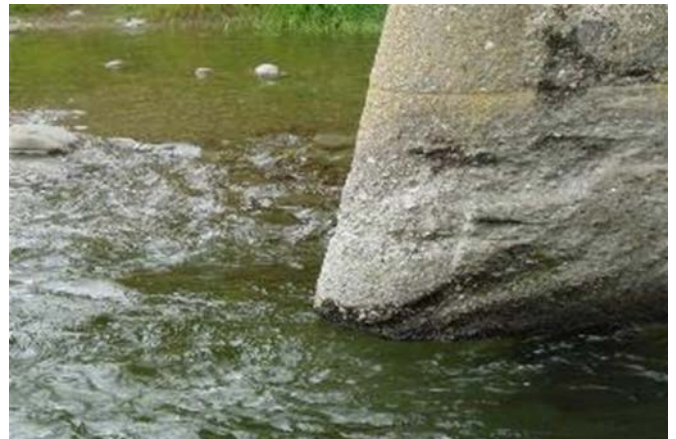
- Abrasion - the deterioration of concrete brought about by vehicles scraping against concrete surfaces, such as decks, kerbs, barrier walls, piers or the result of dynamic and/or frictional forces generated by vehicular traffic, coupled with abrasive influx of sand, dirt and debris. It can also result from friction of waterborne particles against partly or completely submerged members (refer Figure 2.2.6f). This phenomenon is also known as water wash.

Figure 2.2.6f – Abrasion of concrete

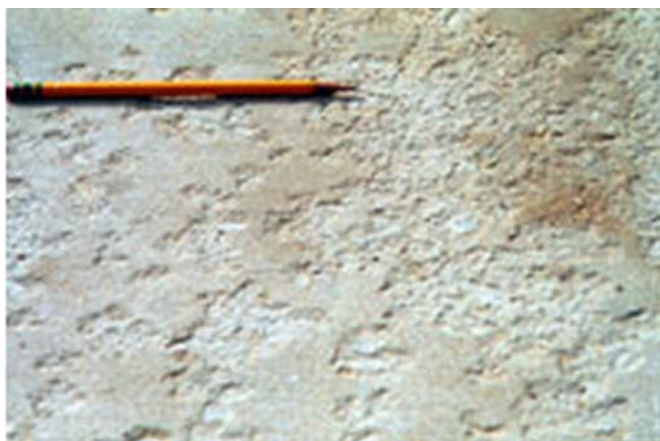
Scaling is the local flaking or loss of the surface portion of concrete or mortar. Scaling is common in non air-entrained concrete but can also occur in air-entrained concrete in the fully saturated condition. Scaling occurs in poorly finished or overworked concrete where too many fines and not enough entrained air is found near the surface. Scaling of concrete is shown in Figure 2.2.7a.

Figure 2.2.7a – Concrete scaling

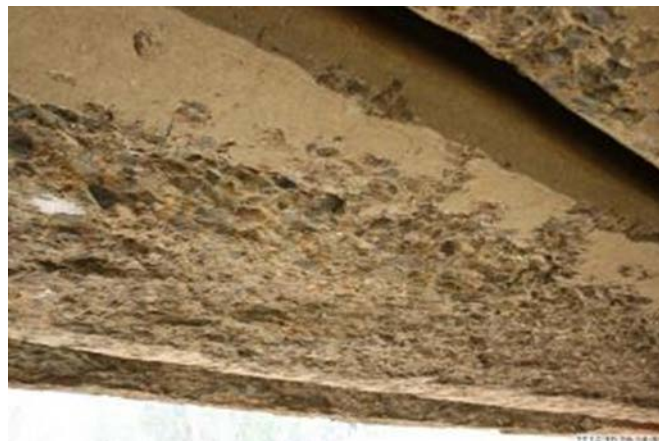
Figure 2.2.7b – Concrete disintegration

Disintegration is the physical deterioration or breaking down of the concrete into small fragments or particles. The deterioration usually starts in the form of scaling and, if allowed to progress beyond the level of very severe scaling, is considered as disintegration. Disintegration of concrete is illustrated in Figure 2.2.7b.

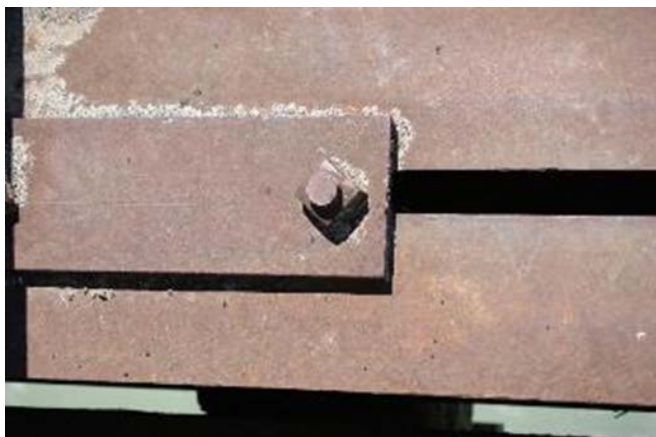
Figure 2.3.1a – Mild surface corrosion

All ferrous alloys are susceptible to corrosion deterioration. Unprotected steel, in the presence of oxygen and moisture and in the absence of contaminants (clean atmospheric conditions) corrodes at approximately 0.02 mm/year. The rate of deterioration is therefore very slow and it will be many years before the integrity of a structure is compromised. However, corrosion is accelerated by continuous (or even intermittent) wet conditions or by exposure to aggressive ions, such as chlorides in de-icing salts or in a marine environment, and other atmospheric industrial contaminants. In these conditions, steel becomes vulnerable to both pitting and general corrosion (refer Figure 2.3.1a and Figure 2.3.1b).

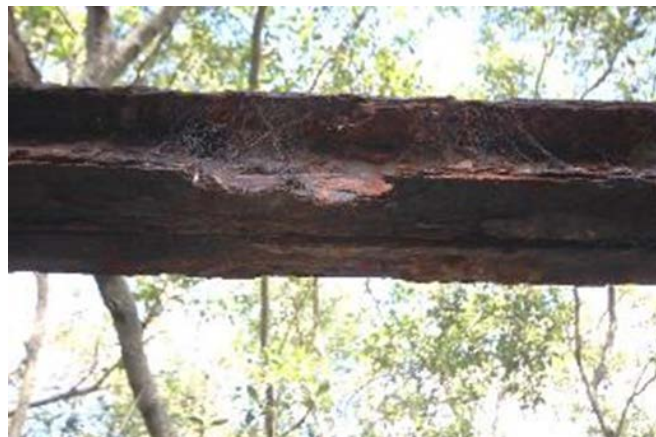
**Figure 2.3.1b – Severe corrosion and loss of section**

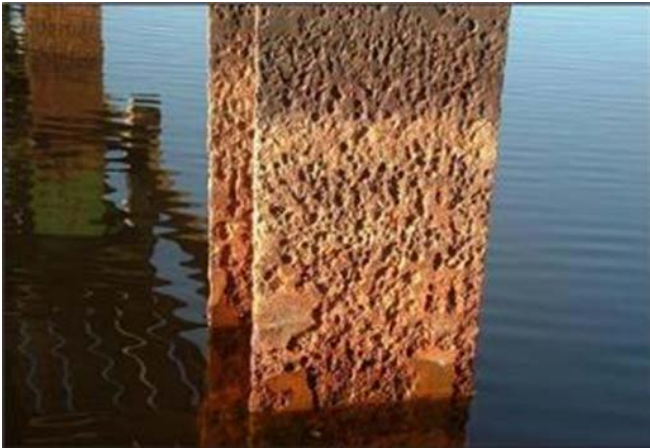
Pitting corrosion is a local large reduction in parent metal and can cause a serious reduction in load-carrying capacity (refer Figure 2.3.1c). It can also lead to local high stresses, which may increase the risk of fatigue failure.

Figure 2.3.1c – Pitting of steel

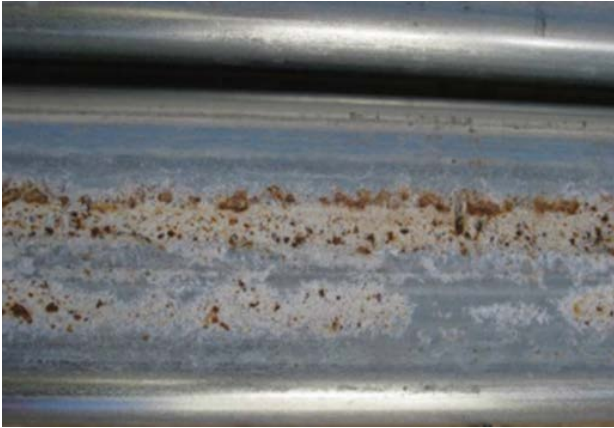
Figure 2.3.2a – White deposit on zinc metal spray

The cause of any white deposit on the surface of paint over zinc metal spray should be investigated as it may be zinc hydroxide (formed by reaction of zinc with water and air), which is the first sign of the zinc coating breaking down. If left untreated corrosion of the zinc will become extensive (refer Figure 2.3.2.a).

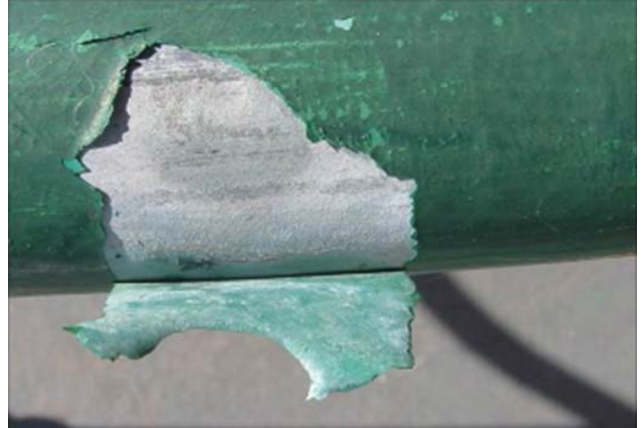
Figure 2.3.2b – Failure of paint system over galvanising

Breakdown of paint over galvanising is often due to the poor adhesion of a wrongly selected paint system (refer Figure 2.3.2b).

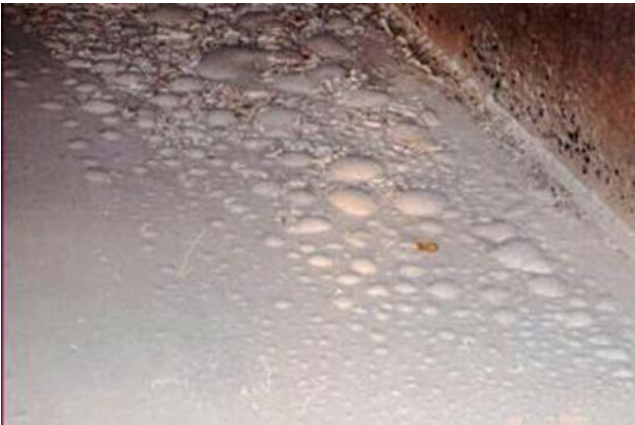
Figure 2.3.2c – Blistering of paint system

- Blistering - generally caused either by solvents which are trapped within or under the paint film, or, by water which is drawn through the paint film by the osmotic forces exerted by hygroscopic or water soluble salts at the paint/substrate interface. The gas or the liquid then exerts a pressure stronger than the adhesion of the paint (refer Figure 2.3.2c).

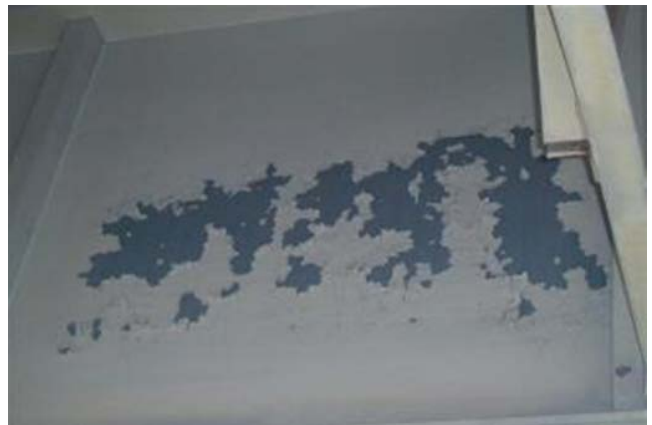
Figure 2.3.2d – Flaking of paint system

- Flaking - flaking or loss of adhesion is generally visible as paint lifting from the underlying surface in the form of flakes or scales (refer Figure 2.3.2d). If the adhesive strength of the film is strong then the coating may form large shallow blisters. Causes include:

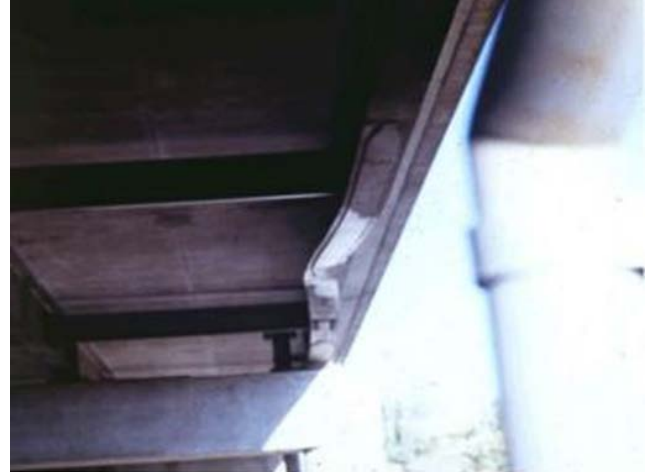
**Figure 2.3.3b – Impact damage to steel beam**

Permanent deformations may be caused by initial distortion, residual stresses, lack of fit, inadequate design, overloading, impact damage, or inadequate or damaged intermediate lateral supports or bracing (refer to Figure 2.3.3a and Figure 2.3.3b).

Permanent bending deformation may occur in the direction of the applied loads and are usually associated with flexural members; however, vehicular impact may produce permanent deformations in bending in any other member.

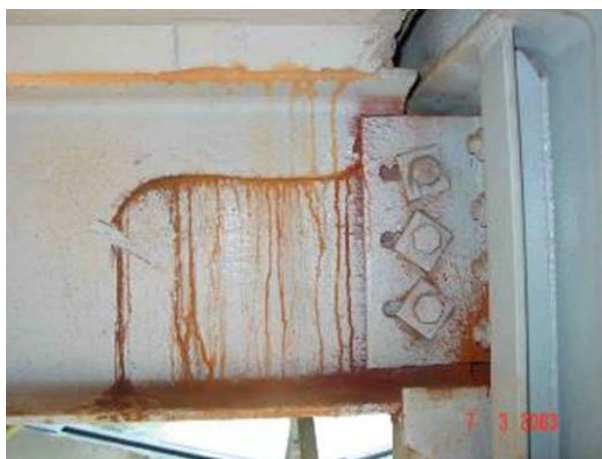
Figure 2.3.4a – Fatigue cracking in web

Fatigue failure is the most common cause of cracking and fracture of steelwork structures. Fatigue is the process by which a structural member or element eventually fails after repeated applications of cyclic stress. Failure may occur even though the maximum stress in any one cycle is considerably less than the fracture stress of the material. Characteristically, a fatigue fractured surface displays two distinct zones: a smooth portion indicating stages in the growth of the fatigue crack, and a rough surface, which represents the final ductile tearing or cleaving. Typically, fatigue failures do not exhibit any significant ductile 'necking' and occur without prior warning or plastic deformation (refer Figure 2.3.4a and Figure 2.3.4b).

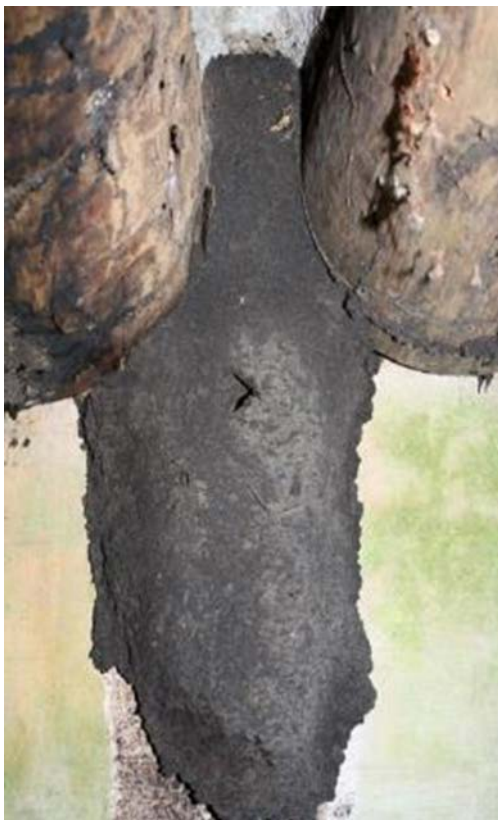
Figure 2.4.2a – Termite nest on bridge pile

Attack by subterranean termites originates from the nest, but may spread well above ground level, either inside the wood or via mud walled tubes called galleries which are constructed on the outside of bridge members (refer Figure 2.4.2a and Figure 2.4.2b). These galleries are essential for termites as they require an absence of light, a humid atmosphere and a source of moisture to survive. At least once a year the alates develop eyes and wings and leave the nest under favourable weather conditions to migrate up to 200 m from the original nest. After migration, their wings fall off and a few of these may pair to start new colonies.

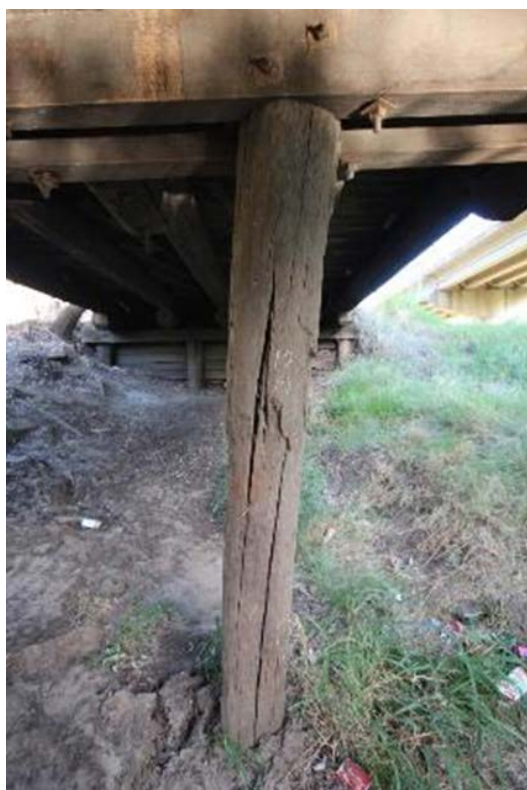
Figure 2.4.4.1a – Splitting in timber pile

The relatively large cross section timbers used in bridges lose their moisture through their exterior surfaces so that the interior of the member remains above the fibre saturation point while the outer layers fall below and attempt to shrink. This sets up tensile stresses perpendicular to the grain and when these exceed the tensile strength of the wood, a check or split develops, which deepens as the moisture content continues to drop. As timber dries more rapidly through the ends of the member than through the sides, more serious splitting occurs at the ends. Deep checks provide a convenient site for the start of fungal decay. Figure 2.4.4.1a and Figure 2.4.4.1b show longitudinal splitting of timber headstocks and piles.

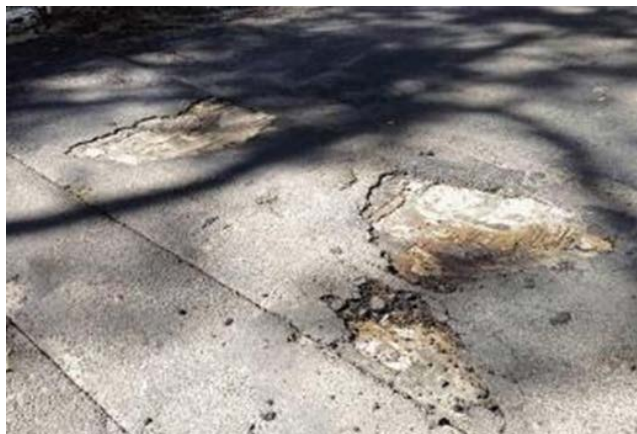
Figure 3.3.3.2a – Abrasion of wearing surface

- Deck wearing surface had been lost over significant areas resulting in the top scarf jointed layer being worn away due to traffic abrasion in places (refer Figure 3.3.3.2a).

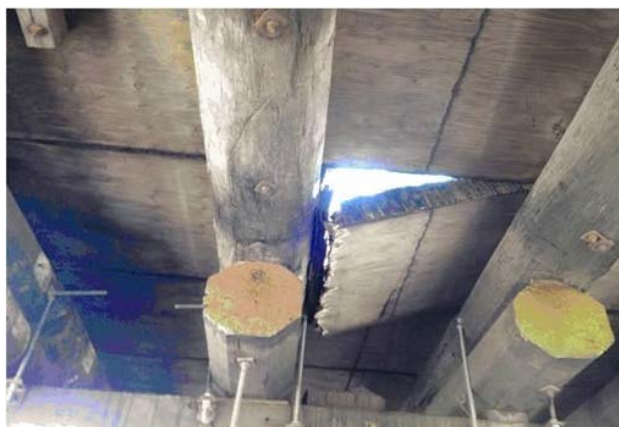
**Figure 3.3.3.2b – Failure of plywood deck panel**

Figure 3.3.3.2b illustrates failure of a plywood panel within the wheel track.

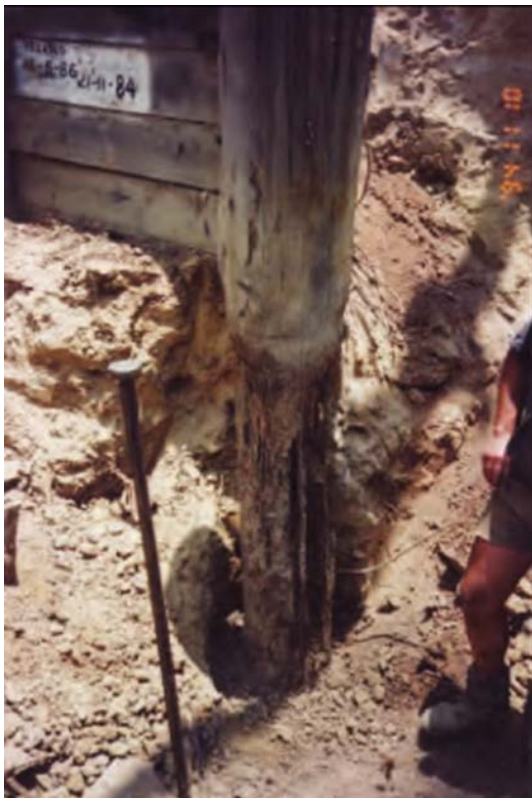
Figure 3.3.5a – Decay of pile below ground level

Piles which take moments are particularly susceptible at ground or normal water level where maximum stress and suspected rot areas coincide. If pipe rot has been detected in these critical areas the extent of decay needs to be defined so the length of repair or replacement of the pile can be determined (refer Figure 3.3.5a).

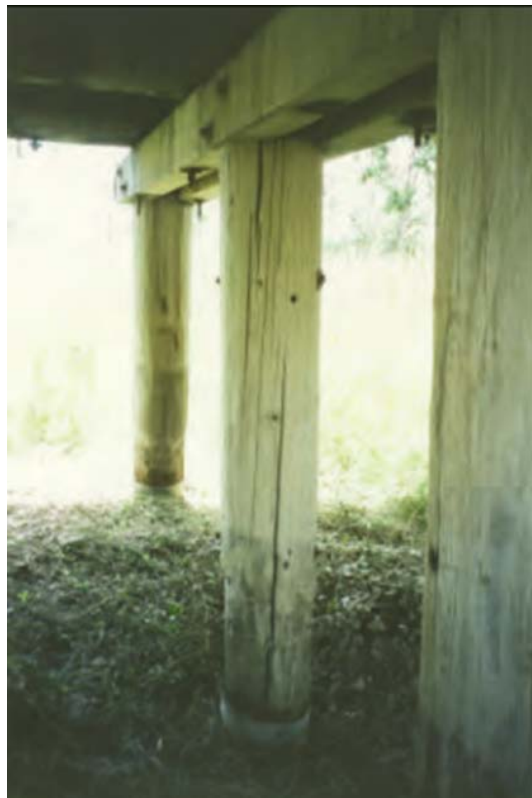
Figure 3.3.5b – Splitting of pile beneath headstock

Piles should be visually checked for areas of rot or splitting in the loaded areas at the top, especially splits originating beneath the headstocks (refer Figure 3.3.5b).

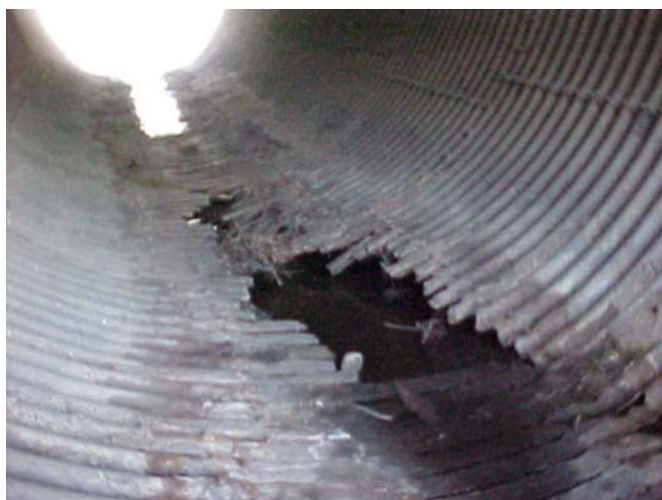
Figure 3.4.2.2c – Perforation of BCM culvert invert

Buried corrugated metal (BCM) culvert structures are recognised worldwide as a high risk structure, comprising a thin wall section of steel or aluminium that is prone to corrode longitudinally at the top of the wetted area or in the invert. If left unattended the corrosion can lead to perforation of the corrugations. Figure 3.4.2.2a and Figure 3.4.2.2b illustrate the typical location of corrosion while Figure 3.4.2.2c and Figure 3.4.2.2d show examples of perforated culverts.

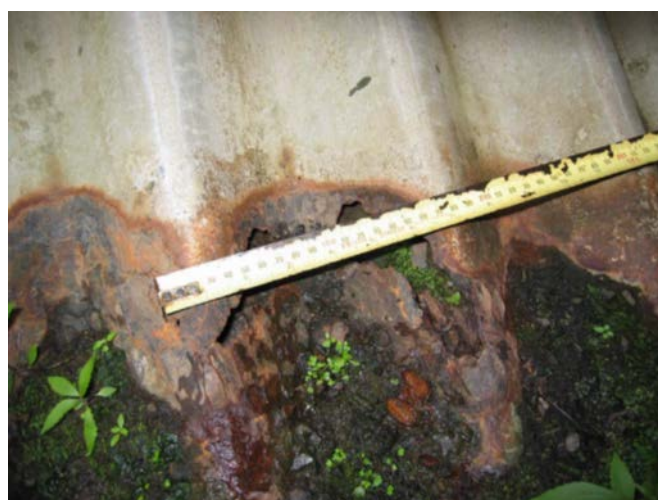
Figure 3.4.2.2d – Perforation of BCM culvert wall

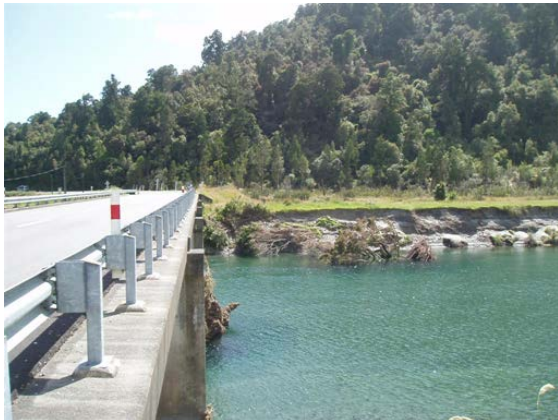
Figure 3.5.7a – Example of recent bank erosion

- loss of vegetation/exposed roots on waterway bank (refer Figure 3.5.7a)
- exposed piles (refer Figure 3.5.7b and Figure 3.5.7c).
- undermining/voiding to toe of bank or provided batter protection
- evidence of batter protection settlement such as cracking in rigid protection or slumping in flexible/semi-rigid protection (refer Figure 3.5.7d)
- loss of abutment batter protection
- undermining/voiding beneath abutment/piers
- accumulation of loose sediment adjacent river banks around piers (the latter may be indicative of localised scour holes being backfilled with loose material as water levels recede).

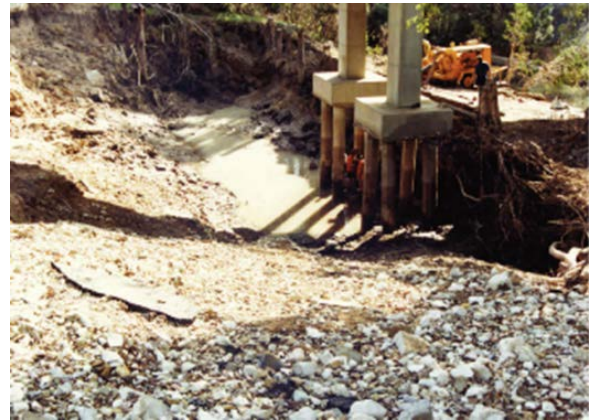
Figure 3.5.7b – Localised scour around pier pile cap and piles

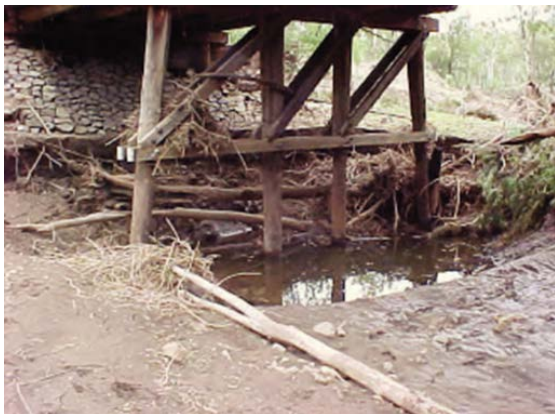
Figure 3.5.7c – Localised scour around pier piles and debris build-up

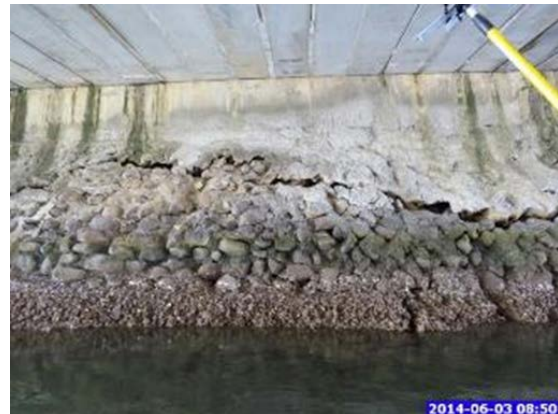
Figure 3.5.7d – Settlement of rigid batter protection
