**Structures Inspection Manual**

**Part 3 - Appendix D: Standard Component Condition  
State Guidelines**

**September 2016**

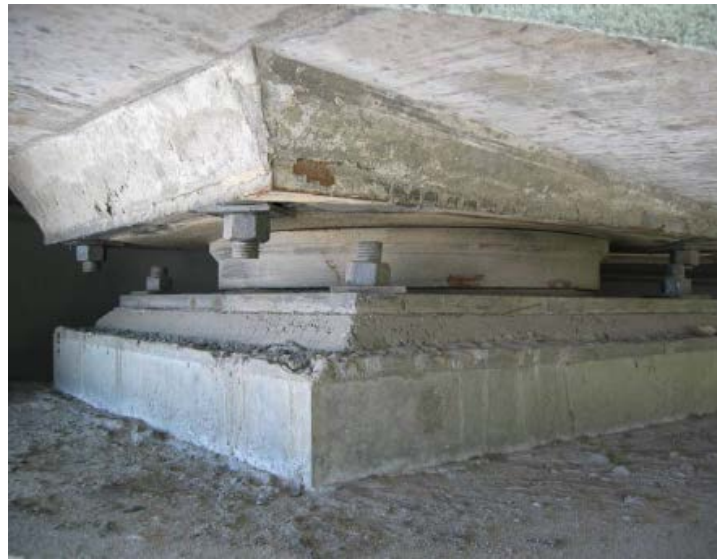
**Figure 2 – Sliding pot bearing**

The base unit is similar in nature to a fixed bearing, consisting of an elastomer/rubber disc seated on a steel piston and covered with a steel cylinder; however, a thin PTFE sheet is adhered to the top of the cylinder (refer Figure 2). The upper portion of the bearing consists of a steel plate with a stainless steel sliding surface that is seated directly onto the PTFE sheet. In some cases, side stops are also installed to ensure that the bearing is only permitted to slide in certain directions. This bearing type is also shown in Figure C22 of Appendix C.

The 'gaps' shown are the dimension between the top of the cylinder and the stainless steel sliding surface, and the gap between the cylinder and piston. These dimensions should be measured using the same methodology as described previously for fixed bearings, the only exception being the permanent reference points for the additional gap should be located on the cylinder and the stainless steel-faced sliding plate.

- excessive rotation, indicated by significant variations in the 'gap' dimensions taken between the cylinder and piston
- excessive displacement of stainless steel-faced sliding plate. Where side stops are not installed, this displacement should be measured in both the longitudinal and transverse directions.

- uplift/separation of the PTFE sheet and stainless steel sliding surface, indicated by an increase in the upper 'gap' dimension. Inspectors should confirm that this is the case by inserting a thin strip of material (that is, a folded piece of paper) into the gap to determine the degree of separation. If the material is making contact at a uniform distance (normally 40–60 mm) around the bearing, then the sliding surface is seated on the PTFE. If there is no contact, then assume the sliding surface has lifted off the PTFE sheet.
