Department of Transport and Main Roads

Guide to the

Visual Assessment of Pavements

Engineering and Technology

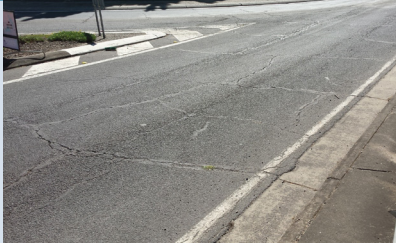
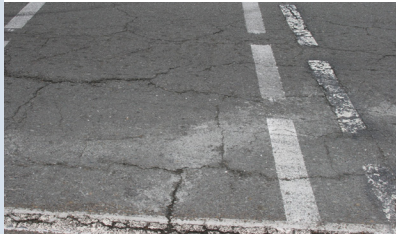
Block cracks (CB)

Multiple interconnected cracks that appear approximately rectangular in shape.

The respective size and shape of the blocks generally indicates the size of the joints within the base layer.

- Reflective cracking due to joints in underlying layer (cemented materials).
- Shrinkage and cracking of the underlying bound (cemented) layer.
- Asphalt shrinkage and cracking due to its inability to expand and contract with daily temperature cycles.

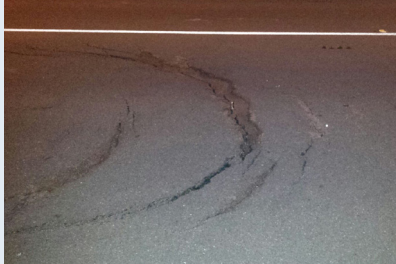
Crescent shaped crack (CC)

Crescent shaped cracks that can commonly occur parallel to another in closely spaced groups.

- Wearing course has poor bond with underlying layers. Low modulus course layers.
- Insufficient wearing course thickness.
- Asphalt has been dragged by paver screed during laying.
- Turning, braking and / or acceleration movement induced stresses.

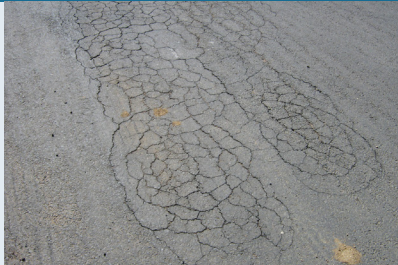
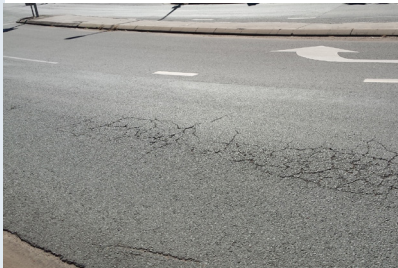
Crocodile crack (CR)

Generally small irregularly shaped polygons that resemble crocodile skin.

Begins as longitudinal cracks within the wheel path that progress with time and loads to a more branched, interconnected series of small polygons that are generally less than 150 mm in size.

- Inadequate pavement layer thickness.
- Asphalt base or wearing course has become brittle with age.
- Weakness in the surface, base or sub-grade.
- Poor drainage.

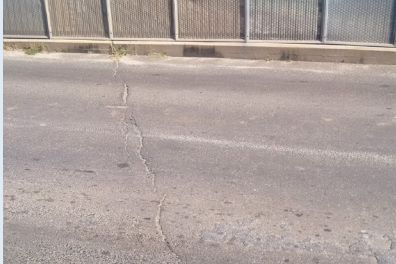
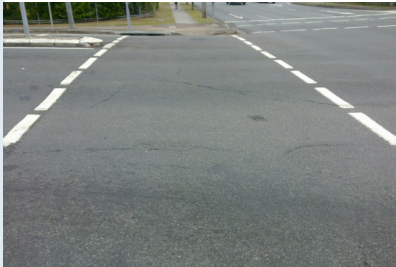
Diagonal crack (CD)

Unconnected cracks that travel diagonally across the direction of traffic.

- Surface layer shrinkage.
- Reflection of shrinkage cracking from the underlying bound layer.
- Differential settlements between embankments, cuts, structures, etc.
- Intrusion of tree roots.
- Installation of various services.

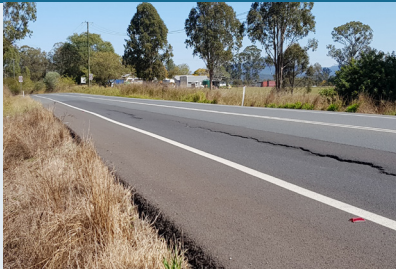
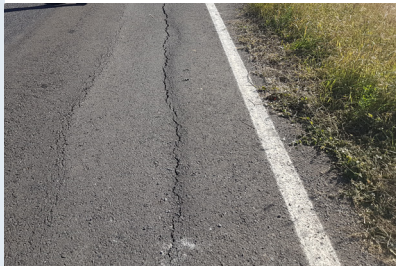
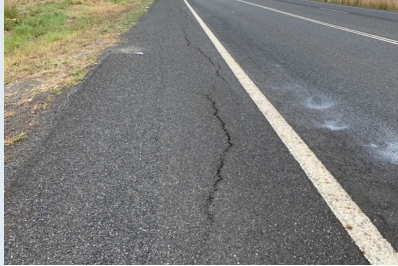
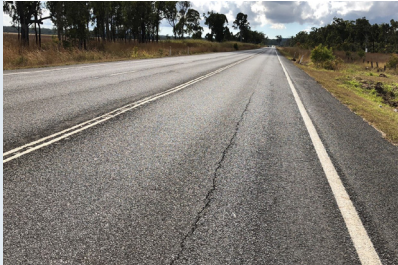
Longitudinal crack (CL)

Cracks that run longitudinally/parallel with the direction of traffic.

These cracks can occur as singular or as a series of parallel cracks.

Some branching may occur.

- Reflection of a shrinkage crack or joint in an underlying cemented base.
- Incorrectly constructed joint in asphalt surfacing.
- Reflection of pavement joints associated with road widening.
- Displacement of joint at pavement widening.

- Volume change of expansive clay subgrade.
- Cyclical weakening of pavement edge.
- Differential settlement between cut and fill.
- Reflection of cracks in underlying cemented sub-base.

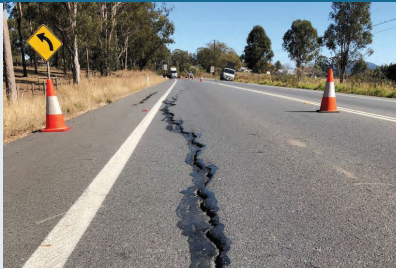
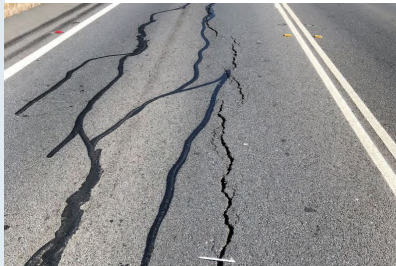
Longitudinal cracking with differential settlement (CLDS)

Severe series of parallel longitudinal cracks.

Cracking gaps are commonly greater than 10 mm.

Commonly occurs on pavement on embankments that are greater than 5 m in height.

- Slip failure of the embankment.
- Differential settlement at the joint between new and old embankment in pavement widening resulting in crack propagation.
- Weak fill or subgrade material.

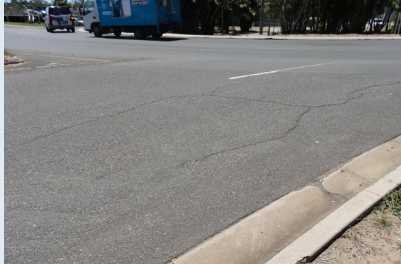
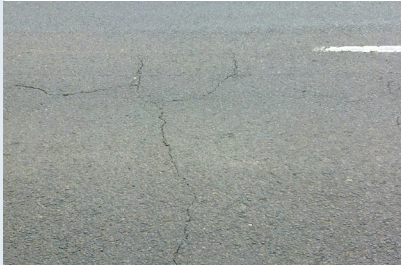
Meandering crack (CM)

Singular, unconnected crack that varies in direction.

- Reflection of shrinkage cracks from underlying bound pavement base material.
- Differential settlement associated with embankments, cuts, adjacent structures and / or underground services.
- Intrusion of tree roots or moisture into the pavement.

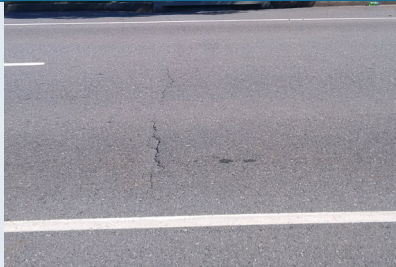
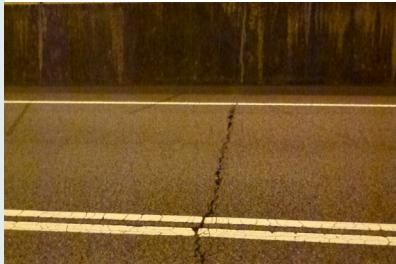
Transverse crack (CT)

Unconnected cracks travelling perpendicular to the direction of traffic.

- Construction joint, contraction or shrinkage of the surfacing layer.
- Reflection of shrinkage cracks or joints from underlying bound pavement base material.
- Settlement due to underground structure or service.

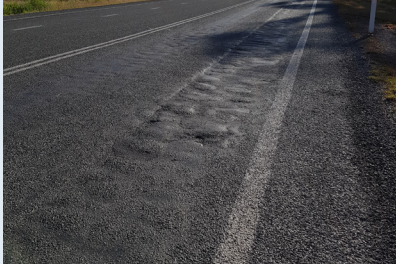
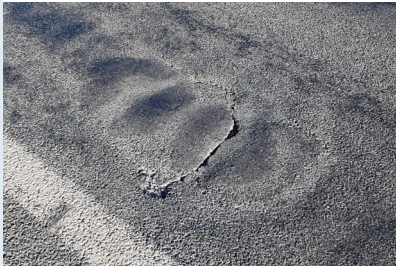
Corrugations (DC)

Ripples – transverse undulations in the pavement surface or base, closely and regularly spaced, with wave lengths ranging between 0.3 m and 2 m.

- Inadequate quality of material to resist heavy vehicle loading.
- Irregular compaction of base and/or other defective work practices.
- Bonding between layers is poor.
- Inadequate stability of asphalt base or surfacing layer.

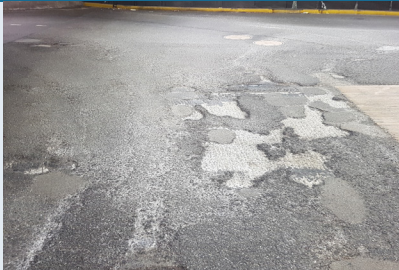
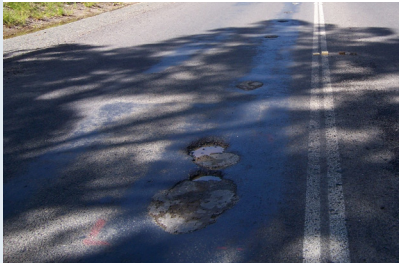
Delamination (SD)

The upper wearing surface has been stripped or removed and exposing the lower layer.

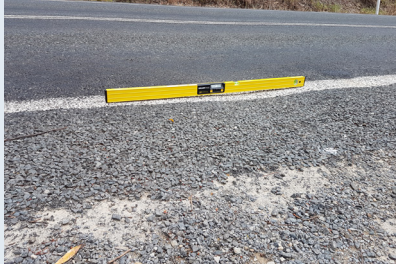
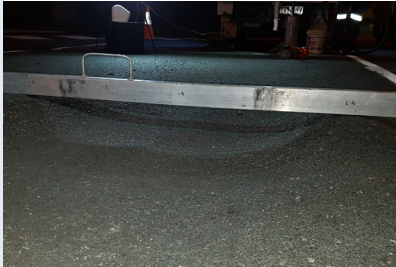
Depressions are not always located along wheel paths but can also extend along the entirety of a lane's width.

Can be clearly identified in wet weather, as depressions collect and fill with water.

- Settlement of service and widening trenches.
- Isolated sections of soft or insufficiently compacted subgrade or embankment.
- Volume alteration of subgrade materials due to environmental influences (e.g. drying out due to trees or change in moisture content of expansive soil).
- Settlement of embankment or subgrade.

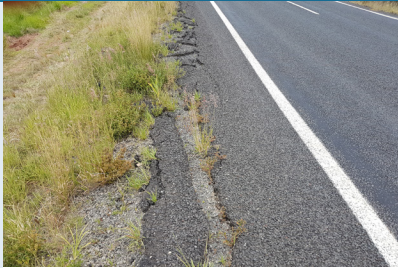
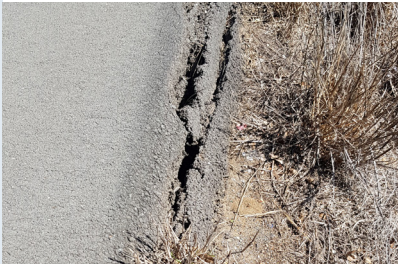
Edge Break (EB)

Edge of bituminous surface has become fretted, broken or irregular.

- The road alignment and/or pavement width are inadequate which results in vehicles travelling along the edge of the pavement.
- Shoulder has become eroded due to water and/or wind.
- Inadequate edge support.
- Loss of adhesion to base.
- Weak seal coat.

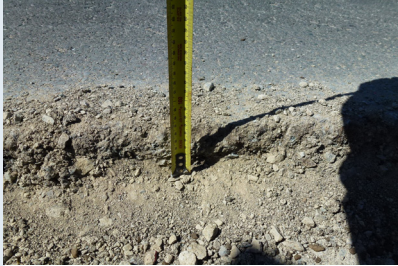
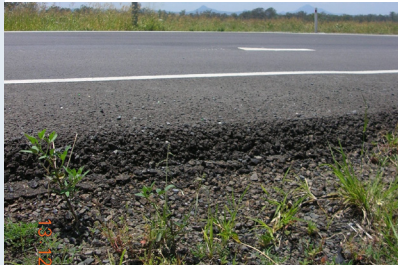
The vertical distance from the surface of the seal at the edge, to the surface of the shoulder.

Not usually considered a defect if the drop-off is less than 10 to 15 mm.

- The road alignment and/or pavement width are inadequate which encourages drivers to travel along the edge of the pavement.
- Shoulder material has insufficient erosion and abrasion resistance.
- The shoulder has not been resurfaced during resurfacing of the pavement.

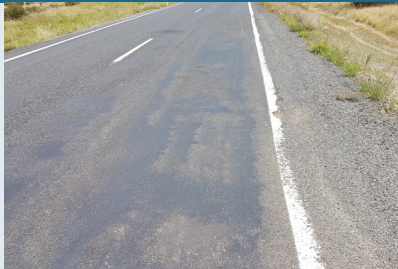
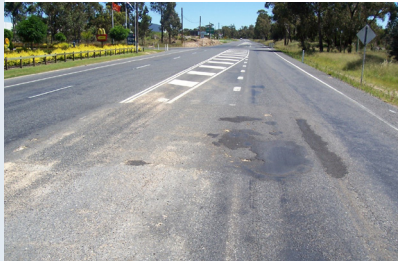
Pavement surface layer contains an excess amount of bitumen, which results in patches.

These patches have inadequate tyre-to-stone contact which lowers the skid resistance.

- Excessive application rate of binder in regards to stone size.
- Excessive prime coat in the seal.
- Underlying patched or flushed area has excessive binder.
- Aggregate has penetrated into the soft surface of the base material.
- Inappropriate asphalt mix design (e.g low air voids, high binder content, or low stiffness for traffic conditions).

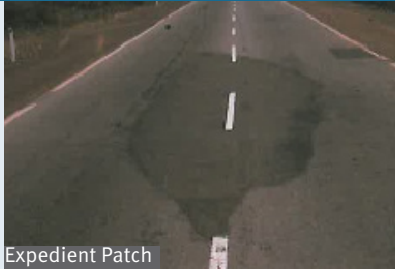
Expedient Patch

Expedient patches (PE) are identified as irregularly sided, usually small patches (a few square metres or less).

- Inadequate compaction may lead to further deformation and distress.
- Repair of surface deficiencies.

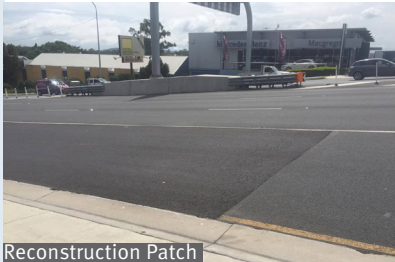
Reconstruction Patch

Reconstruction patches (PR) are usually straight sided.

- Reconstruction of pavement deficiencies, within surface course, pavement or subgrade.
- Excavation required for services.

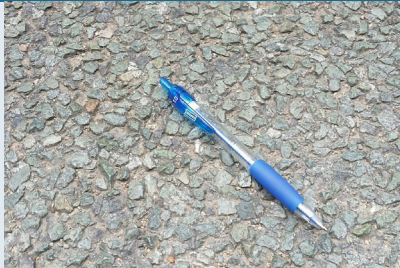
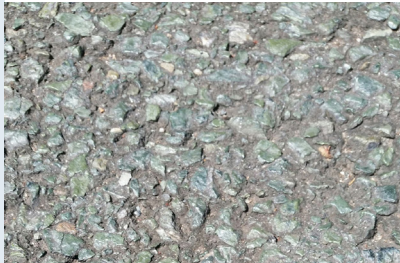
Identified by the difference in texture and appearance of the trafficked and un-trafficked sections of the pavement.

Polished areas feel smooth and appear shiny.

- Surface aggregates have poor resistance to polishing, especially in areas where heavy traffic movements occur.
- Naturally smooth and uncrushed aggregates (e.g. water-worn gravel) have been used.

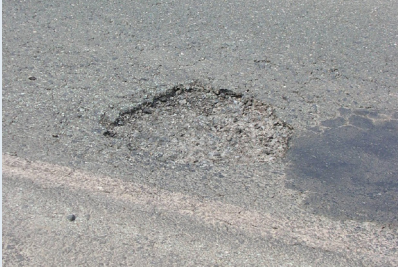
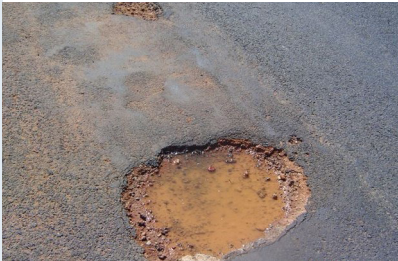
Varying sized, bowl-shaped cavity in the pavement surface that extends into wearing surface, base layers and/or subgrade layer.

The dynamic nature of heavy vehicle axles can often cause a rapid increase in the size of potholes, and/or create a series of potholes along a length of wheelpath.

- Loss of surface course as a result of cracking being left untreated.
- Cracked surface has allowed entrance of water into pavement layers.
- Heavy loading has disintegrated the base.
- Binder adhesion to tyres has damaged and/or lifted the surfacing layer.

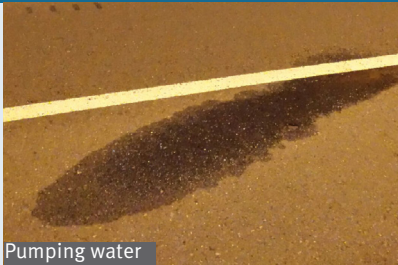
Pumping water

Seepage that has emerged through pavement cracks.

- Underlying services (Water mains) have begun to leak.
- Water has infiltrated the pavement through wet subgrades, adjacent cuttings, poor pavement drainage, or cracked / permeable surfacing.
- Vehicle loading has induced a pumping affect which moves the pavement fines to the pavement surface using water as the medium.

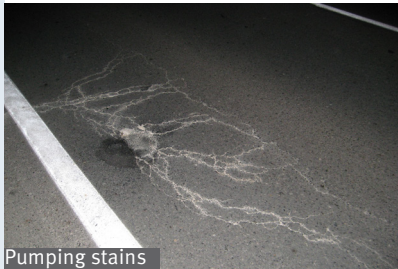
Pumping stains

Fines have been carried from the base, subbase(s) and/ or subgrade to the pavement surface.

After the water has ceased the fines then stain the pavement, also known as pumping stains.

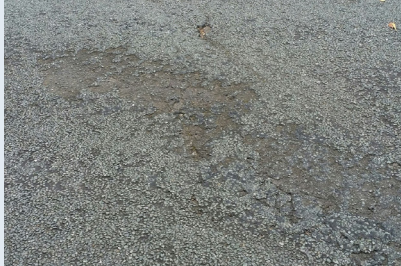
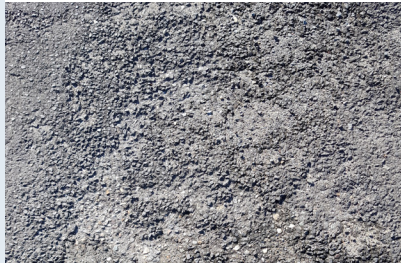
Ravelling (SR)

Progressive disintegration of the pavement surface due to the loss of both binder and aggregates.

- Poor adhesion between the asphalt and aggregate.
- The stone and/or binder has deteriorated.
- Dusty, hydrophilic, wet and/or dirty aggregates have been used.
- Inadequate asphalt mix design.
- Inadequate compaction.
- Construction during wet or cold weather.

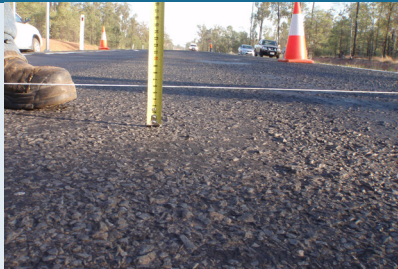
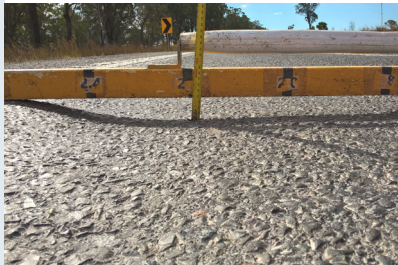
Rutting (DR)

Channelised depressions that are located along wheel paths and commonly found in long sections.

- Maximum depth (under a transverse 1.2 m straight edge) (mm)
- Length (m)

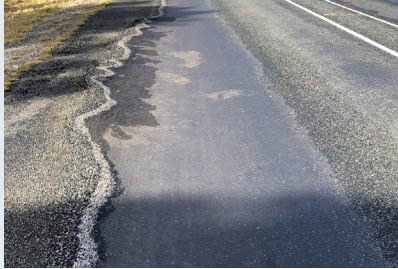
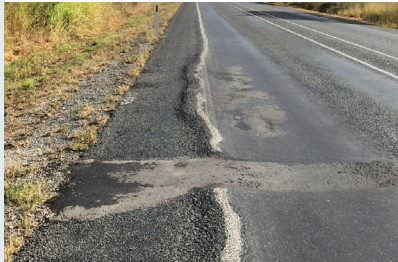
Swells, bulges and horizontal deformations that have developed mainly in the direction of traffic where braking or acceleration movements occur.

Shoving can also occur in locations where there are high horizontal shear stresses i.e. roundabouts.

- Maximum depth of bulge under 1.2 m straight edge from high point (mm)
- Area affected (m²)

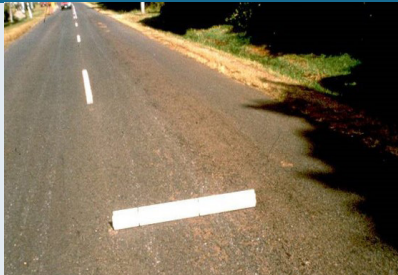
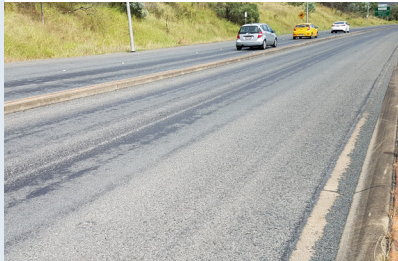
Can occur as loss of individual stones, or as the complete loss of stone in a localised area.

Loss of bond between aggregates and binder in lower asphalt layers (stripping in asphalt surface is referred as ravelling).

- Area affected (m²)
- Percentage of stone throughout affected area (%)

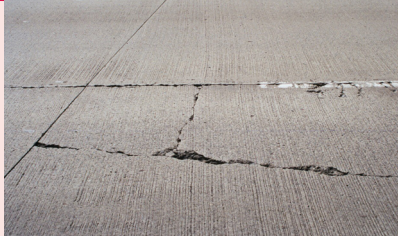
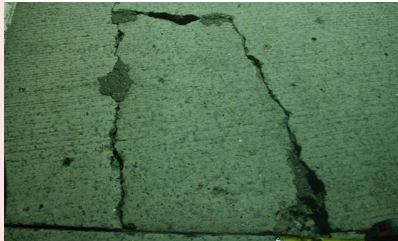
Block cracks (CB)

Multiple cracks that form a series of blocks. Commonly distributed over the entire pavement.

- Predominant crack width (mm)
- Area affected (m²)

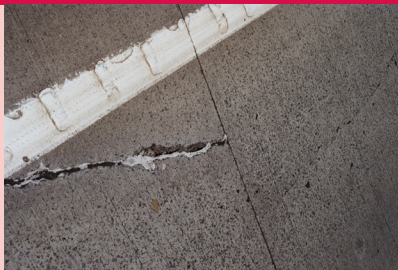
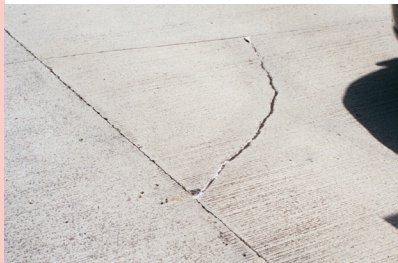
Corner crack (CN)

A singular crack that connects diagonally between a longitudinal edge and a transverse joint near the corner.

- Crack width (mm)
- Crack length (m)
- Number of slabs affected

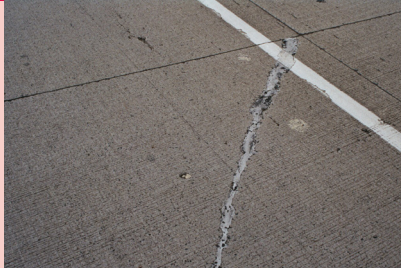
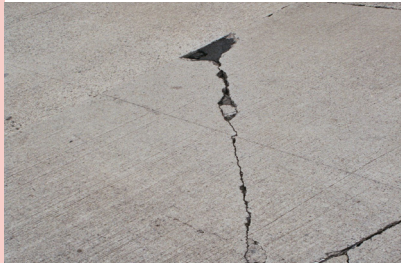
Diagonal crack (CD)

A singular, unconnected crack diagonally across a pavement/slab.

- Crack width (mm)
- Crack length (m)
- Number of slabs affected

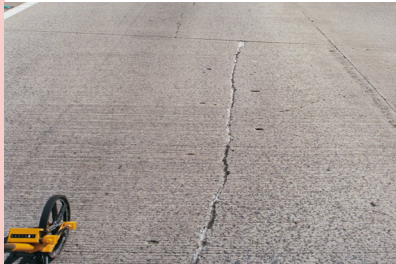
Longitudinal crack (CL)

Cracks that run parallel with the direction of traffic.

These cracks can occur as singular cracks or as a series of parallel cracks.

Some branching may occur.

- Crack width (mm)
- Crack spacing (mm)
- Crack length (m)
- Area affected (m²)

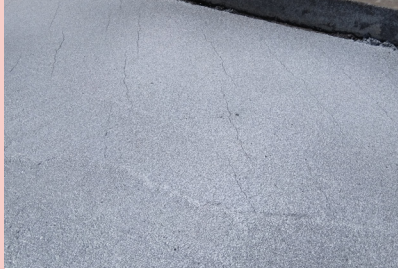
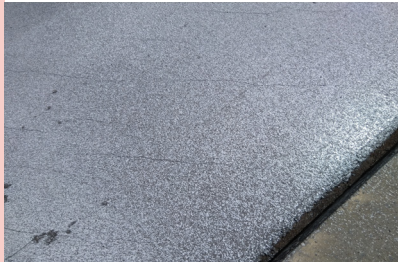
Plastic shrinkage crack (CP)

Individual or series of cracks that are spaced 50 – 500 mm apart.

The orientation of the cracks can be either transverse, diagonal or longitudinal.

Formed prior to concrete setting and are visible after the finishing of the concrete.

- Crack width (mm)
- Crack depth (mm)
- Crack length (m)
- Number of slabs affected

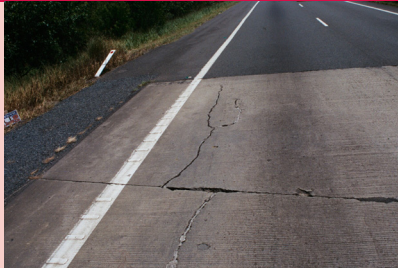
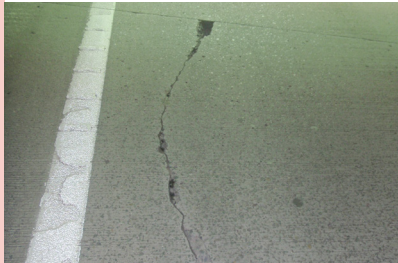
Meandering crack (CM)

Irregularly winding crack that is unconnected and commonly singular.

- Predominant width of crack (mm)
- Crack length (m)
- Number of slabs affected

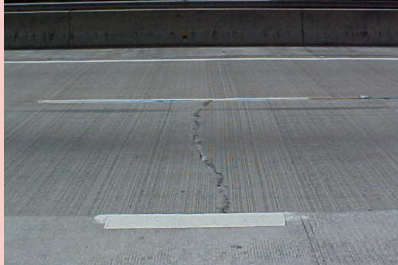
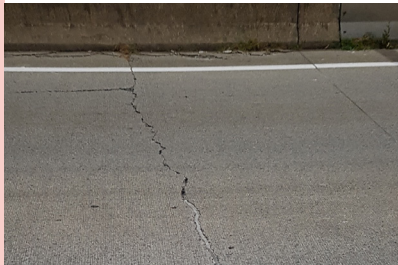
Transverse crack (CT)

Unconnected crack travelling transversely across the slab.

- Crack width (mm)
- Crack spacing (mm)
- Crack length (m)
- Area affected (m²)

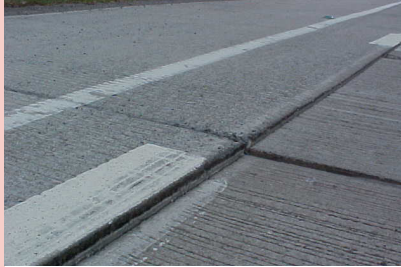
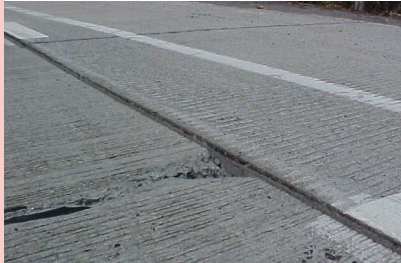
Differential residual vertical displacement of abutting slabs at joints and cracks creating a 'step' deformation.

Pumping of fines often occurs with faulting.

The pumping action may cause the approach slab to be higher in elevation than the departure slab.

- Difference in elevation 9 mm across the joint or crack
- Number of slabs affected

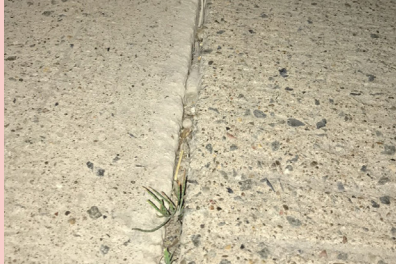
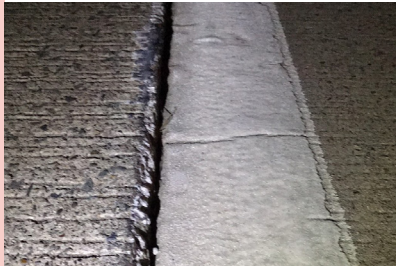
Joint Seal defects (JD)

Loose material entering joints due to the loss, stripping and/or cracking of the joint's seal.

- Percentage (by length) of joint affected

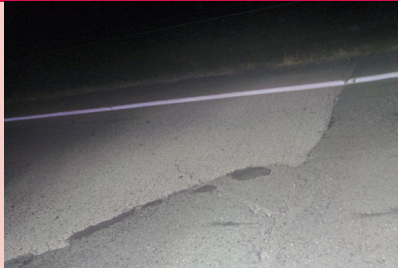
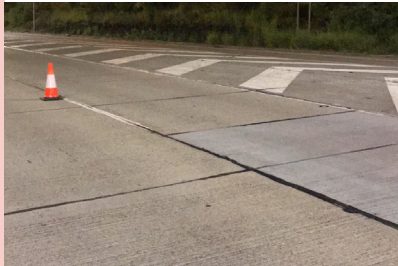
Patch (PA)

Localised area that has been replaced with new material for repair purposes.

- Area of patch (m²)
- Number of patches (m)

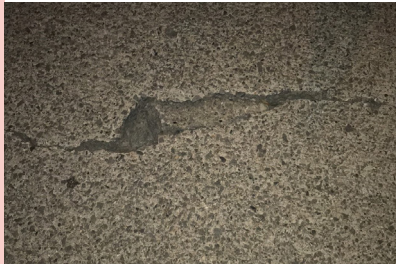
Pothole (HO)

Depression or broken part of the slab that is roughly bowl shaped.

- Depth of hole (mm)
- Area of pothole (m²)
- Number of potholes

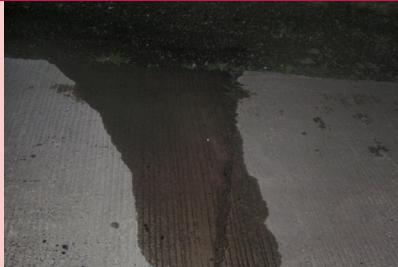
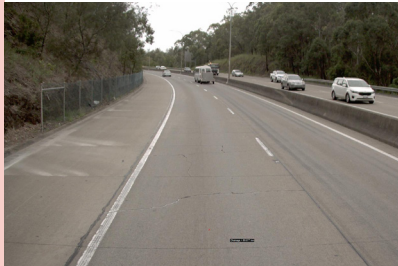
Pumping water and stains (DP)

Seepage that emerges through pavement cracks.

Fines have been carried from the base, subbase(s) and/ or subgrade to the pavement surface.

After the water has ceased the carried fines stain the pavement, resulting in pumping stains.

The severity of this defect cannot be determined by a visual inspection. At a later stage, voids or weak spots may develop within the granular or subgrade layers, as more fines are pumped out. This will affect the pavement strength and integrity. Early intervention and testing are recommended to assess the severity of the issue.

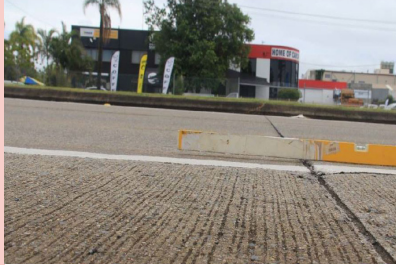
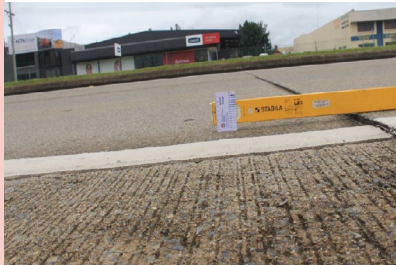
Rocking (DK)

Dynamic phenomenon where vertical movement occurs at a joint or crack due to live traffic loads.

- Magnitude of movement caused by the passage of a standard axle – cannot usually be quantified

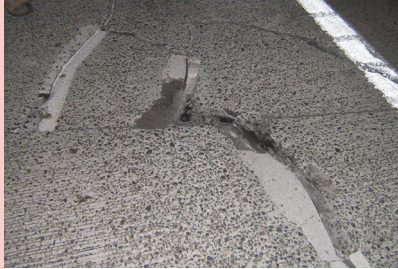
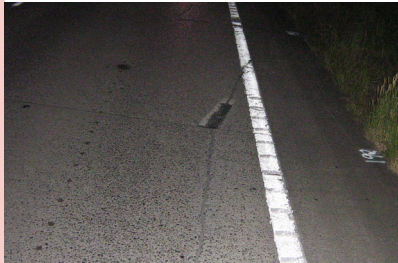
Spalling (LL)

Disintegration, breakdown, cracking or chipping at joint, or crack edges.

- Maximum depth of spall (mm)
- Length of joint or edge affected (m)

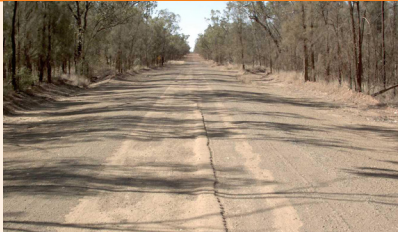
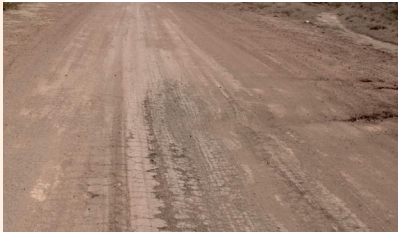
Channel (DN)

Linear feature that is irregularly sided, steep and commonly occurs in the direction of wheel path or maximum slope.

- Depth of channel (mm)
- Length of road affected (m)

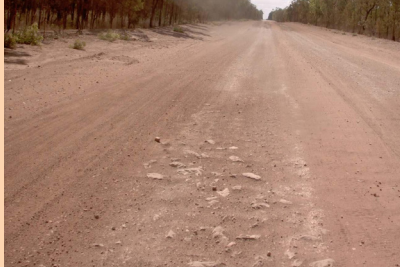
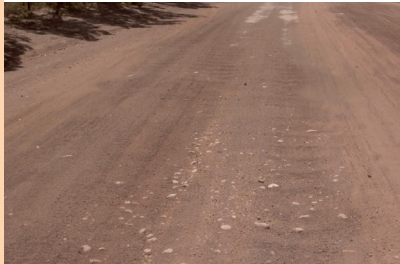
Pavement surface has coarse aggregate or rock (great than 75mm particle size) protruding the surface layer.

Can also contain loose material.

- Projection of aggregate, proud of average pavement surface (mm)
- Area affected (m²)

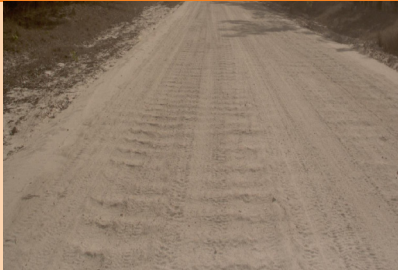
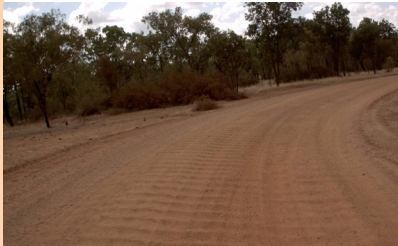
Corrugations (DC)

Closely and consistently spaced transverse undulations on the surface.

- Maximum depth under 1.2 m straight edge (mm)
- Crest-to-crest spacing (mm)
- Length of pavement affected (m)

- The quality of base material used, is insufficient for the local climate and traffic conditions. Common in dry conditions.

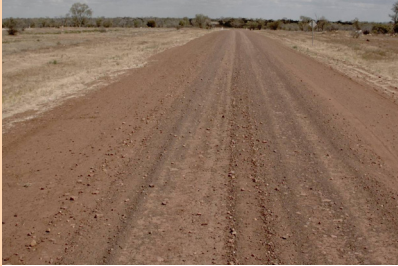
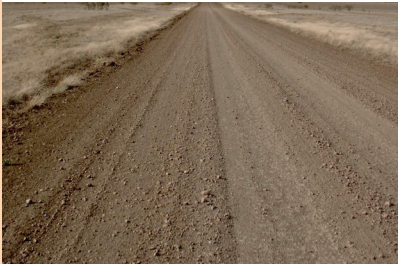
Loose materials (SL)

Surface contains unbound fine and/or coarse aggregate materials.

- Thickness of loose material (mm)
- Particle type (dust, sand, gravel)
- Length of affected pavement (m)

- Environmental or traffic actions have loosened weakly bound pavement materials.
- Materials have been transported onto or away from the roadway via wind or water.

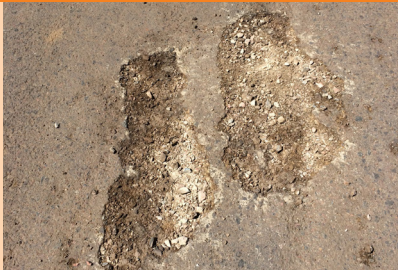
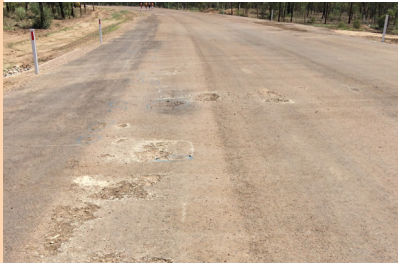
Pothole (HO)

A cavity that penetrates the pavement layers and is bowl shaped or irregularly shaped.

- Depth (mm)
- Area of pothole (m²)
- Number of potholes

- Collection and pooling of water.
- Moisture or traffic action has weakened the pavement.
- Insufficient initial compaction.

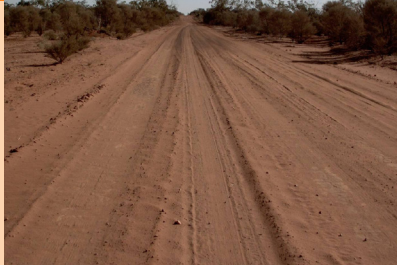
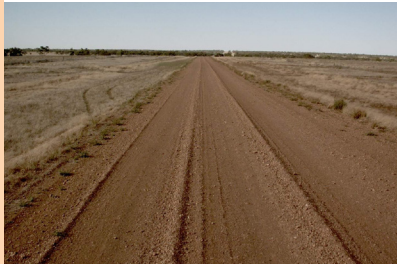
Deformation located at wheel paths that is relatively smoothed and travels longitudinally.

Steep sided ruts are created due to local wet weather.

- Maximum depth under a 1.2 m straight edge (mm)
- Length of pavement affected (m)

- The subgrade or pavement layer has insufficient moisture resistance/wet strength.
- Erosion of surface material.
- Excessive loose material.
- Traffic compaction of pavement or subgrade.

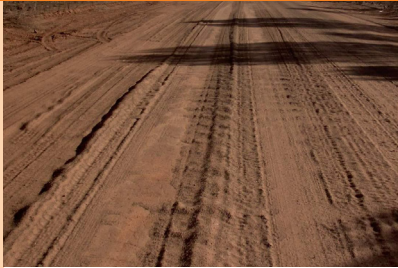
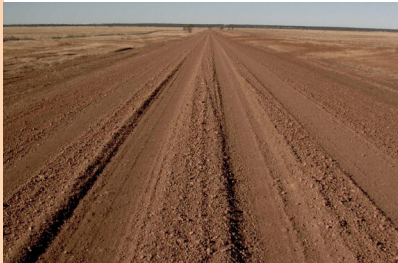
Shoving (DS)

Plastic bulging of surface associated with depression or rutting.

- Depth from high point under a 1.2 m straight edge (mm)
- Area affected (m²)

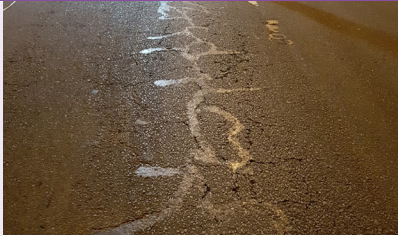
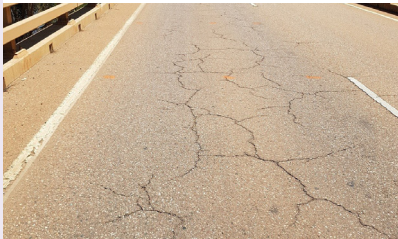
Crocodile crack (CR)

The polygons are often confined to wheel paths and are generally less than 150 mm.

Begin as longitudinal cracks and develop over time into crocodile cracking.

- Predominant width of crack (mm)
- Area affected (m²)

- Insufficient wearing surface thickness.
- Increased heavy vehicle loading has exceeded wearing surface load bearing capacity.
- Wearing course has become brittle with age.

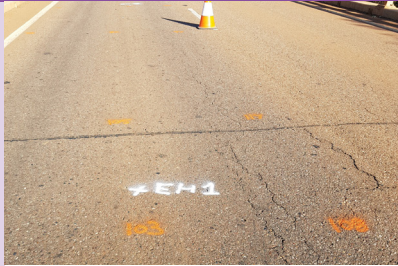
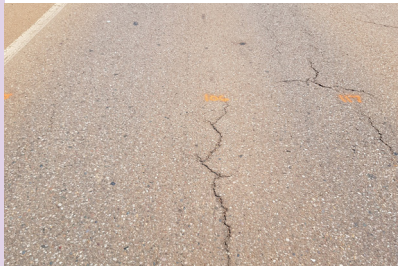
Longitudinal crack (CL)

Cracks that run longitudinally with the direction of traffic.

These cracks can occur as singular or as a series of parallel cracks.

Some branching may occur.

- Width of dominant crack (mm)
- Length of dominant crack (m)
- Spacing (mm)
- Area affected (m²)

- Reflection of a shrinkage crack or joint from an underlying concrete bridge deck unit.
- Incorrectly constructed joint in asphalt surfacing.

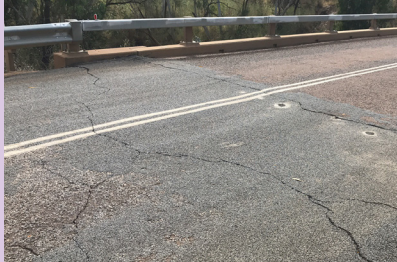
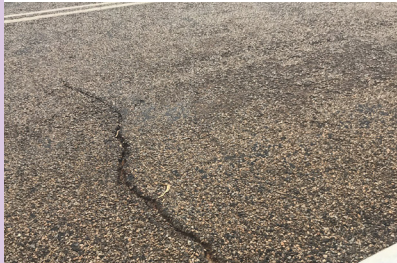
Meandering crack (CM)

Singular or group, cracks that vary in direction.

- Predominant width of crack (mm)
- Length of crack (m)
- Area affected (m²)

- Reflection cracking from the underlying pavement base material or concrete bridge deck unit.
- Ageing and brittle wearing surface.

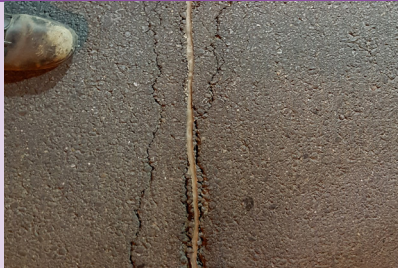
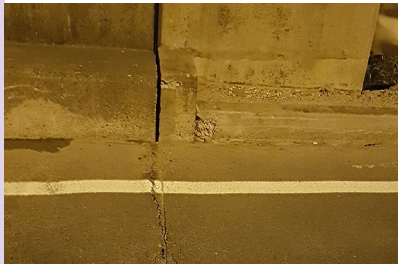
Transverse crack at saw cut joint (CMTJ)

Multiple, commonly unconnected crack in transverse direction at bridge joints.

- Predominant width of crack (mm)
- Length of crack (m)
- Area affected (m²)

- Bridge joint movements.
- Aged and damage DWS joint.
- Unsuitable DWS joint.
- Damaged underlying bridge deck concrete nosing.

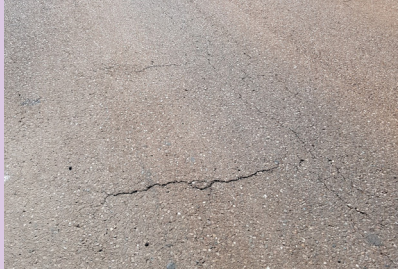
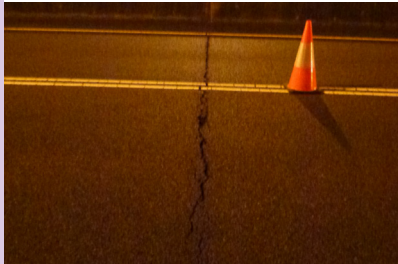
Transverse crack (CT)

Unconnected crack travelling perpendicular to the direction of traffic.

- Predominant crack width (mm)
- Spacing (mm)
- Length (m)
- Area affected (m²)

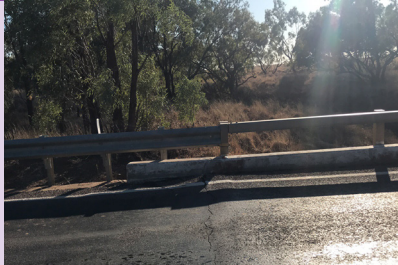
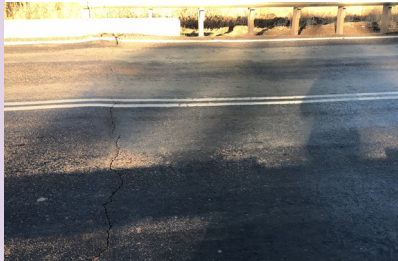
Abutment settlement (DAS)

Wearing surface on abutment and bridge deck is not even and in worse cases forming a step.

- Repetitive heavy vehicle loading has caused the abutment fill or subgrade to settle.
- Abutment erosion has created void under relieving slab.
- Inadequate compaction on the upper layer abutment.

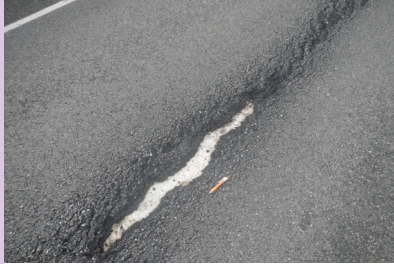
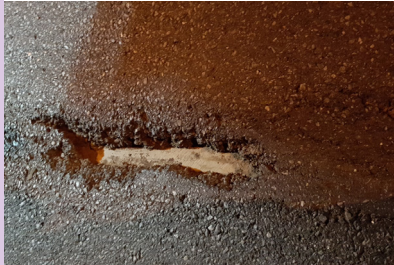
Asphalt split (DSA)

A crescent shaped crack that is more severe and deeper than the standard crescent crack.

- Crescent cracks that have not been repaired and have continued to develop/deteriorate.

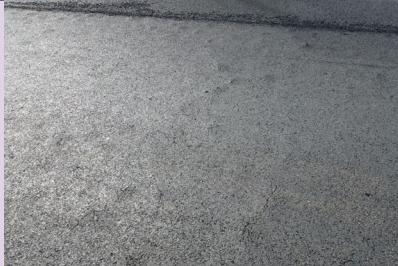
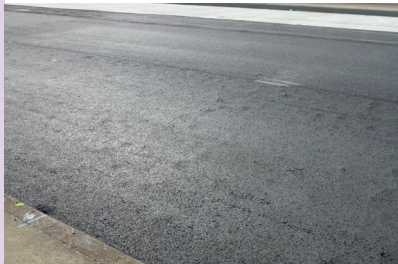
Asphalt Blister (DB)

Asphalt blisters or bubbles that appear on the freshly laid asphalt surface.

- Commonly occur on asphalt over liquid sprayed waterproofing membrane that has been installed in hot weather or summer.
- Chemical components of the waterproofing membrane may not be suitable for hot weather condition and require adjustments or alterations.
- When hot mixed asphalt is placed, excessive moisture on the concrete deck turns into steam. This steam is trapped underneath waterproofing membrane and when expanding it forms voids or bubbles that push up asphalt layer, creating asphalt blisters.

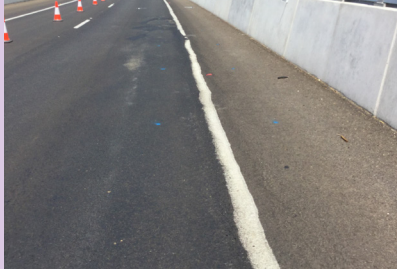
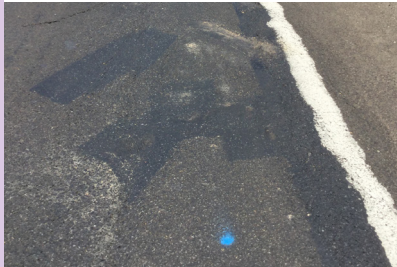
Corrugations (DC)

Transversely oriented undulations in the asphalt surface.

- Insufficient bonding between asphalt and waterproofing membrane.
- Substandard asphalt has become malleable due to hot climates.
- Asphalt has slipped/moved from the deck surface.

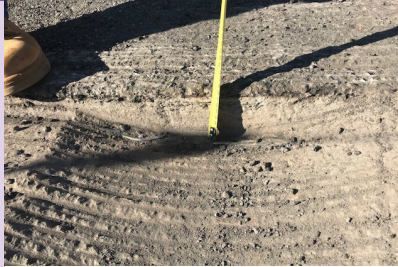
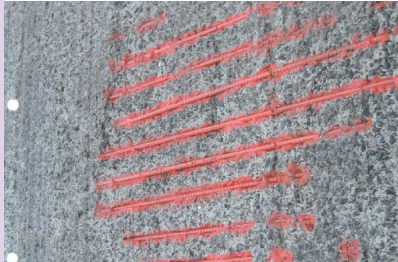
Damaged concrete bridge deck (DCBD)

Concrete cover of bridge deck has been reduced. Reinforcing steel or post tensioned strands within concrete deck have become exposed or damaged.

- Asphalt profiler operator miscalculating the milling depth thus causing the profiler machine to mill too deep and damage concrete bridge deck.
- This damage may occur during removal of existing asphalt deck wearing surface or during texturing of the concrete bridge deck.

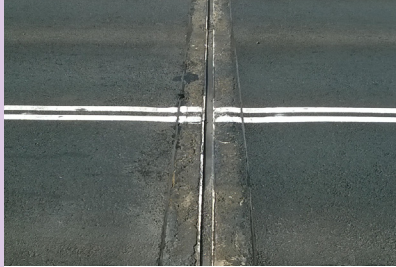
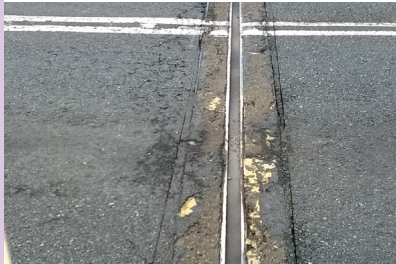
Damaged epoxy on bridge joint nosing (DDE)

Epoxy on expansion joint nosing has begun to deteriorate (severe cracking, plugging off or peeling off).

- Ageing.
- Traffic loading.
- Extreme weather conditions.
- Incorrect installation.

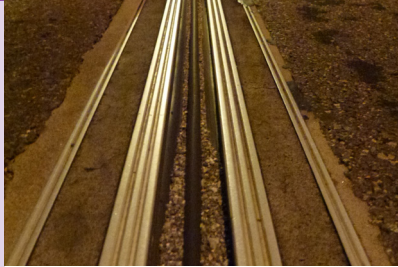
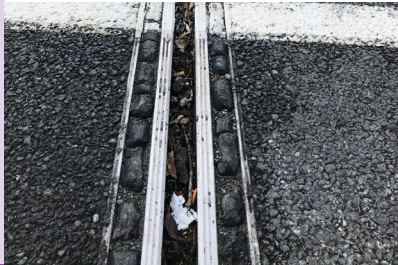
Debris in expansion joint gap (DDEJ)

Expansion joint's gap above seal gland has filled with debris and loose materials.

- Accumulated road debris over the years.
- Lack of bridge joint maintenance.

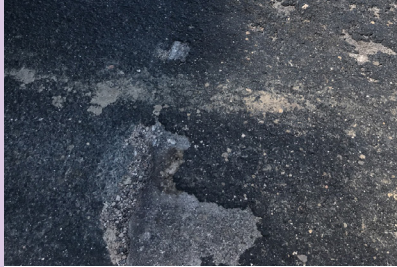
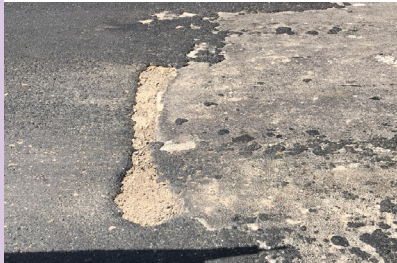
Delamination (SD)

The wearing surface has peeled off.

- Thickness of layer(s) removed (mm)
- Area (typical) of individual defects (m²)
- Number of defects

- Insufficient cleaning and surface preparation before installation of wearing surface layer has resulted in a poor bonding.
- Traffic action and/or water penetration have weakened the bond between wearing surfacing layer and the layer below.

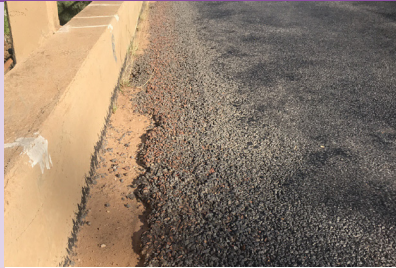
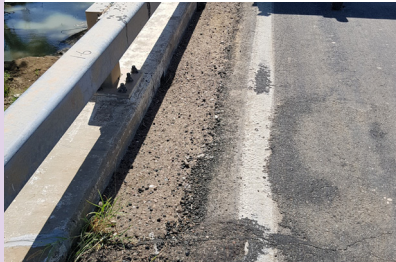
Edge of bituminous surface has become fretted, broken, absent or irregular.

Over the years, debris have accumulated along the bridge kerb and obstruct the scupper drains.

- Maximum width of surfacing loss along the kerb (mm)
- Length over which break occurs (m)

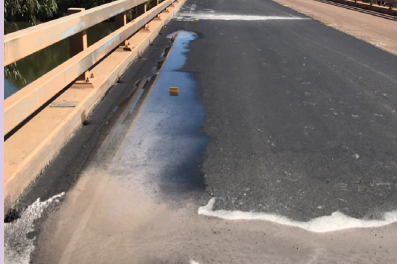
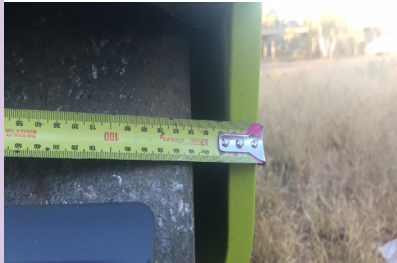
The level of the asphalt at the edge of the deck wearing surface has not been properly compacted, therefore creating a step.

This lip then obstructs water from being able to drain through the scuppers.

Water will then pond on the wheel paths of the deck, resulting in potential aqua planing.

- The bridge railing prevents asphalt roller reaching bridge kerb due to inadequate compaction side clearance and therefore the drum of the roller could not compact the entire width of the asphalt.

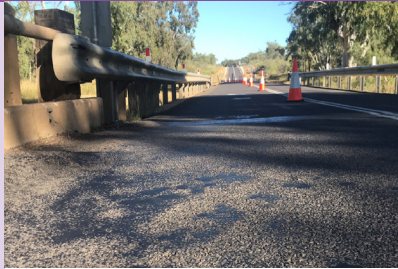
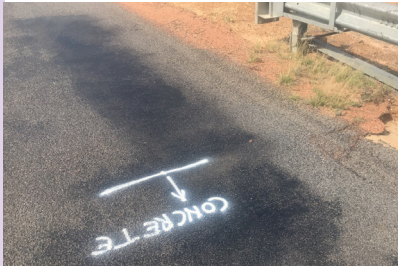
Flushing (SF)

Pavement surface layer contains excess amount of bitumen which results in patches. These patches have inadequate tyre-to-stone contact which lowers the skid resistance.

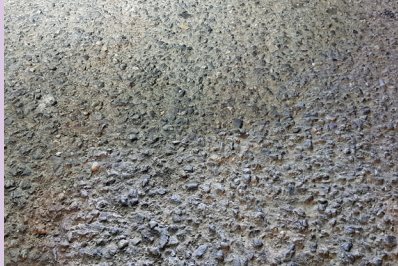
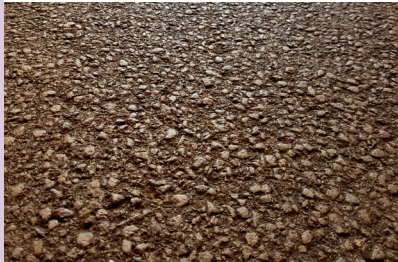
Polishing (SP)

Deck wearing surface aggregates have become polished, smoothed, and appear shiny.

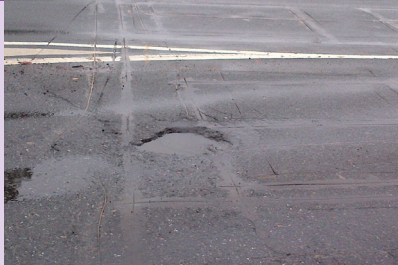
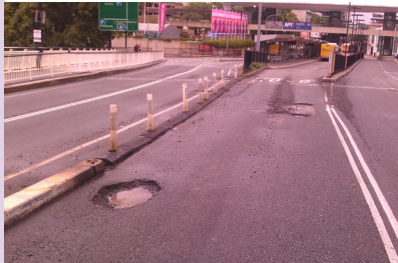
Pothole (HO)

Varying sized, bowl-shaped cavity in the pavement surface that extends into wearing surface, base layers and/or subgrade layer.

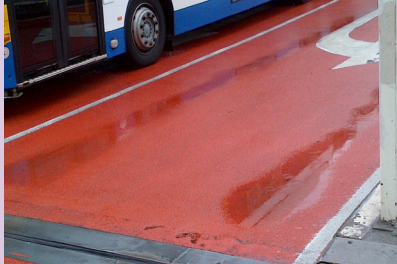
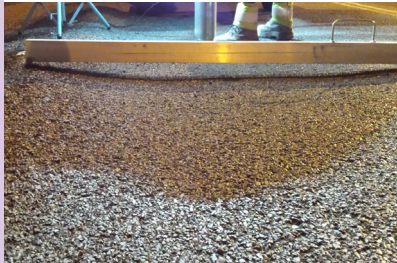
Rutting (DR)

Channelised depressions that are located along wheel paths.

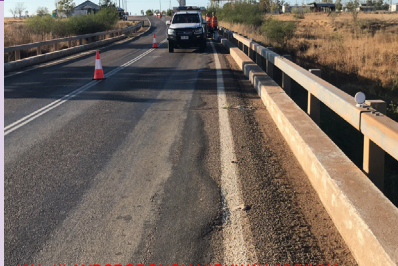
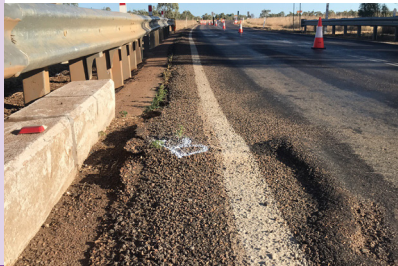
Swells, bulges and horizontal deformations that have developed along the wheel path.

Swelling can also occur in locations where there are severe horizontal stresses i.e. roundabouts.

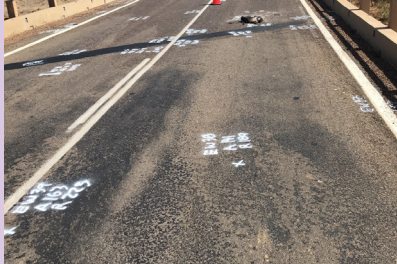
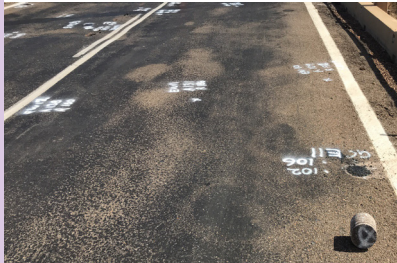
Can happen as the loss of individual stones, or as the complete loss of stones within the layer.

Stripping can lead to development of potholes.
